# Site Sensitivity Verification Report

## PROPOSED UPGRADE OF THE DR3342 BETWEEN DR3463 NEAR GASESE AND N14 NEAR WASHINGTON, NORTHERN CAPE PROVINCE

**RE: SITE SENSITIVITY VERIFICATION REPORT FOR BASIC ASSESSMENT APPLICATION FOR PROPOSED UPGRADE OF THE DR3342 BETWEEN DR3463 NEAR GASESE AND N14 NEAR WASHINGTON, NORTHERN CAPE PROVINCE.**

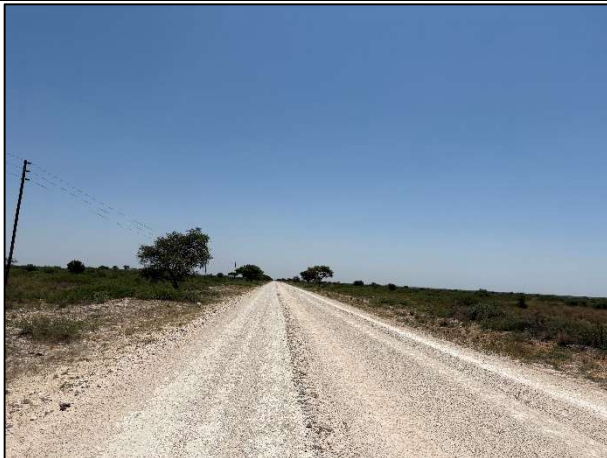
**Photo 1:** The road proposed to be upgraded is already thoroughly disturbed, compacted with road margins disturbed by prior road construction and maintenance and overgrazing.

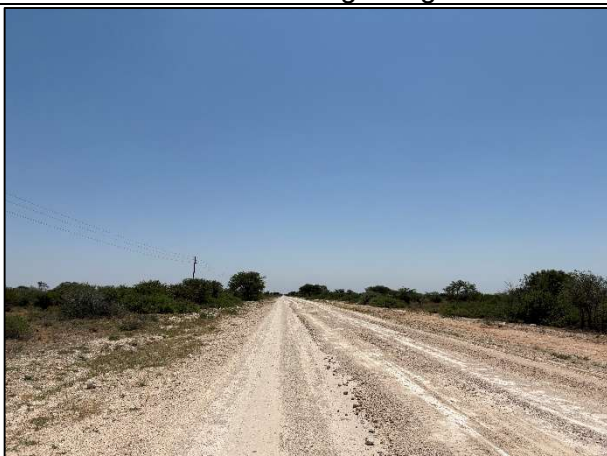
**Photo 3:** The same observations as noted at

photo location 1 was pertinent throughout most of the development footprint.

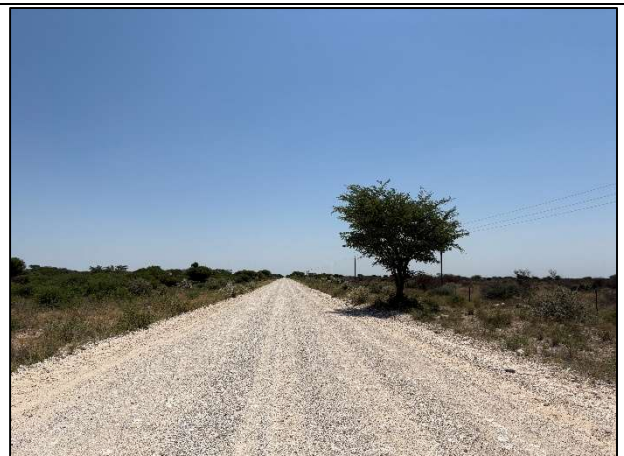
**Photo 4:** It was noted in the terrestrial ecological

assessment that a throughout walkthrough of the development footprint should be conducted to identify any protected flora before the commencement of development. This will take place to identify whether relocation permits need be applied for. Protected plant and SCC observation reporting procedures have also been included in the EMPr (Appendix G).

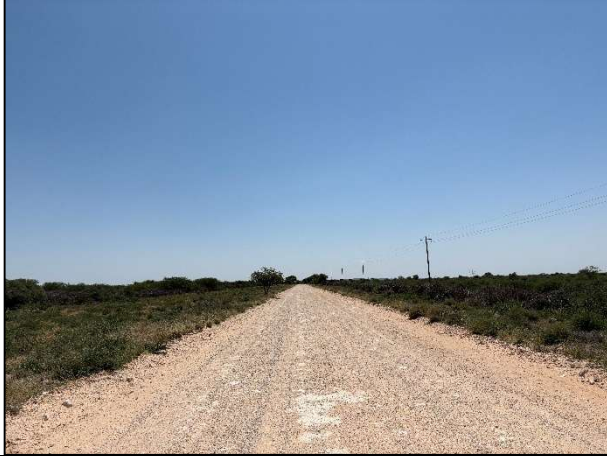
**Photo 5:** The same observations as noted at photo location 1 was pertinent throughout most of the development footprint.

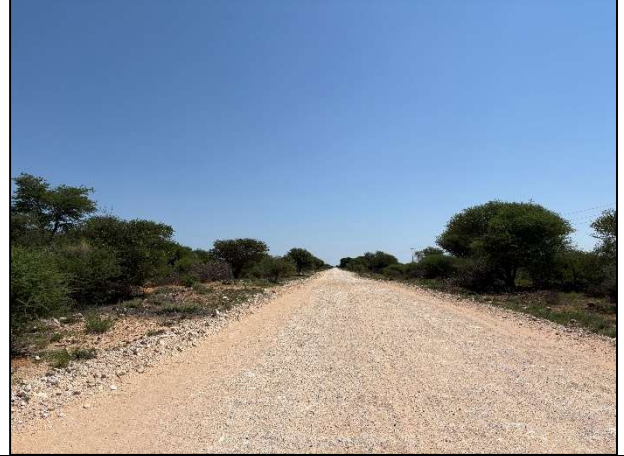
**Photo 6:** The same observations as noted at photo location 1 was pertinent throughout most of the development footprint.

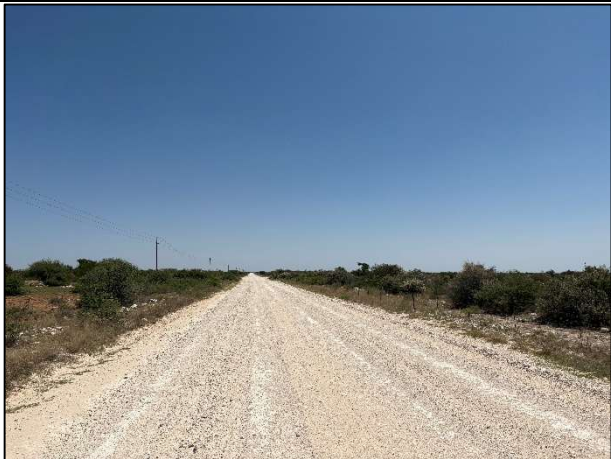
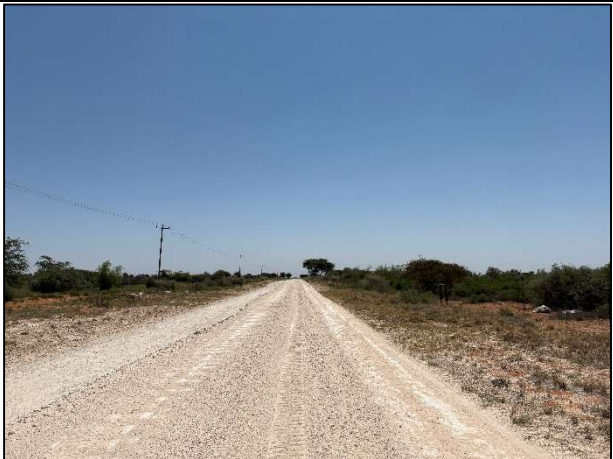
| <p><b>Photo 1:</b> The road proposed to be upgraded is already thoroughly disturbed, compacted with road margins disturbed by prior road construction and maintenance and overgrazing.</p> | <p><b>Photo 2:</b> The same observations as noted at photo location 1 was pertinent throughout most of the development footprint.</p> |

- **redirecting by-passes as far as possible to avoid clearance of trees**
- **rehabilitating the bypasses with indigenous grasses typical of the natural vegetation types of the area**
- **entirely avoiding the removal of trees which have active nests.**

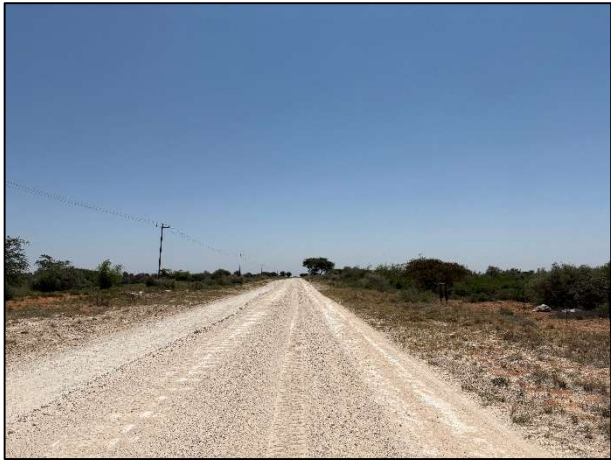
| <p><b>Photo 3:</b> The same observations as noted at photo location 1 was pertinent throughout most of the development footprint</p> | <p><b>Photo 4:</b> The same observations as noted at photo location 1 was pertinent throughout most of the development footprint</p> |

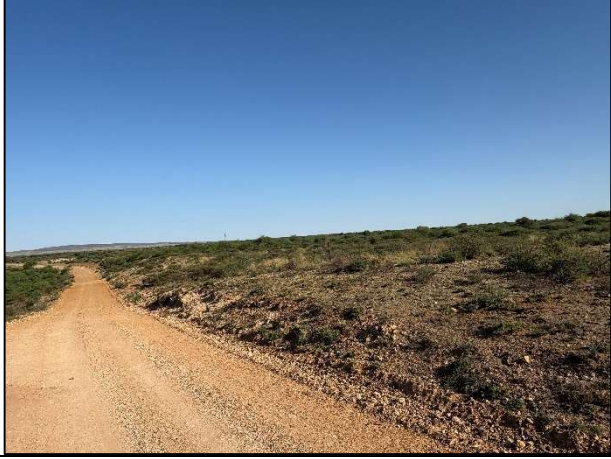
| <p><b>Photo 5:</b> Some areas adjacent to the proposed development were notably more pristine than others, such as when approaching the Mathwaring River. The development area itself, however, remains compacted, and cleared of vegetation being a gravel road.</p> | <p><b>Photo 6:</b> A greater degree of anthropogenic disturbance (mostly constructions) was observed in some areas adjacent to the proposed development area, notably as one enters into the town of Tsineng.</p> |

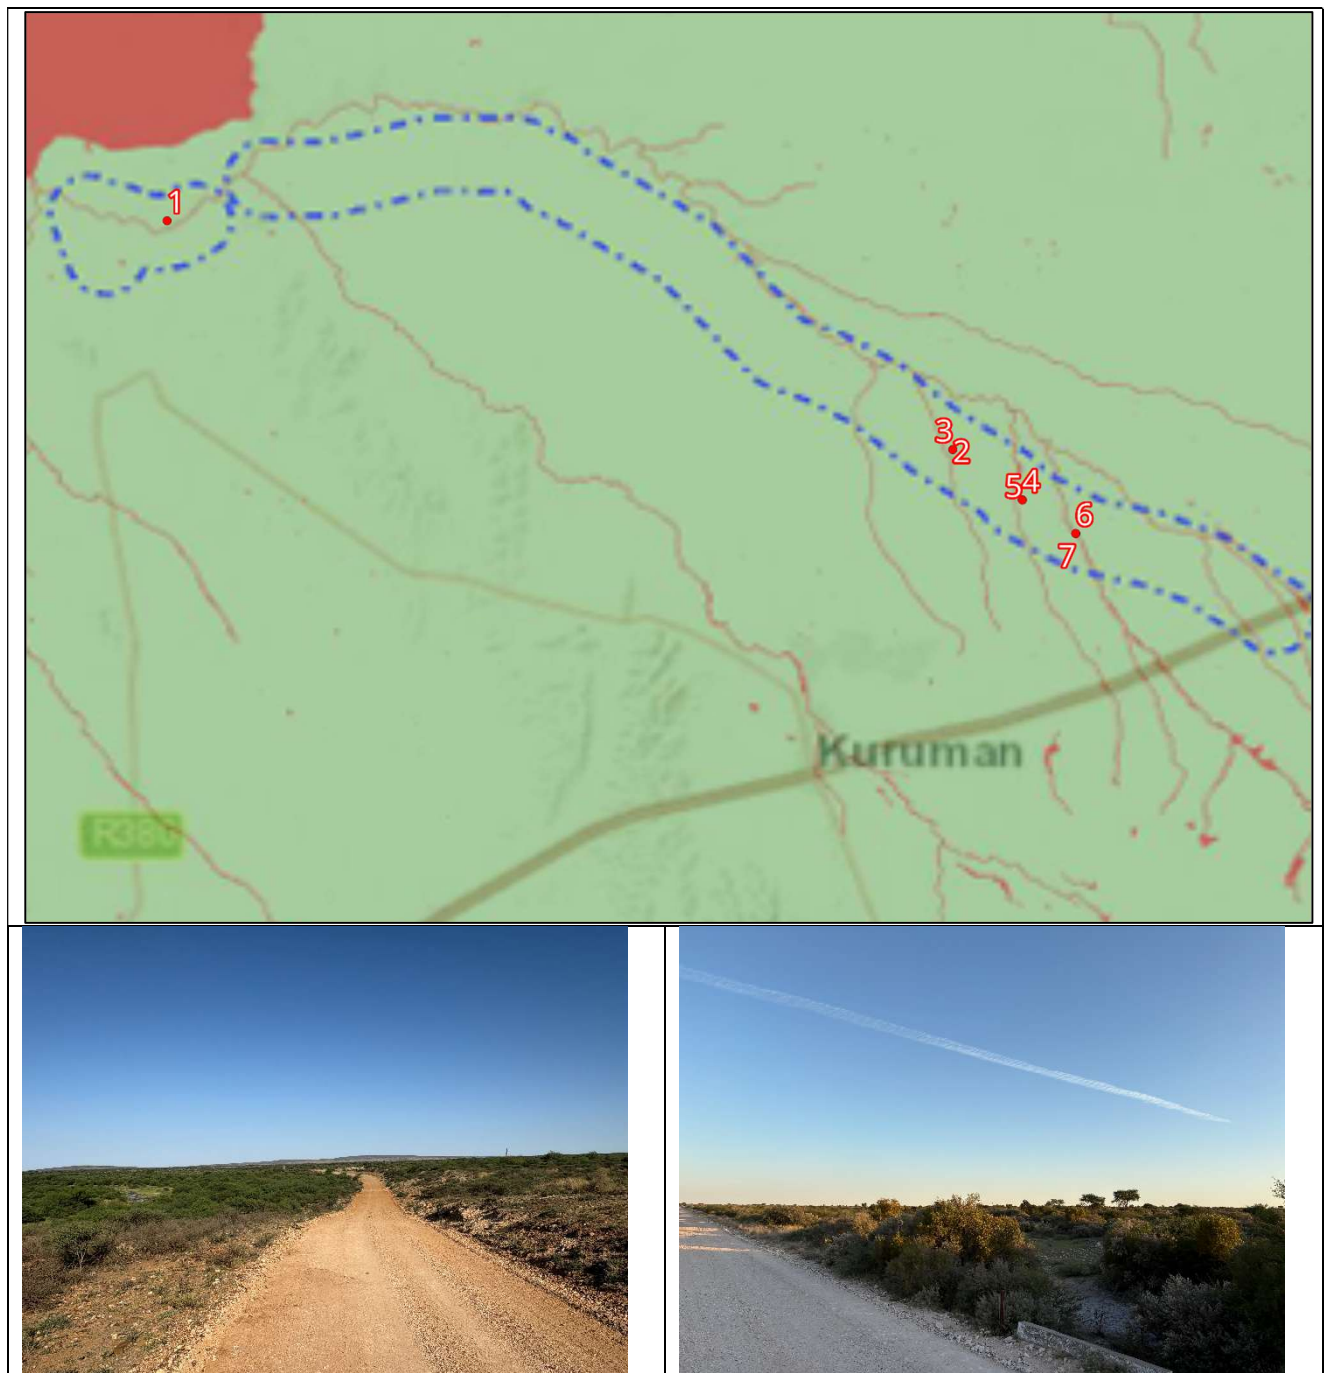
**Photo 1:** The Matlwharing River to the North of the development area. Multiple drainage lines were observed in this area.

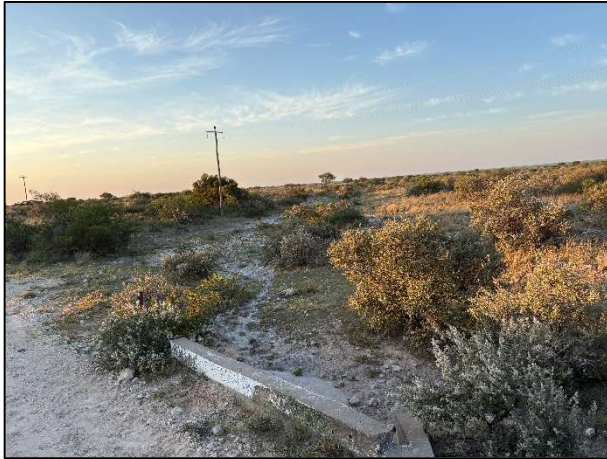
**Photo 2:** A culvert at a point at which the proposed development would cross an ephemeral watercourse (South-facing).

Furthermore, it should be noted that one of the major findings of the aquatic specialist report was to note the observed detrimental effect of the current infrastructure on account of the inadequacy of the culverts to accommodate the natural flow regimes at river crossings. This has also been noted by the design team who as part of the proposed upgrading of the D3342, propose to replace the current culverts with culverts with an increased throughput capacity where found to be historically inadequate.

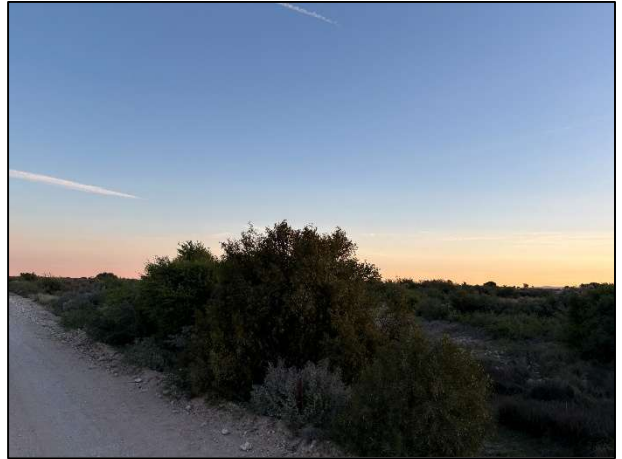
**Photo 3:** A culvert at a point at which the proposed development would cross an ephemeral watercourse (North-facing).

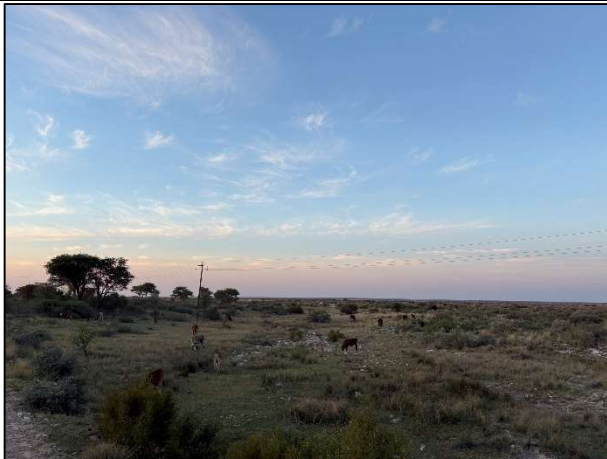
**Photo 4:** A point at which the proposed development would cross an ephemeral watercourse (South-facing).

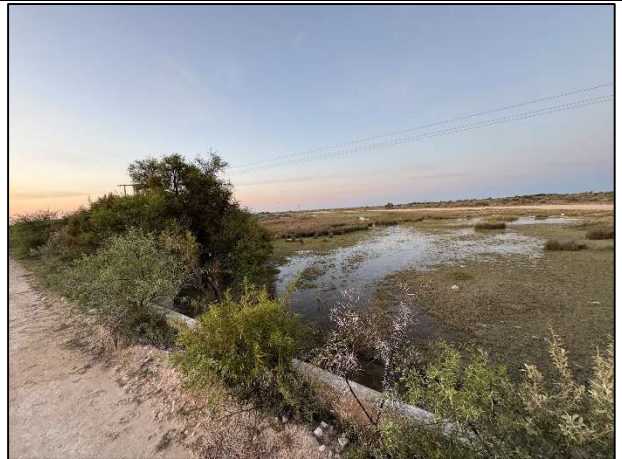
**Photo 5:** A point at which the proposed development would cross an ephemeral watercourse (North-facing), with evidence of overgrazing.

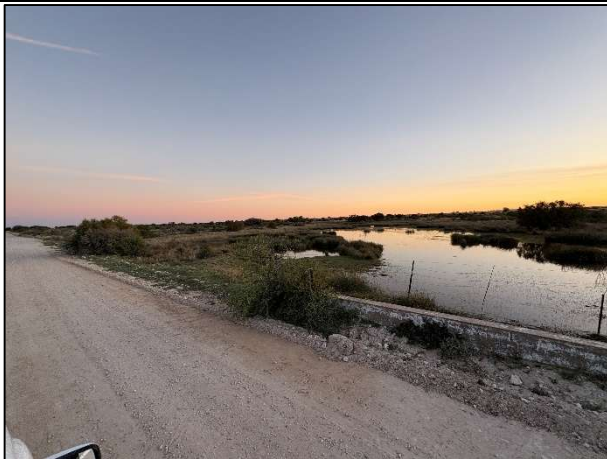
**Photo 6:** A culvert at a point at which the proposed development would cross a seasonal watercourse (North-facing).

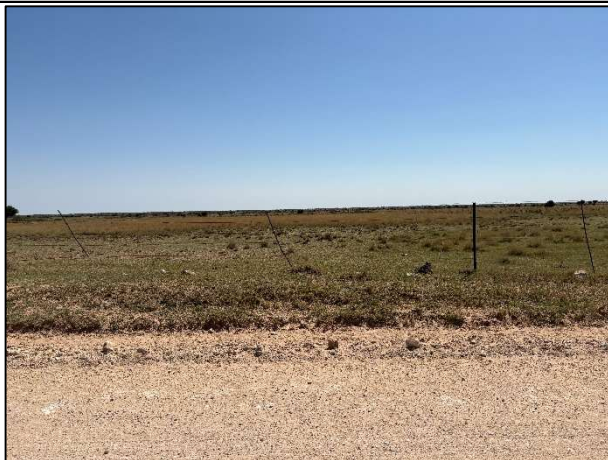
**Photo 1:** Fenceline indicating the edge of the road reserve within which the proposed development will take place.

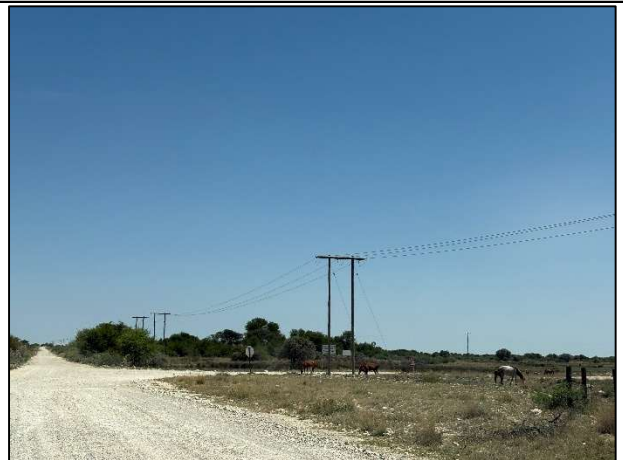
**Photo 2:** Phone cables, compacted road and livestock grazing indicating evidence of disturbance.

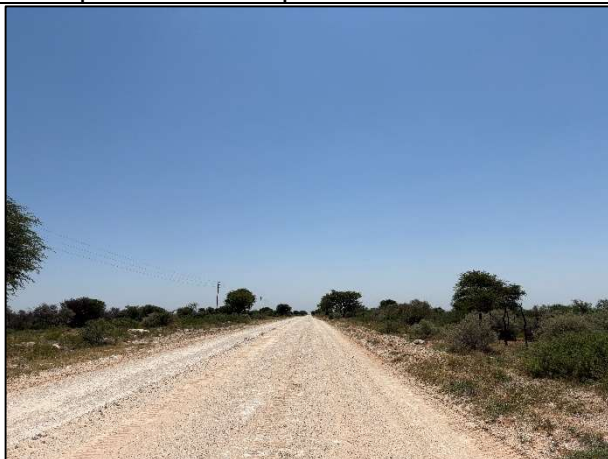
**Photo 3:** The typical appearance of the proposed development area (as noted in the Heritage

Heritage Impact Assessment) with degraded limestone and wind-blown soils of no discernible conservation value at the location of photo 3.

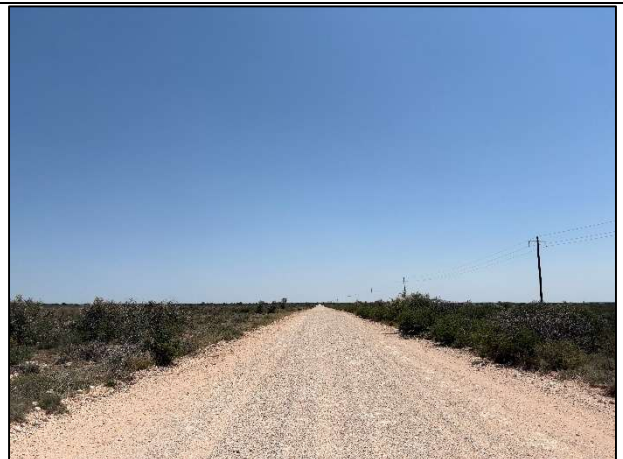
**Photo 4:** The typical appearance of the proposed development area (as noted in the

Impact Assessment) with degraded limestone and wind-blown soils of no discernible conservation value at the location of photo 3.

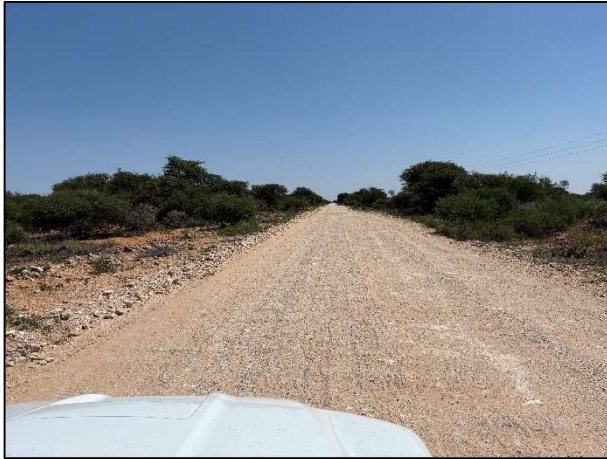
**Photo 5:** The typical appearance of the proposed development area (as noted in the Heritage Impact Assessment) with degraded limestone and wind-blown soils of no discernible conservation value at the location of photo 5.

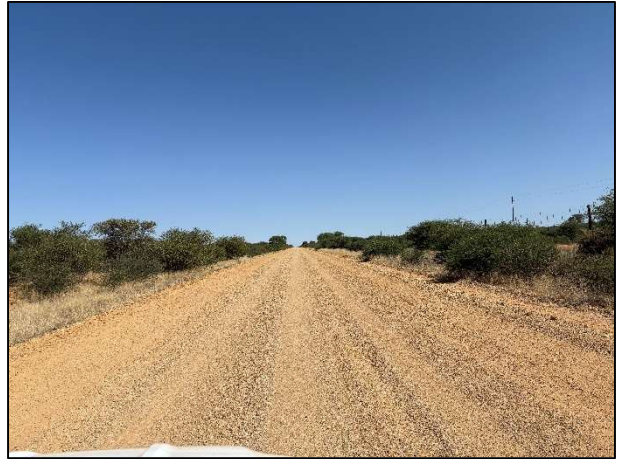
**Photo 6:** The typical appearance of the proposed development area (as noted in the Heritage Impact Assessment) with degraded limestone and wind-blown soils of no discernible conservation value at the location of photo 6.

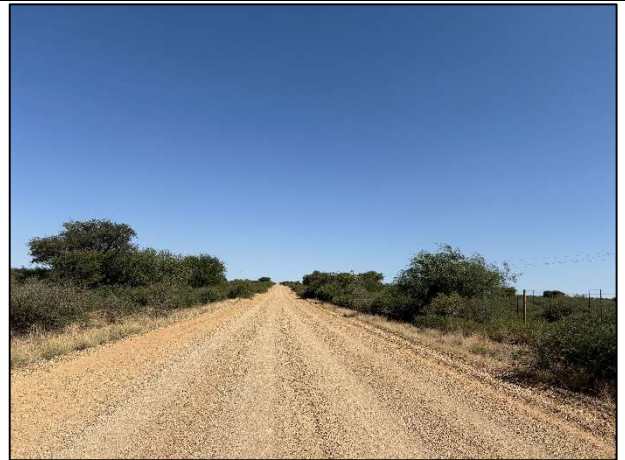
**Photo 2:** The low current road which approximates the height of the proposed development (being a road) between 8 and 15km of an aerodrome.

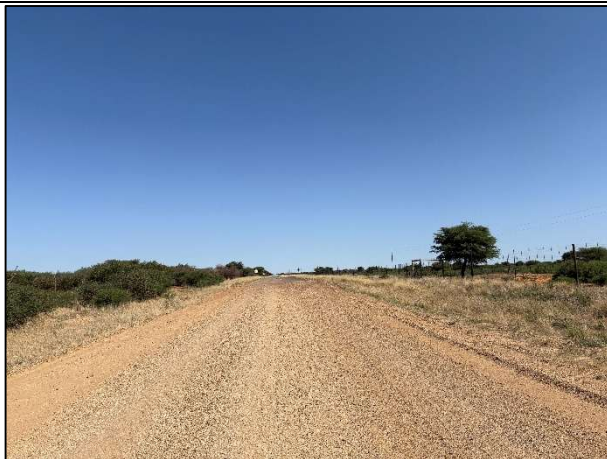
**Photo 3:** The low current road which approximates the height of the proposed development (being a road) within 8km of an aerodrome.

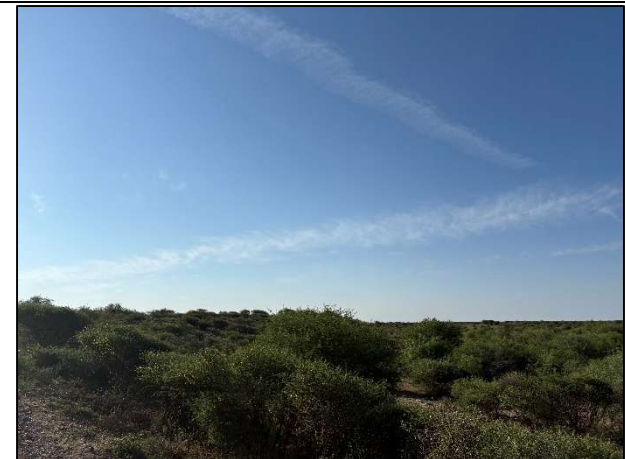
**Photo 4:** The low current road which approximates the height of the proposed development (being a road) between 8 and 15km of an aerodrome.

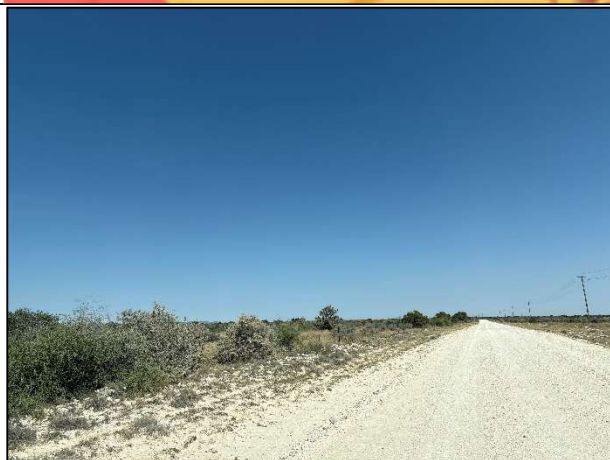
**Photo 1:** A thoroughly compacted gravel road surface displaying severely degraded limestone and windblown soils of no discernible conservation value typical of the proposed development area at photo location 1.

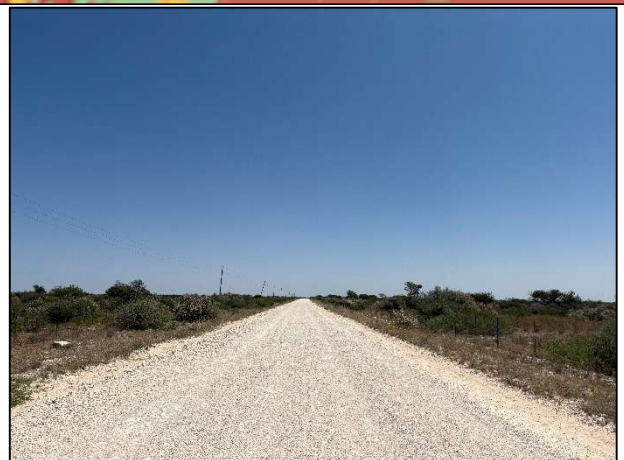
**Photo 2:** A thoroughly compacted gravel road surface displaying severely degraded limestone and windblown soils of no discernible conservation value typical of the proposed development area at photo location 2.

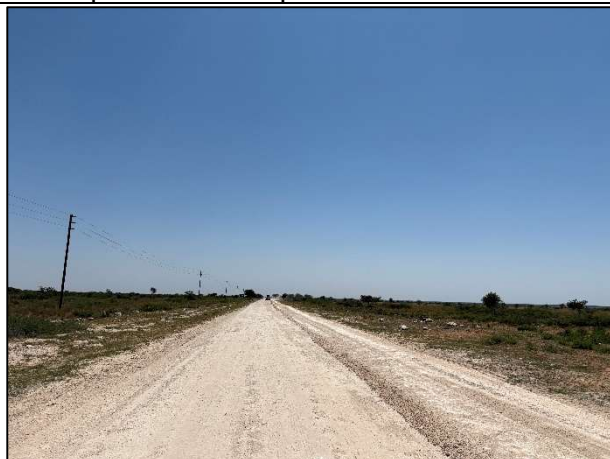
**Photo 3:** A thoroughly compacted gravel road surface displaying severely degraded limestone and windblown soils of no discernible conservation value typical of the proposed development area at photo location 3.

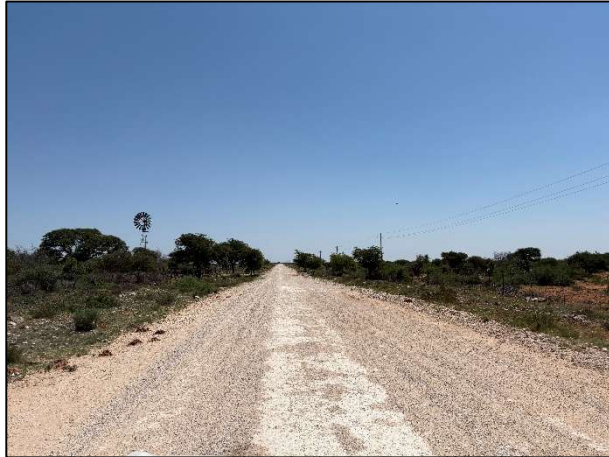
**Photo 4:** A thoroughly compacted gravel road surface displaying severely degraded limestone and windblown soils of no discernible conservation value typical of the proposed development area at photo location 4.

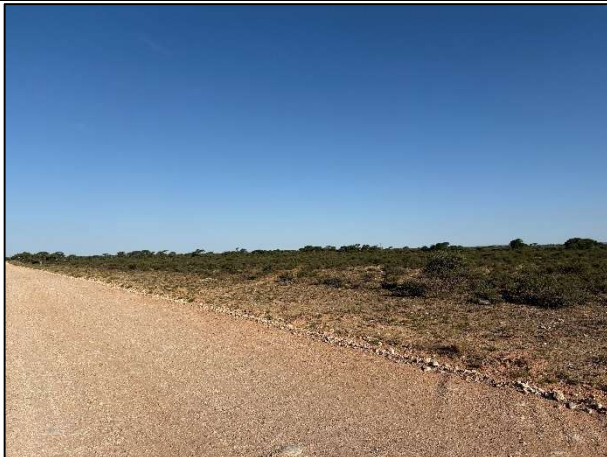
**Photo 6:** Surrounding landscape outside of the proposed development area indicating a watercourse (greenery beyond the drop off of the road) with which the palaeontological sensitivity is closely aligned.

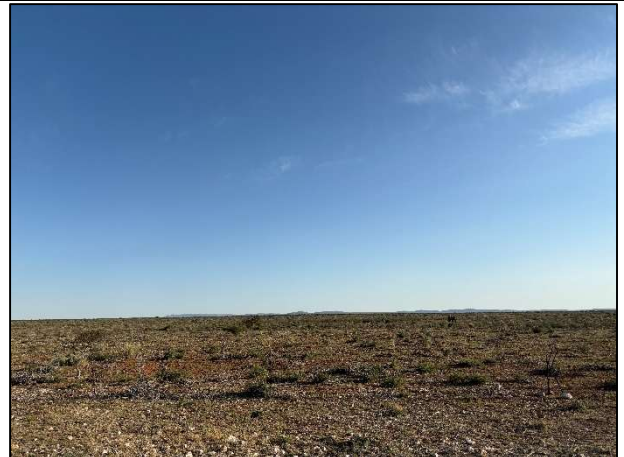
**Photo 7:** The road surface with the visible a disturbed road reserve (beyond which is the area anticipated by the DFFE screening tool to have a high palaeontological sensitivity).

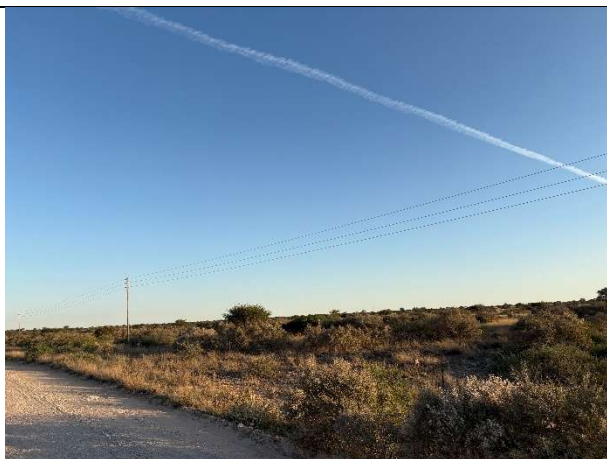
**Photo 8:** The landscape surrounding the road which the DFFE screening tool demarcates as having a high palaeontological sensitivity into which the development is not anticipated to expand.

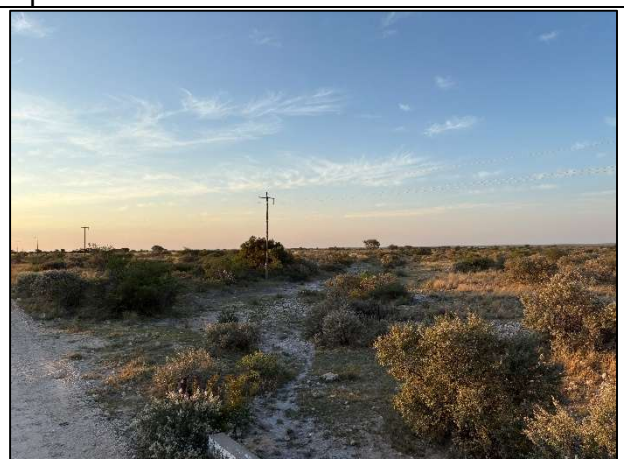
**Photo 9:** The landscape surrounding the road which the DFFE screening tool demarcates as having a high palaeontological sensitivity into

| <p>which the development is not anticipated to expand.</p> | <p>palaeontological sensitivity is closely aligned.</p> |

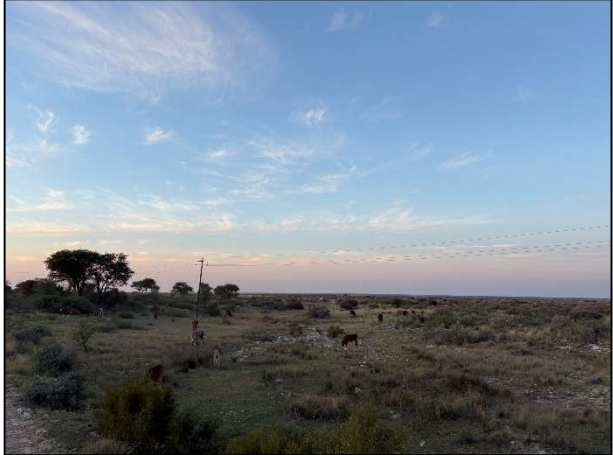
| <p><b>Photo 11:</b> Overgrazing activities seen in an ephemeral watercourse contributing to the area's disturbed nature.</p> | <p><b>Photo 12:</b> Surrounding landscape outside of the proposed development area indicating a watercourse with which the palaeontological sensitivity is closely aligned.</p> |

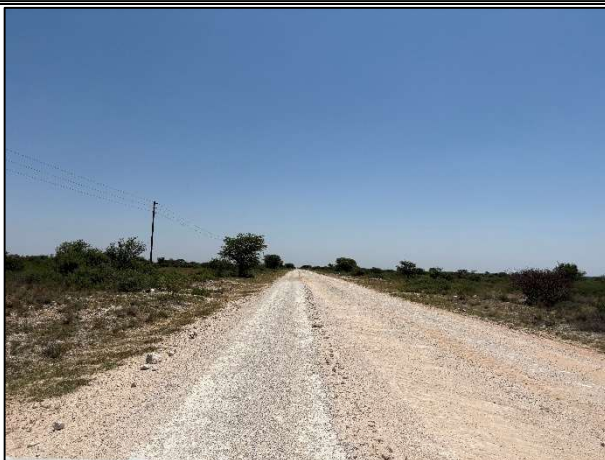
**Photo 1:** The thoroughly compacted and disturbed road surface typical of the proposed development surface area at photo location 1.

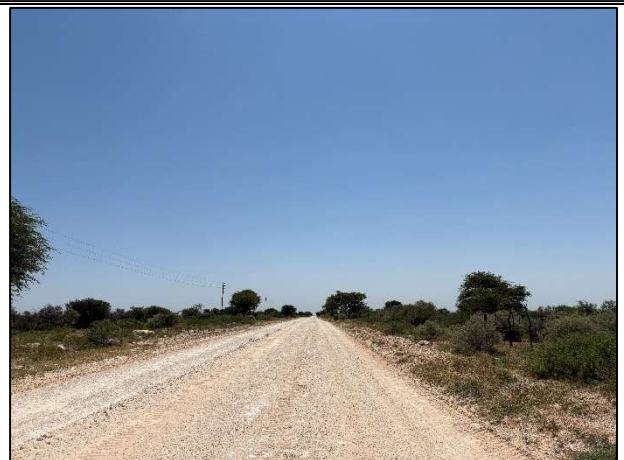
**Photo 2:** The thoroughly compacted and disturbed road surface typical of the proposed development surface area at photo location 2.

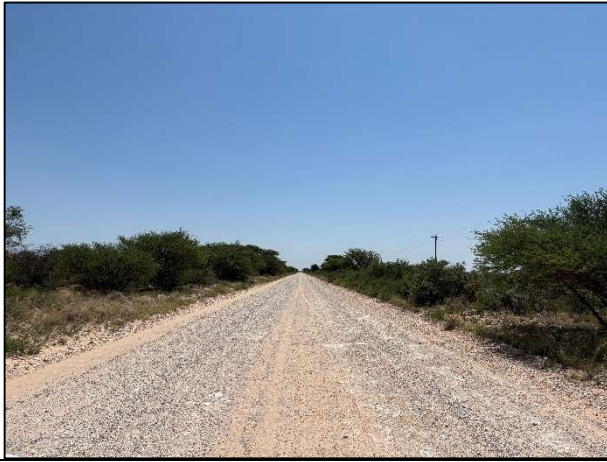
**Photo 3:** The thoroughly compacted and disturbed road surface typical of the proposed development surface area at photo location 3.

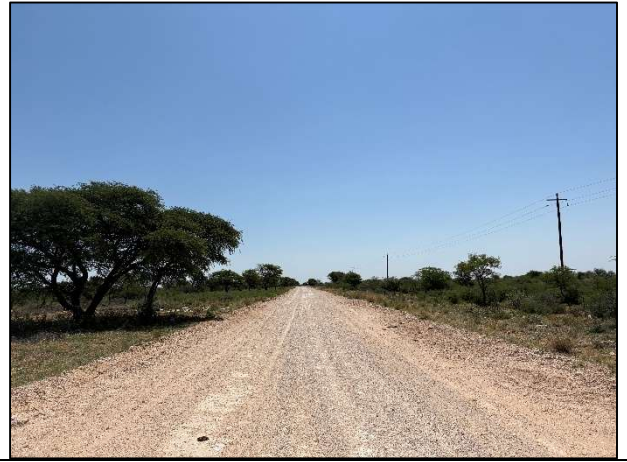
**Photo 4:** A thorough walk-through by a botanist has been recommended as a mitigation in the terrestrial ecological assessment which will determine the need for any removal or relocation permits for protected flora.

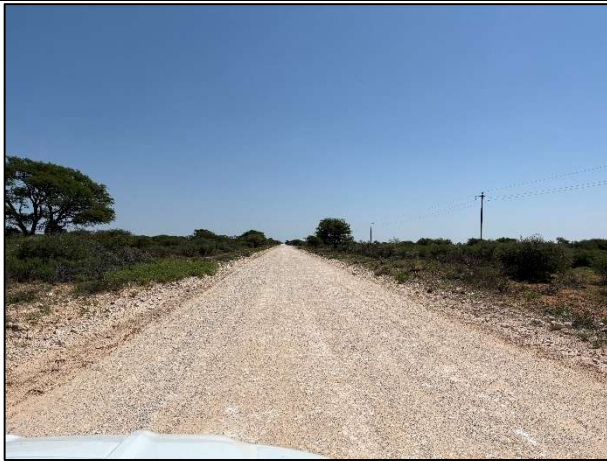
**Photo 5:** The thoroughly compacted and disturbed road surface typical of the proposed development surface area at photo location 5.

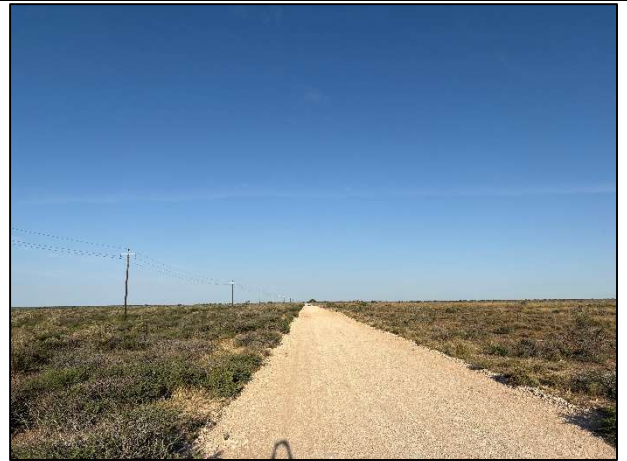
**Photo 6:** The thoroughly compacted and disturbed road surface typical of the proposed development surface area at photo location 6.

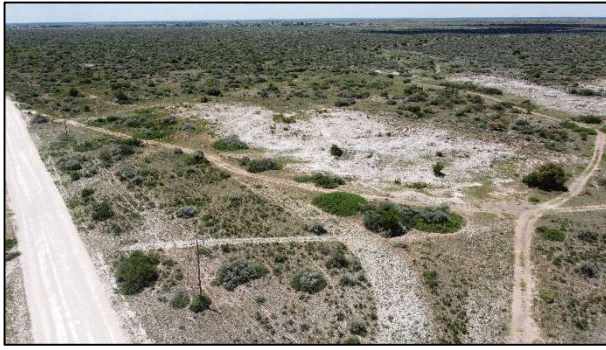
**Photo 1:** Anthropogenic land clearance with associated stockpiles accompanied by gravel access roads in an ephemeral watercourse.

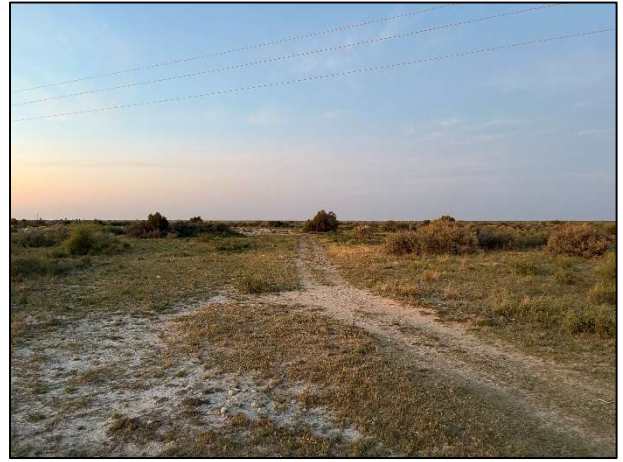
**Photo 2:** Access road leading to the stockpiles soil seen in photo 1.

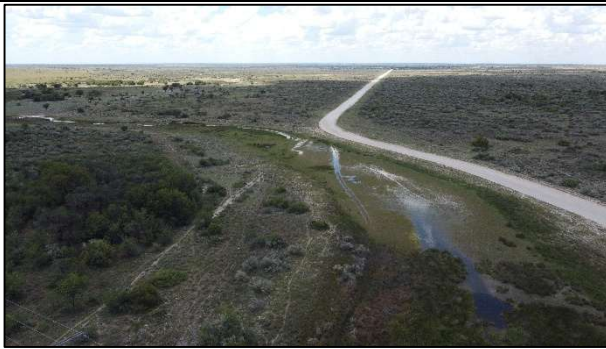
**Photo 3:** Gravel road adjacent to ephemeral watercourse which is crossed by the proposed development.

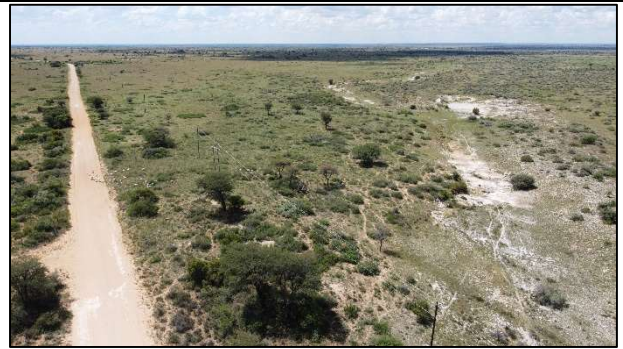
**Photo 4:** Dry ephemeral watercourse adjacent to the current gravel road proposed to be upgraded downstream of where the watercourse is crossed by the proposed development.

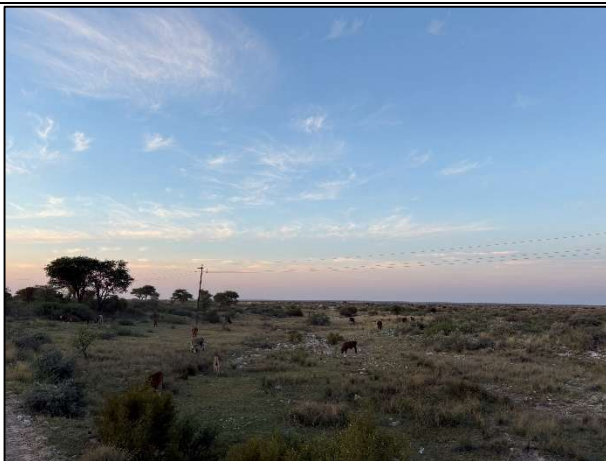
**Photo 5:** Indicators of overgrazing (cattle) and anthropogenic disturbance (powerlines) in the dry ephemeral watercourse.

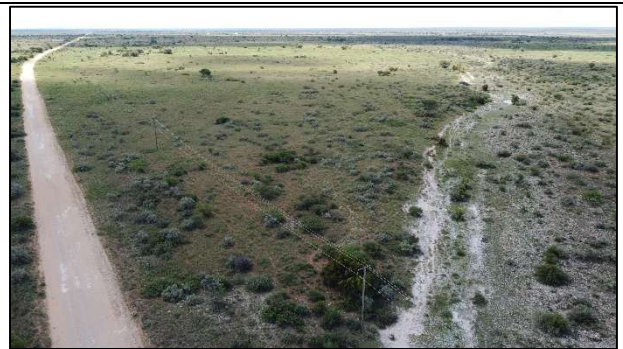
**Photo 6:** Dry ephemeral watercourse adjacent to the current gravel road proposed to be upgraded downstream of where the watercourse is crossed by the proposed development.

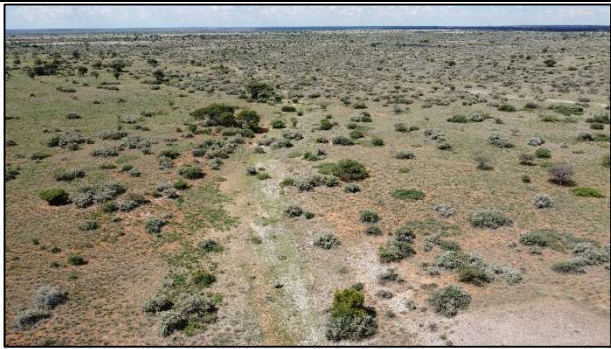
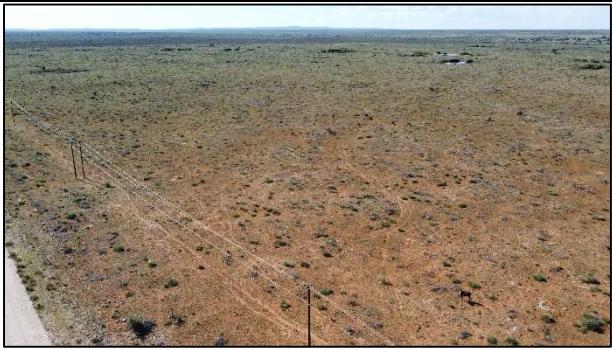
| <p><b>Photo 7:</b> Dry ephemeral watercourse adjacent to the current gravel road proposed to be upgraded downstream of where the watercourse is crossed by the proposed development.</p> | <p><b>Photo 8:</b> Overview of the CBA 1 associated with the 500m buffer around the pans observed below the horizon.</p> |
