# **Appendix D**

## **Specialist Reports:**

## **Wetland Assessment for the proposed upgrading of the road between Ga-Sese and Washington, situated to the north of Kuruman, Northern Cape Province.**

December 2024

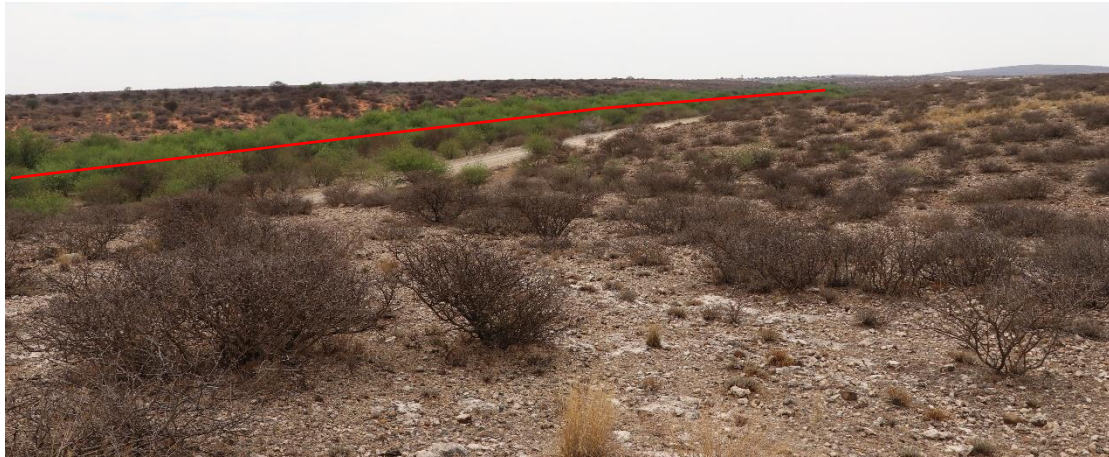
Figure 1: The landscape in this area is dominated by fairly uniform, flat plains, with some habitat diversity occurring along larger watercourses (Red).

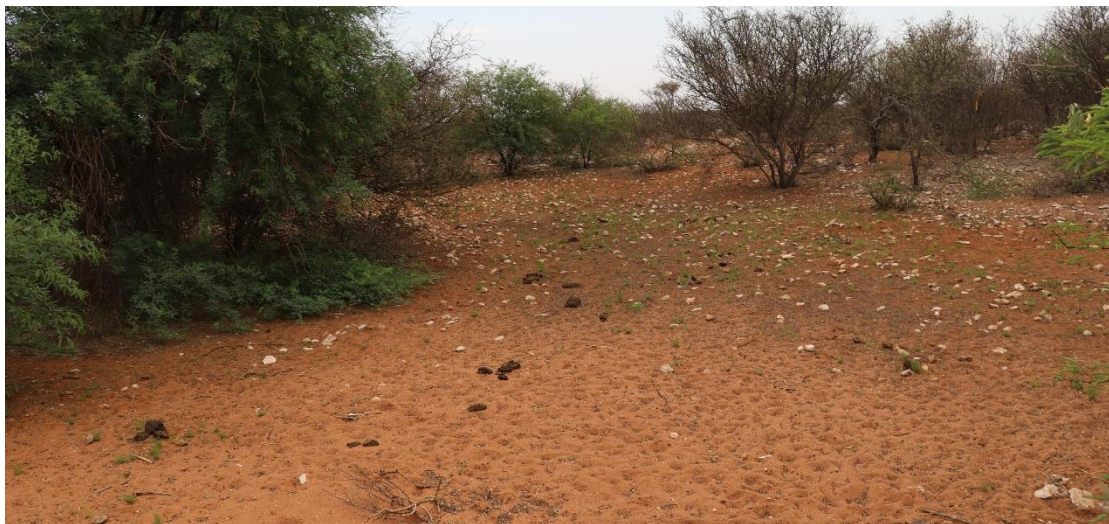
Figure 2: One of the main impacts is caused by trampling and overgrazing by domestic livestock, which is most evident along watercourses. Note also significant infestation by invasive *Prosopis glandulosa* trees.

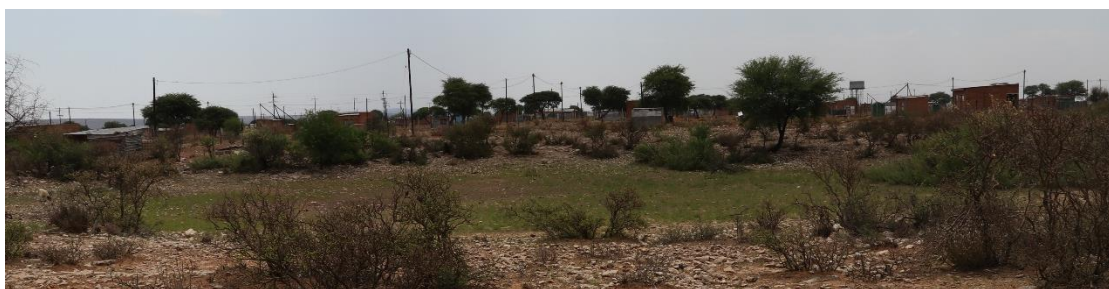
Figure 3: Rural settlements also contribute toward localised disturbances.

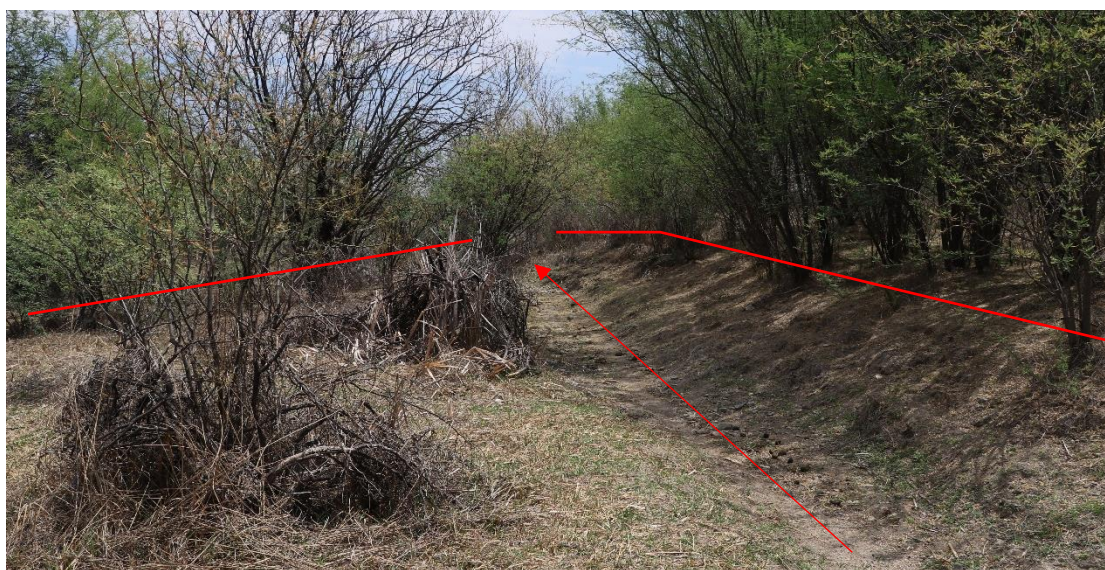
Figure 6: The affected watercourses contain an active channel and well-defined channel banks (Red). Flow also occurs as unidirectional flow within the channel (Arrow).

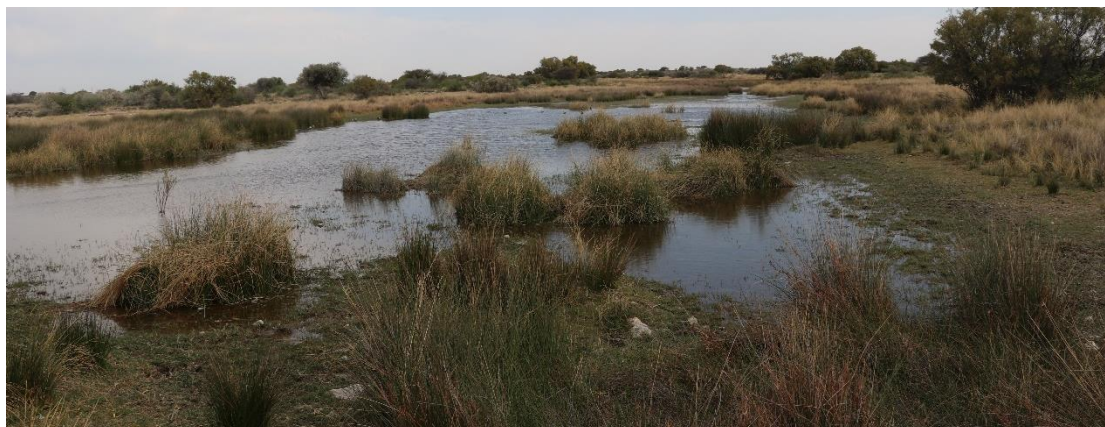
Figure 7: The Manyeding River contains extensive wetland conditions. Note the surrounding topography, which is clearly dominated by a flat plain, while valley side slopes are absent, thus indicating the system being a floodplain wetland.

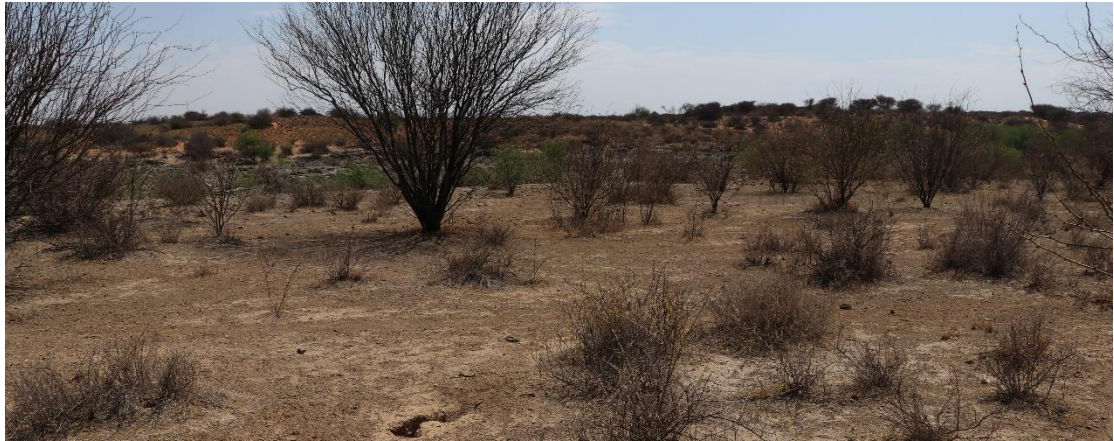
Figure 9: Watercourses and their floodplains are affected by very high levels of overgrazing and trampling by domestic livestock and this leads to a substantial decrease in vegetation cover, which will also contribute toward erosion and sedimentation.

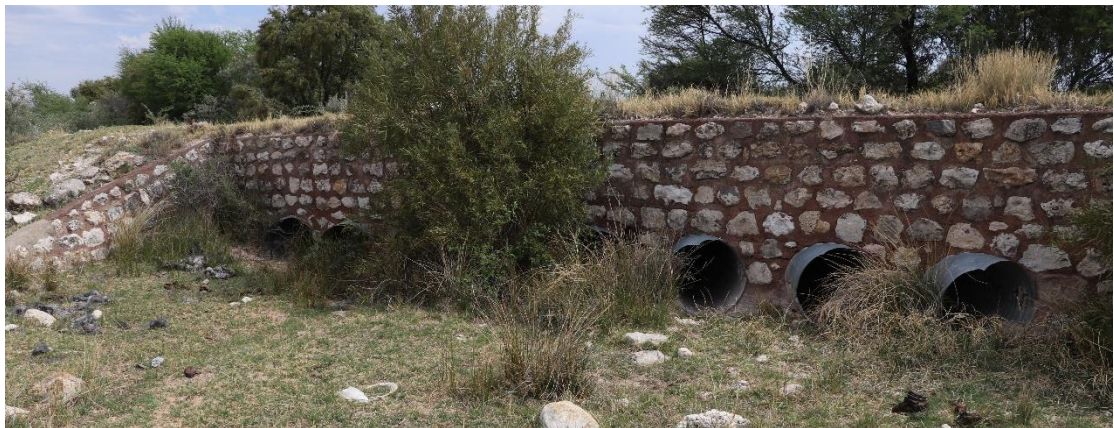
Figure 10: The existing road and culvert crossings also act as barriers to unimpeded flow and in several instances, culverts have become blocked or obstructed, which will further affect the natural flow of these watercourses.

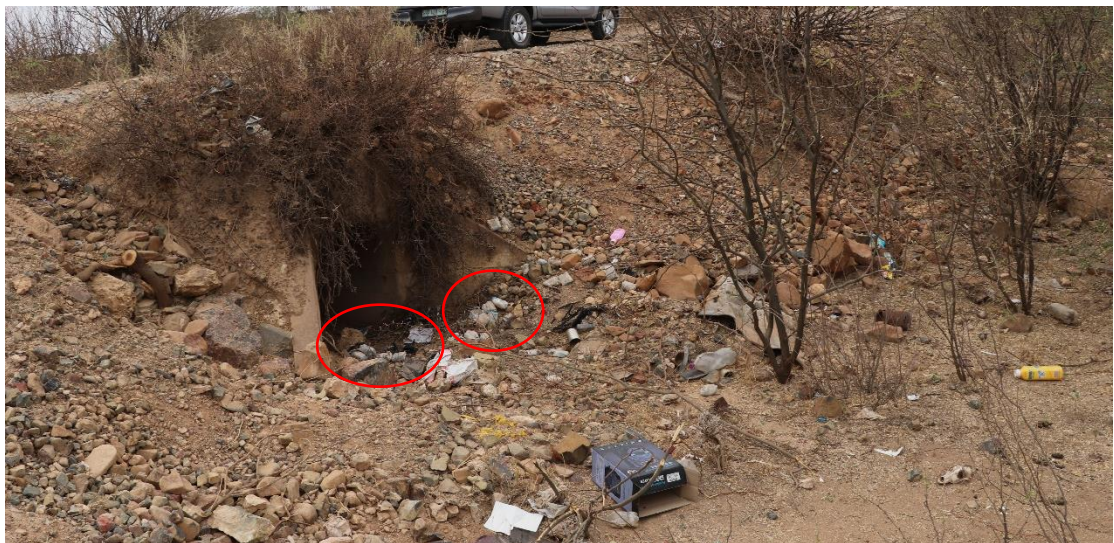
Figure 11: Associated with the rural settlements are also significant littering and refuse dumping, which may also include dumping of used diapers (Red).

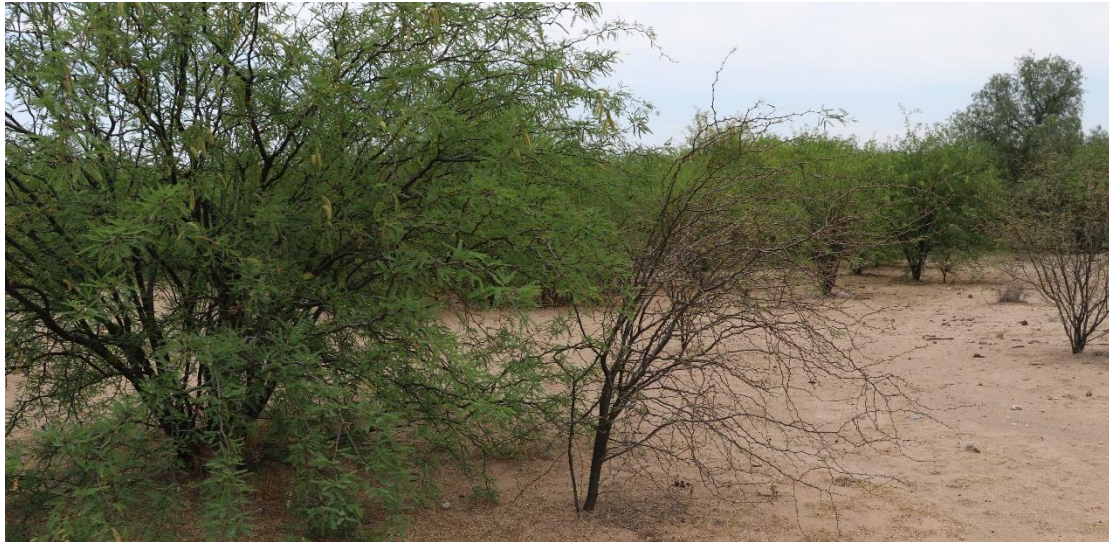
Figure 12: Coupled with disturbances as indicated, an extensive infestation of especially the Kuruman River, by invasive *Prosopis glandulosa* has occurred resulting in further modification of the affected system.

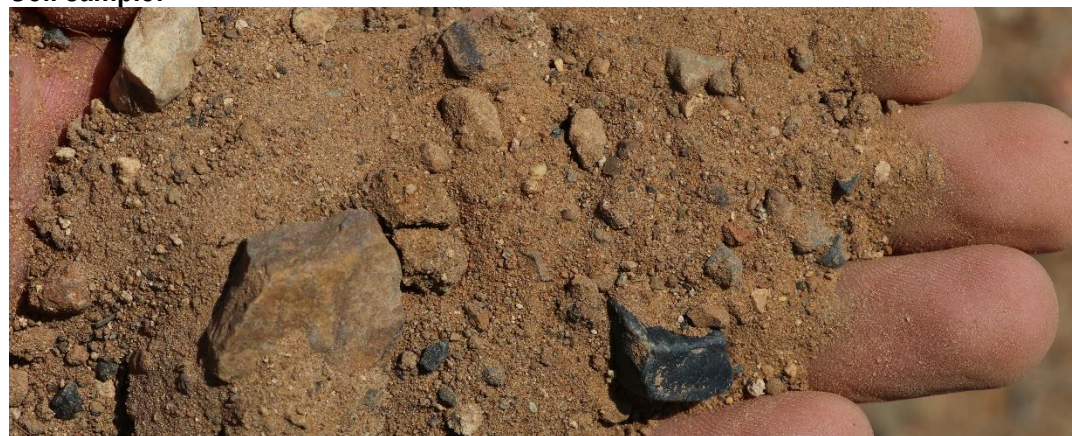
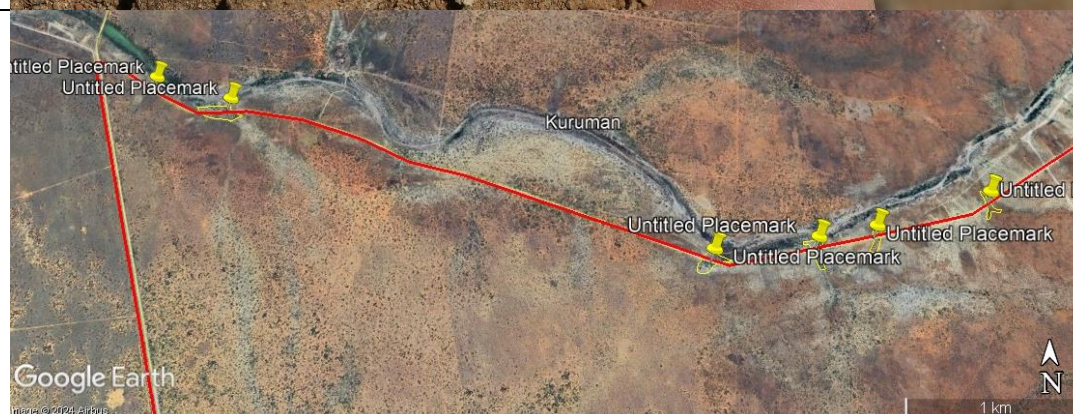
View of the drainage lines (Yellow), draining from ridges to the south, being crossed by the existing road (Red) and flowing into the Kuruman River immediately to the north.

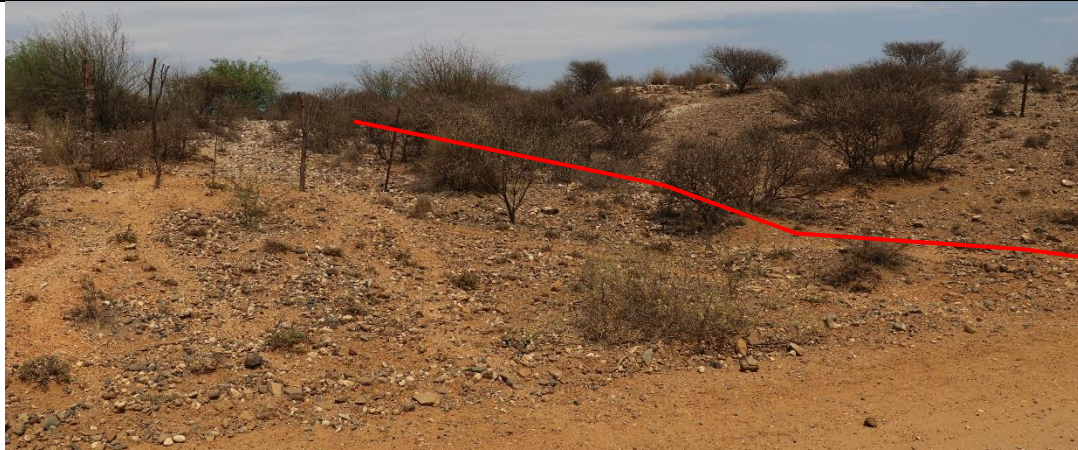
View of drainage lines, flowing from the adjacent ridges and flowing toward the Kuruman River. Note the small size, though a channel is evident.

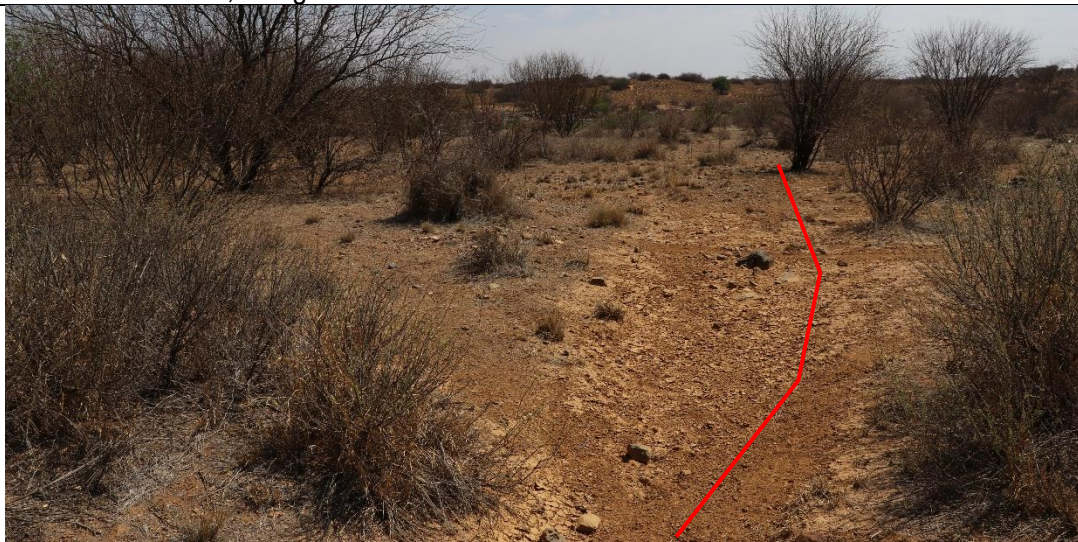
These drainage lines also drain into the floodplain of the Kuruman River, immediately adjacent to the site. Here the channel (Red) becomes obscured where it integrates into the floodplain.

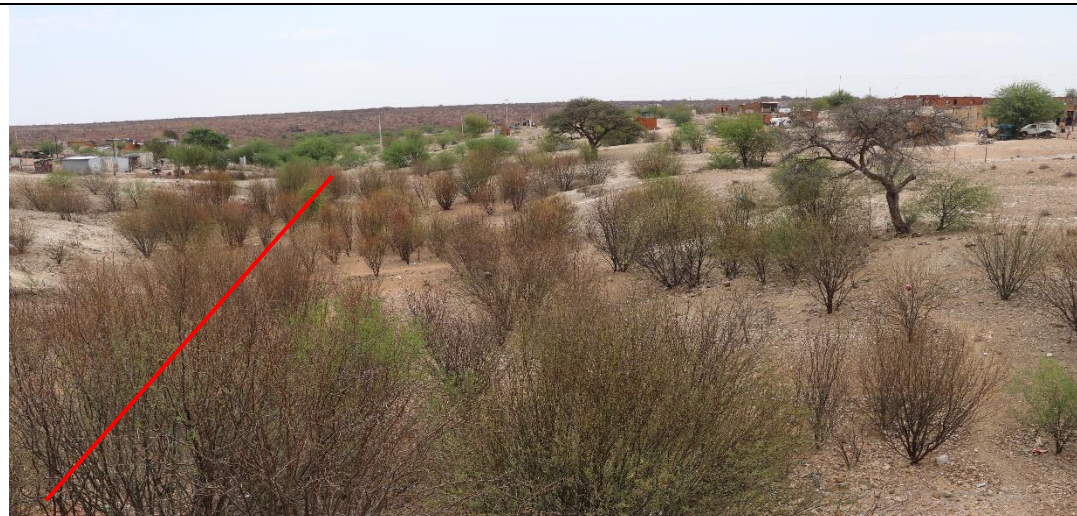
View of one of the drainage lines, where a channel is quite prominent (Red). Note also quite heavy infestation by invasive *Prosopis glandulosa*.

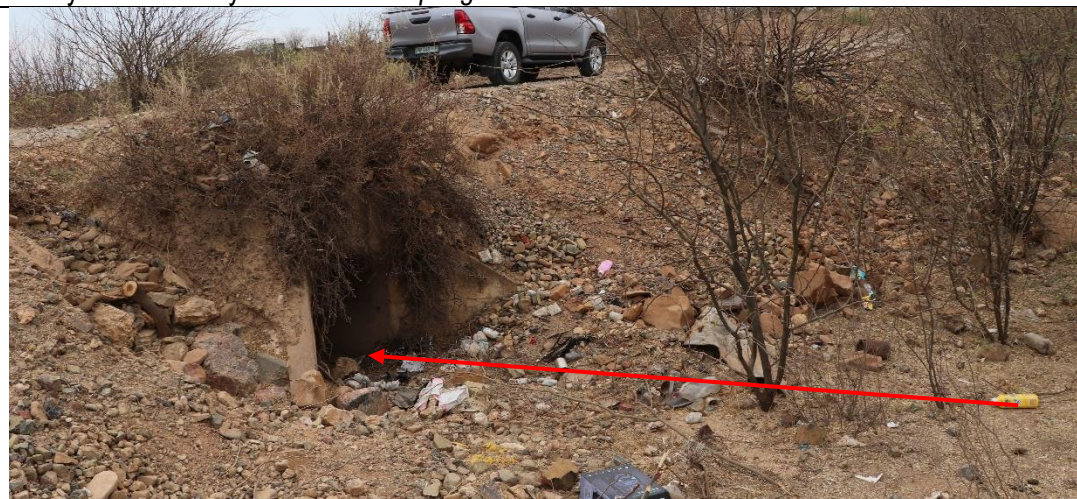
The existing road crosses over the drainage lines by means of box culverts clearly contributing toward flow obstruction.

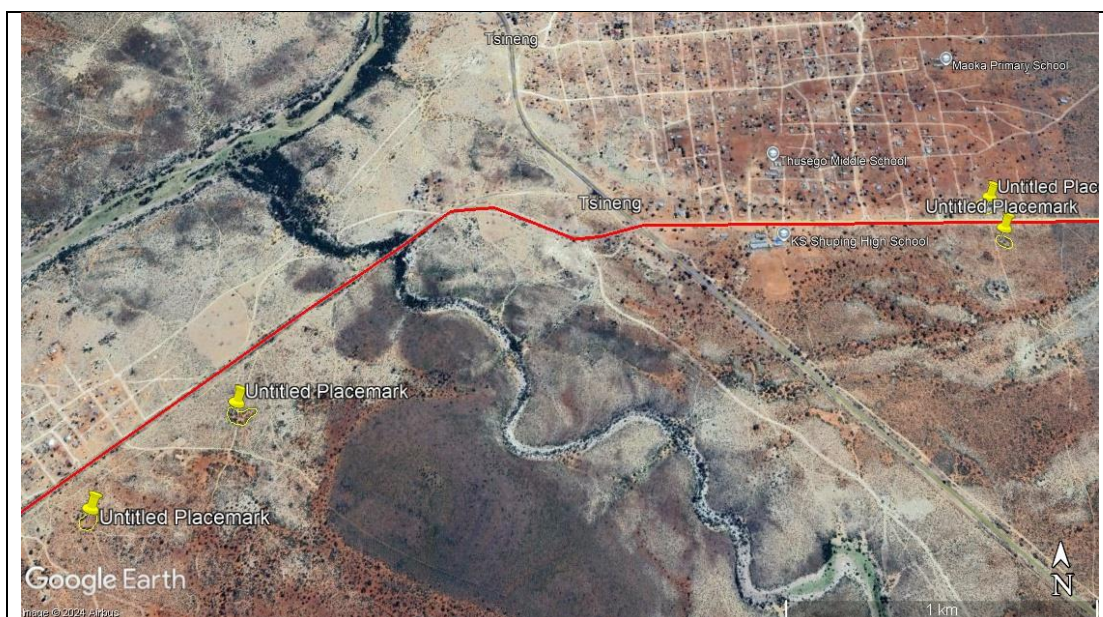
View of the small pans which are located to the west and east of the Kuruman River. Note that they are situated in close proximity to the existing road, but should be easily avoidable by any construction activities.

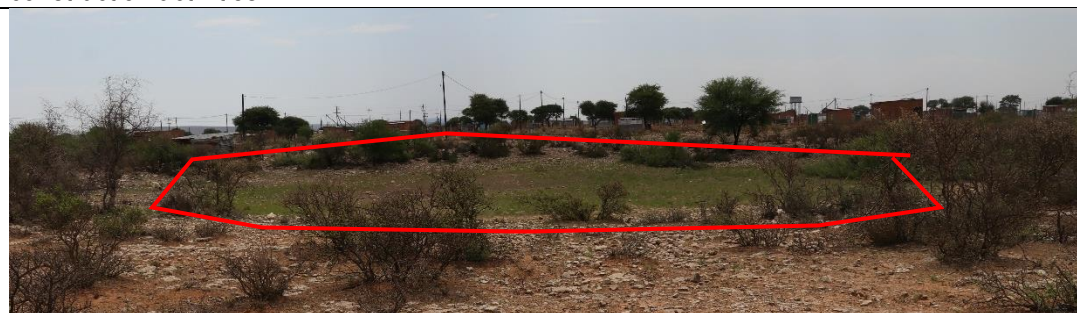
The small pans are in most cases visible as circular and very shallow depressions.

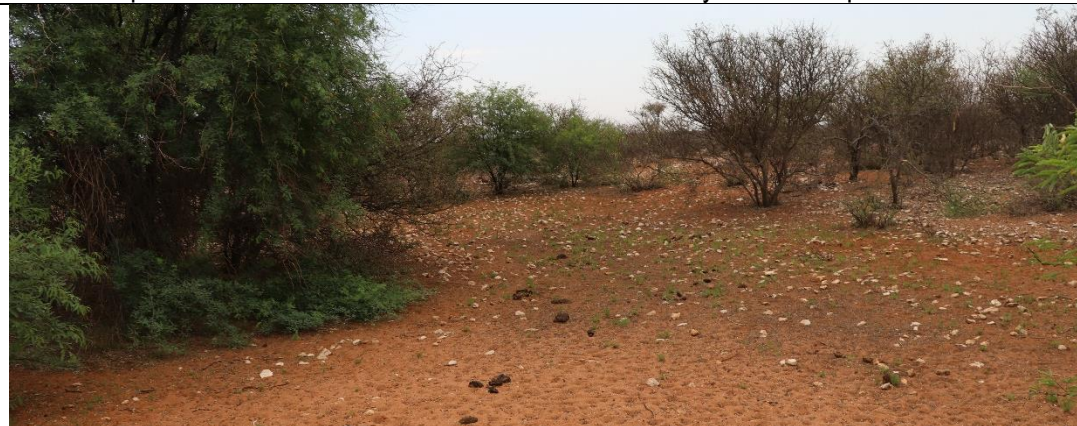
These pans can also be quite poorly defined. Note also high levels of trampling by domestic livestock.

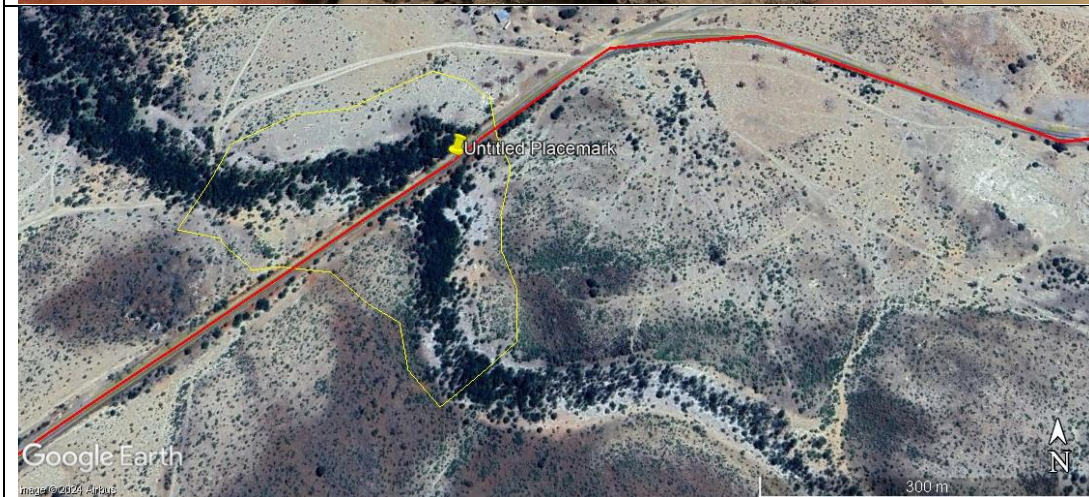
View of the Kuruman River crossing. Note a significant riparian zone, with floodplain fairly extensive.

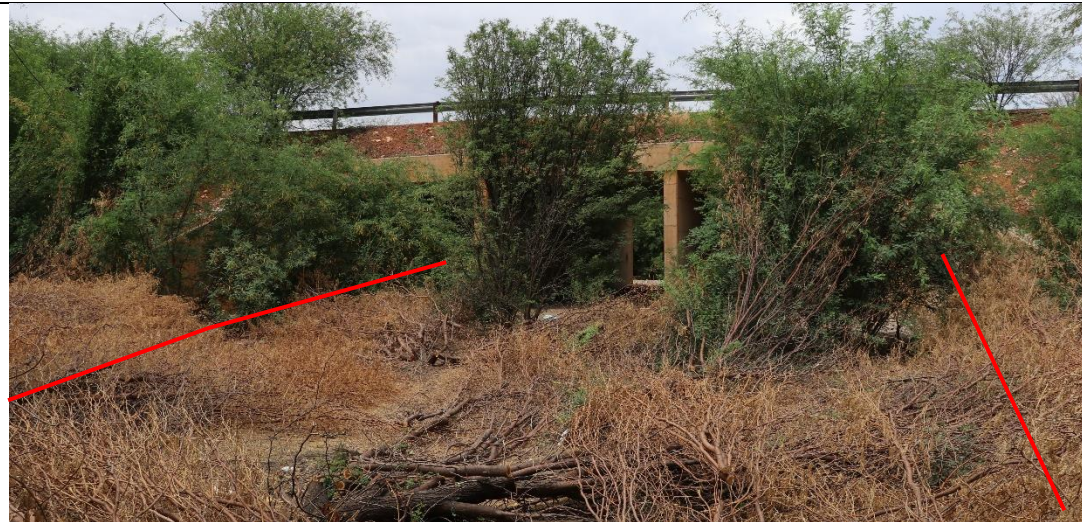
View of the main channel (Red), which is fairly narrow, with an extensive infestation by invasive *Prosopis glandulosa* also evident. The bridge structure is also clear.

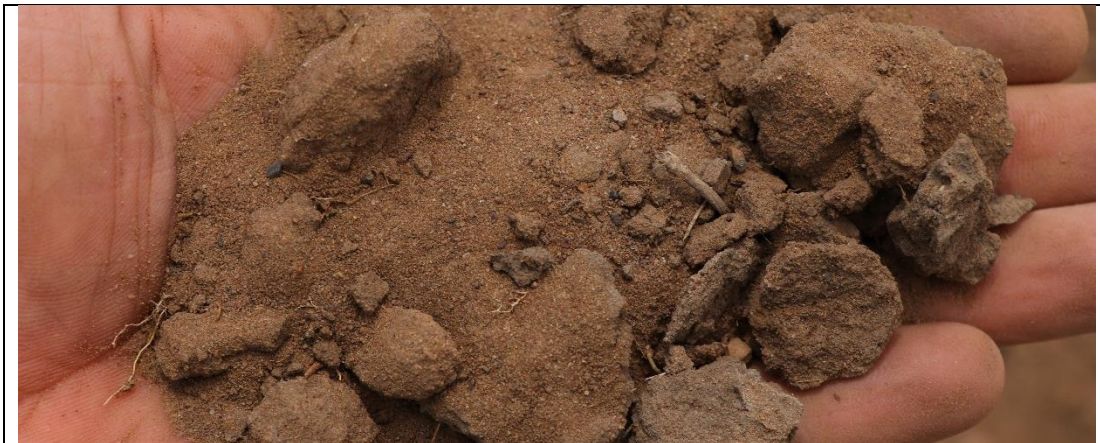
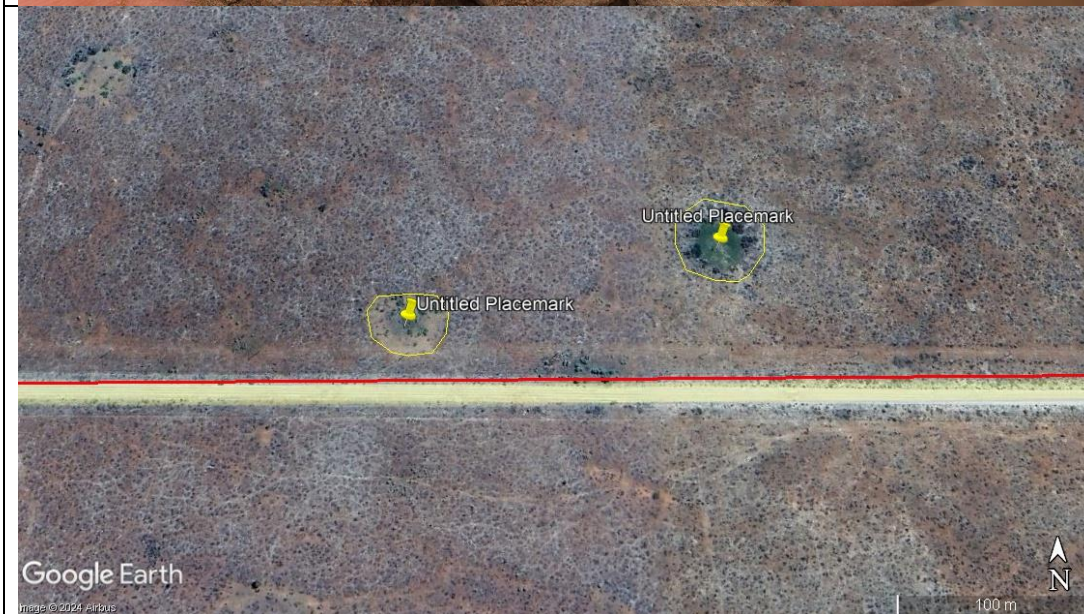
View of the small pans which are located to the north of the existing road. Note that they are situated in close proximity to the existing road, but should be easily avoidable by any construction activities.

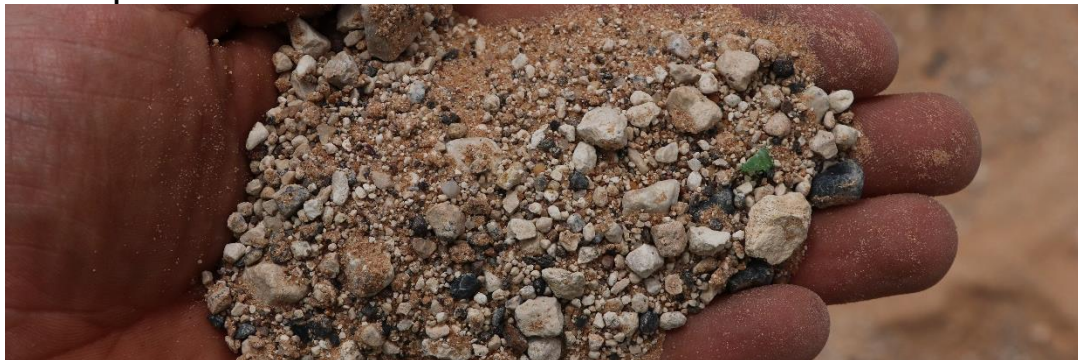
View of the ephemeral stream (Yellow), draining from the plains to the south and being crossed by the existing road (Red).

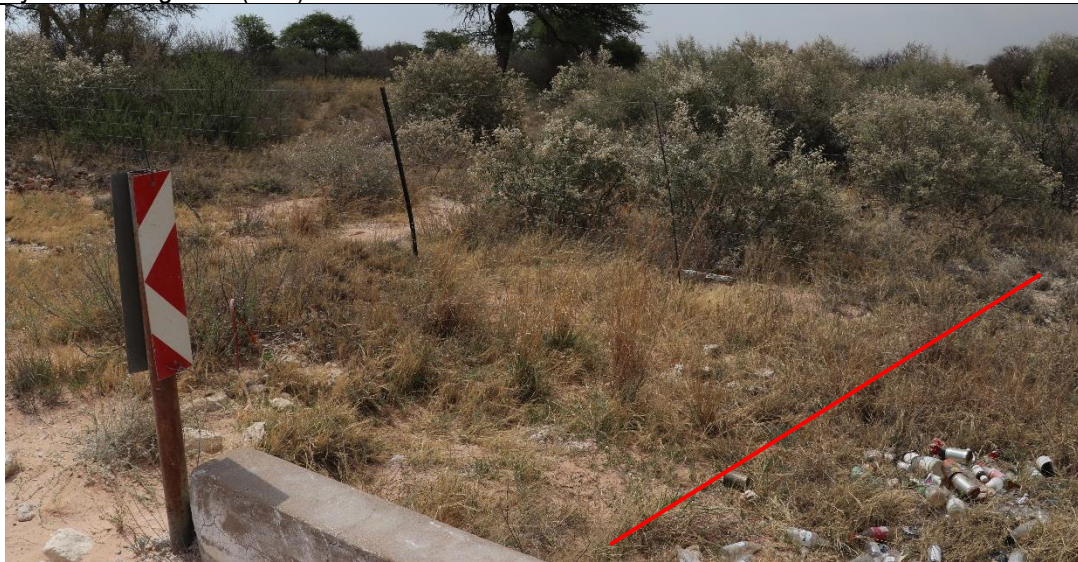
The stream is clearly quite small though still containing a clear channel.

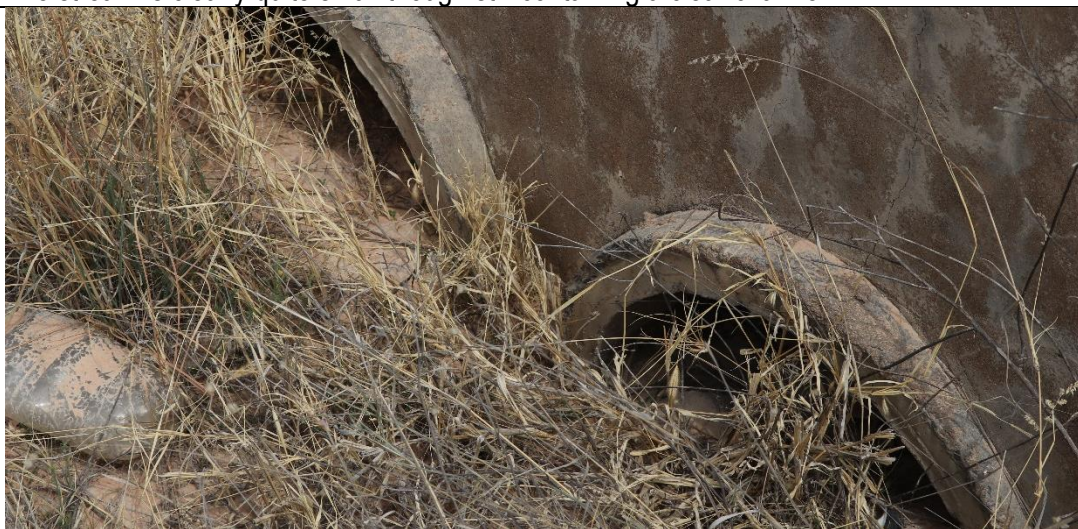
The stream is affected by several impacts and sedimentation is clearly problematic. Note how culverts have become almost completely blocked by sediment accumulation.

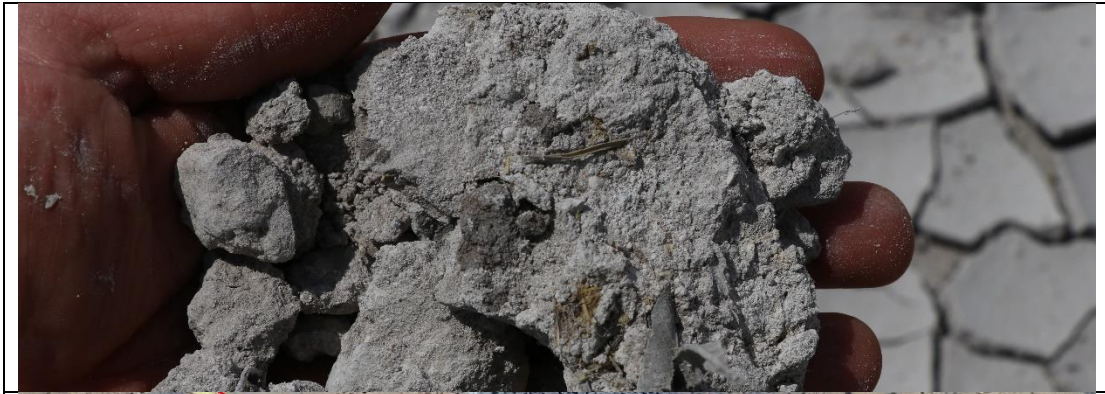
View of the ephemeral stream (Yellow), draining from the plains to the south and being crossed by the existing road (Red). Note a quite prominent channel is visible.

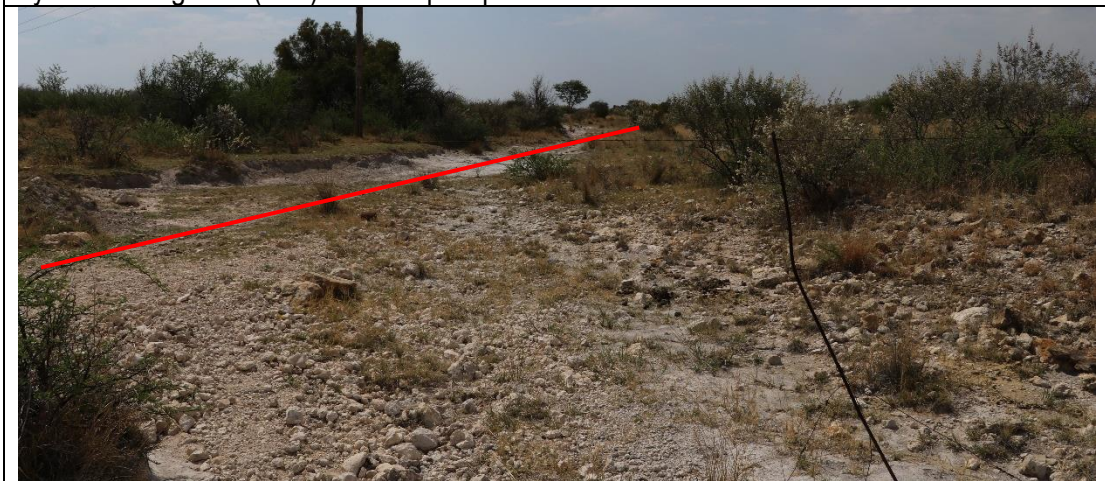
The stream is still small but quite prominent and with a well-defined channel visible.

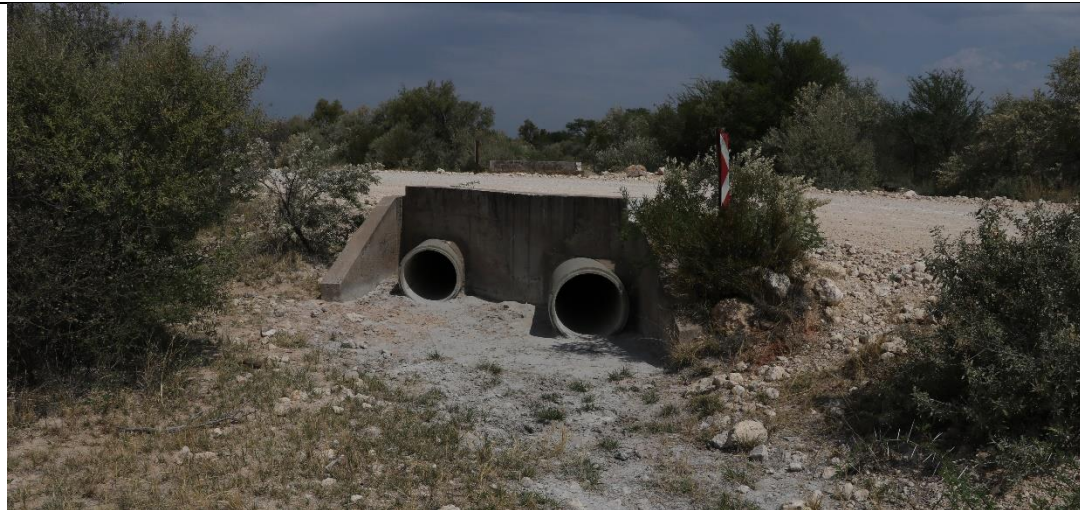
The culverts underneath the existing road will enable sufficient flow but will clearly still result in constriction of flow.

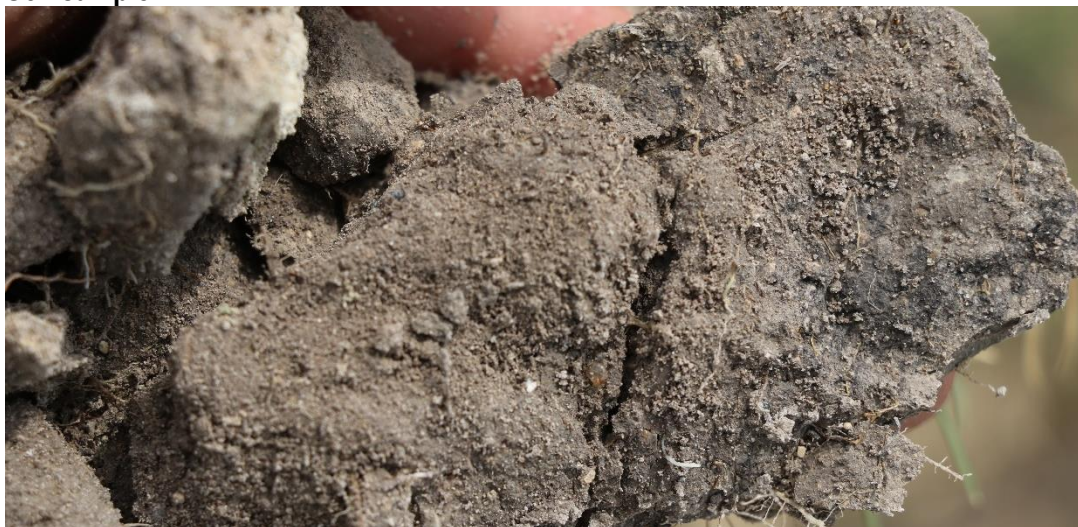
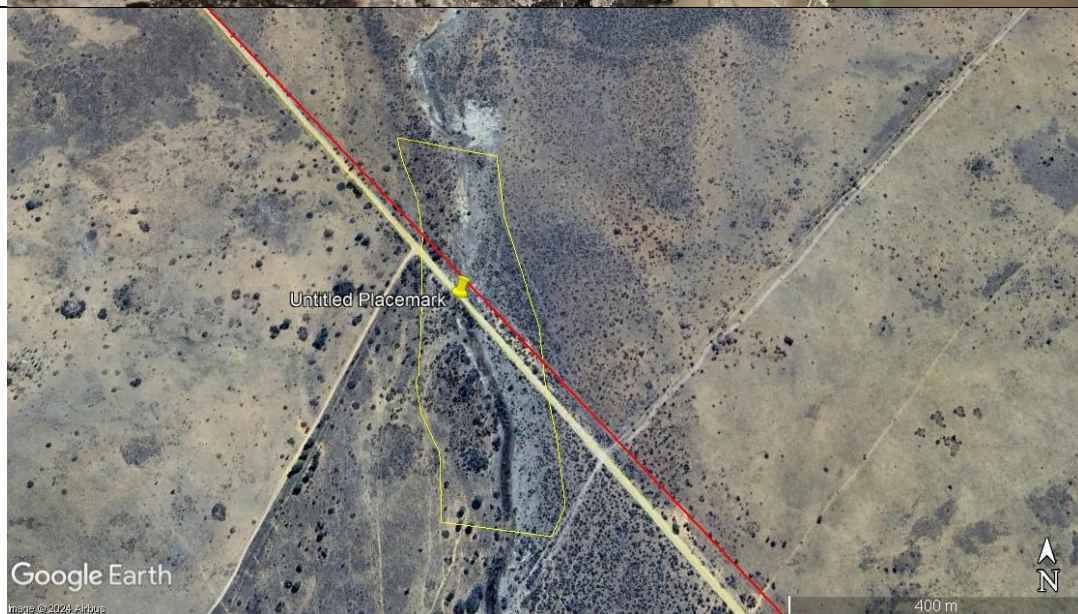
View of the ephemeral stream (Yellow), draining from the plains to the south and being crossed by the existing road (Red). Note a prominent channel and fairly extensive floodplain.

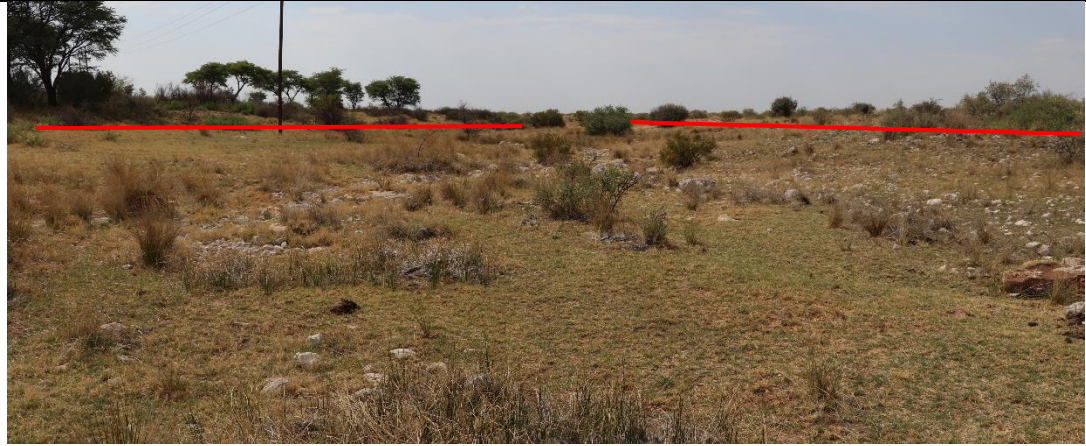
The main channel is broad, with an abundance of wetland vegetation being present.

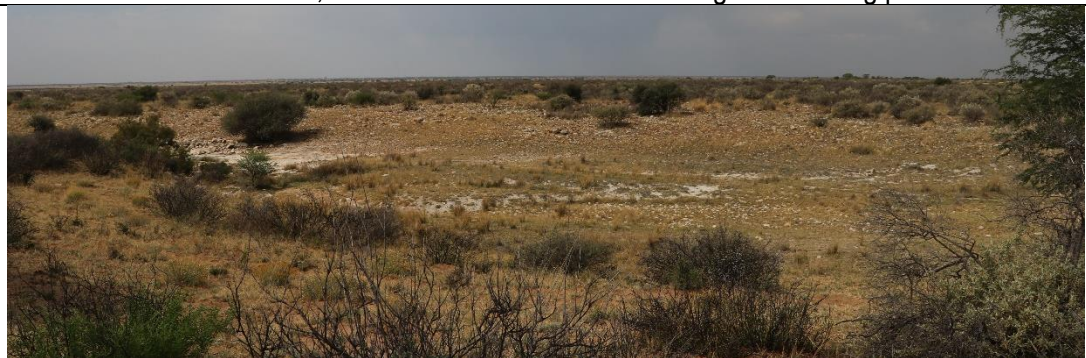
The stream is large, containing a high diversity of habitats. Note also exposed calcrete habitats which sustain several unique species.

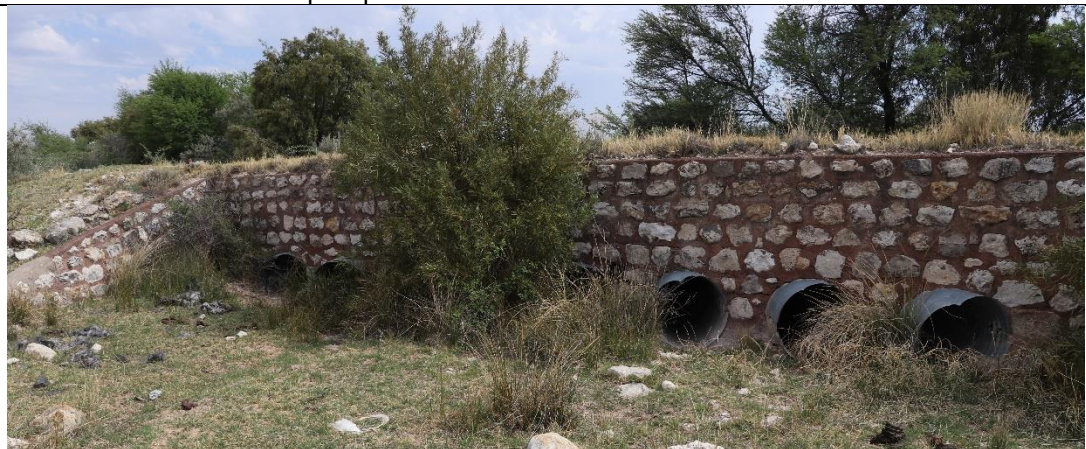
The existing crossing contains numerous culverts, though several of these are clearly being obstructed and will influence the flow through the system.

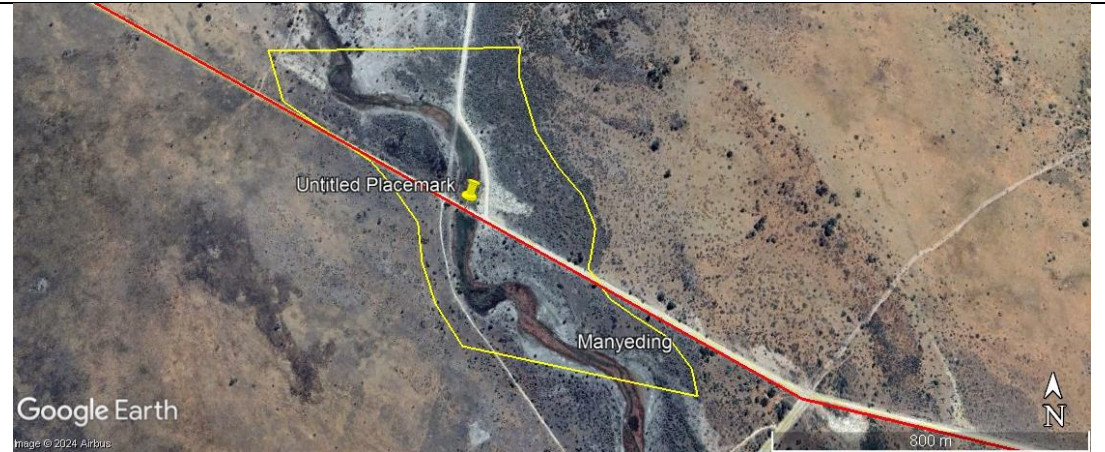
View of the Manyeding River (Yellow), draining from the plains to the south and being crossed by the existing road (Red). Note a prominent channel and fairly extensive floodplain.

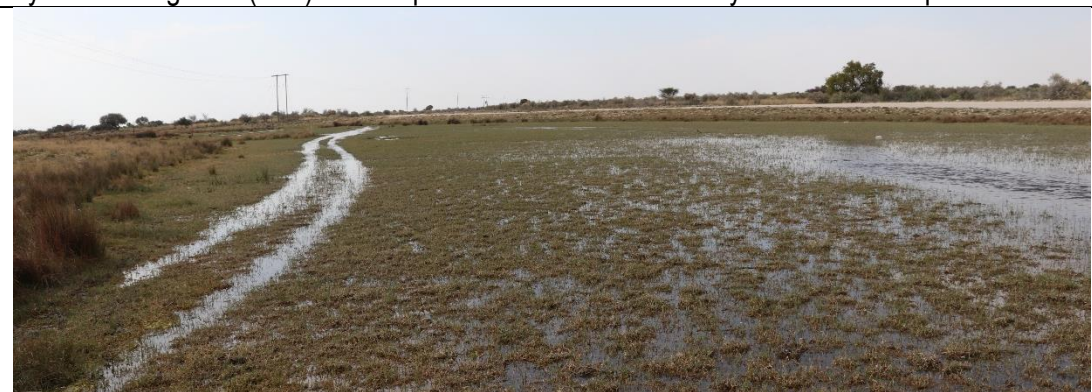
The Manyeding River is extensive, being fed by an artesian eye, containing extensive wetland habitats, which is characteristic of a floodplain wetland system.

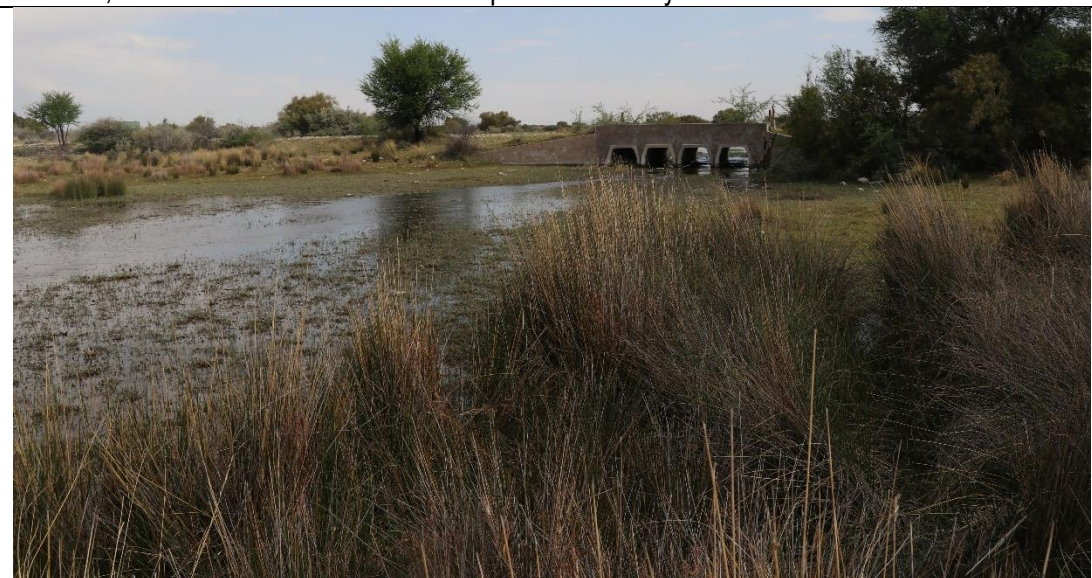
The existing crossing contains several culverts, which are still likely to result in some constriction of flow. Note abundance of flow, even at the end of the dry season, which indicates that the system is likely to be almost perennial.

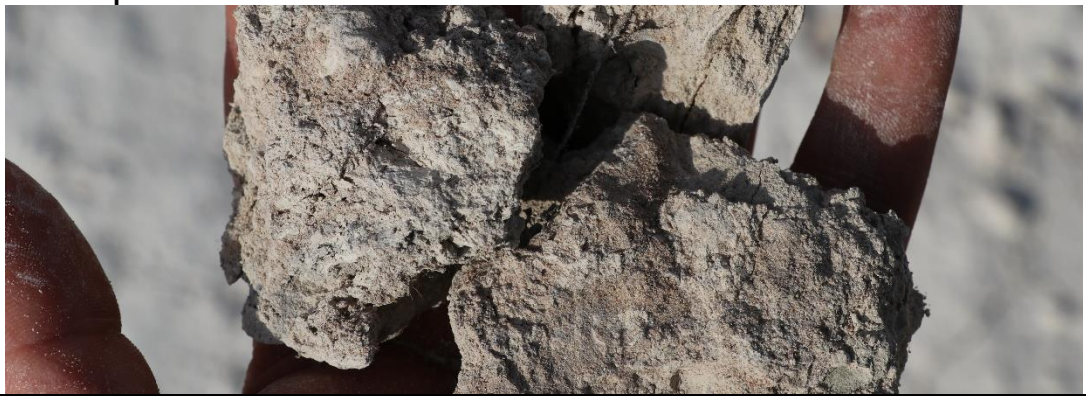
View of the ephemeral drainage line (Yellow), which is situated near its origin, being less well-defined and being crossed by the existing road (Red).

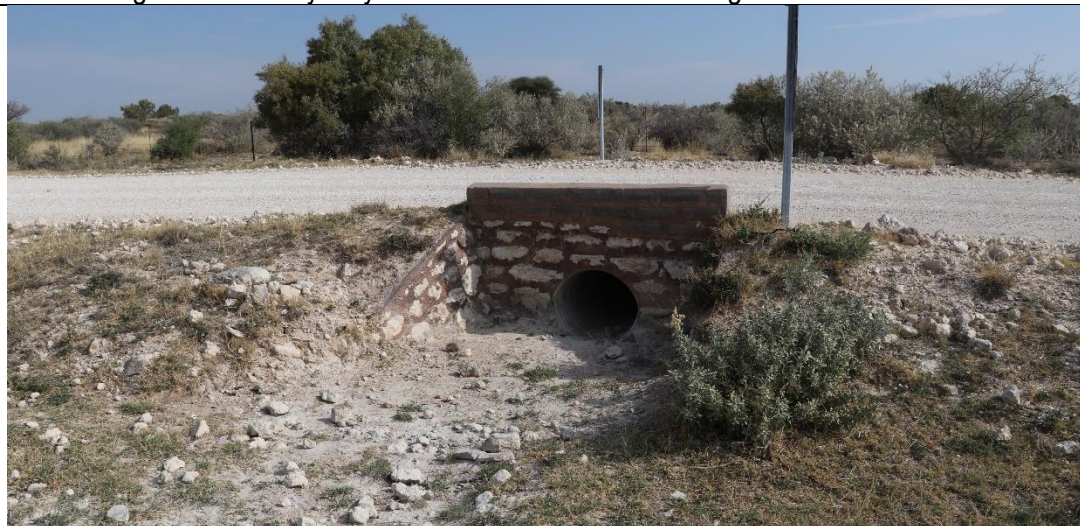
The small culvert will still facilitate flow, but will most likely also cause some constriction of flow.

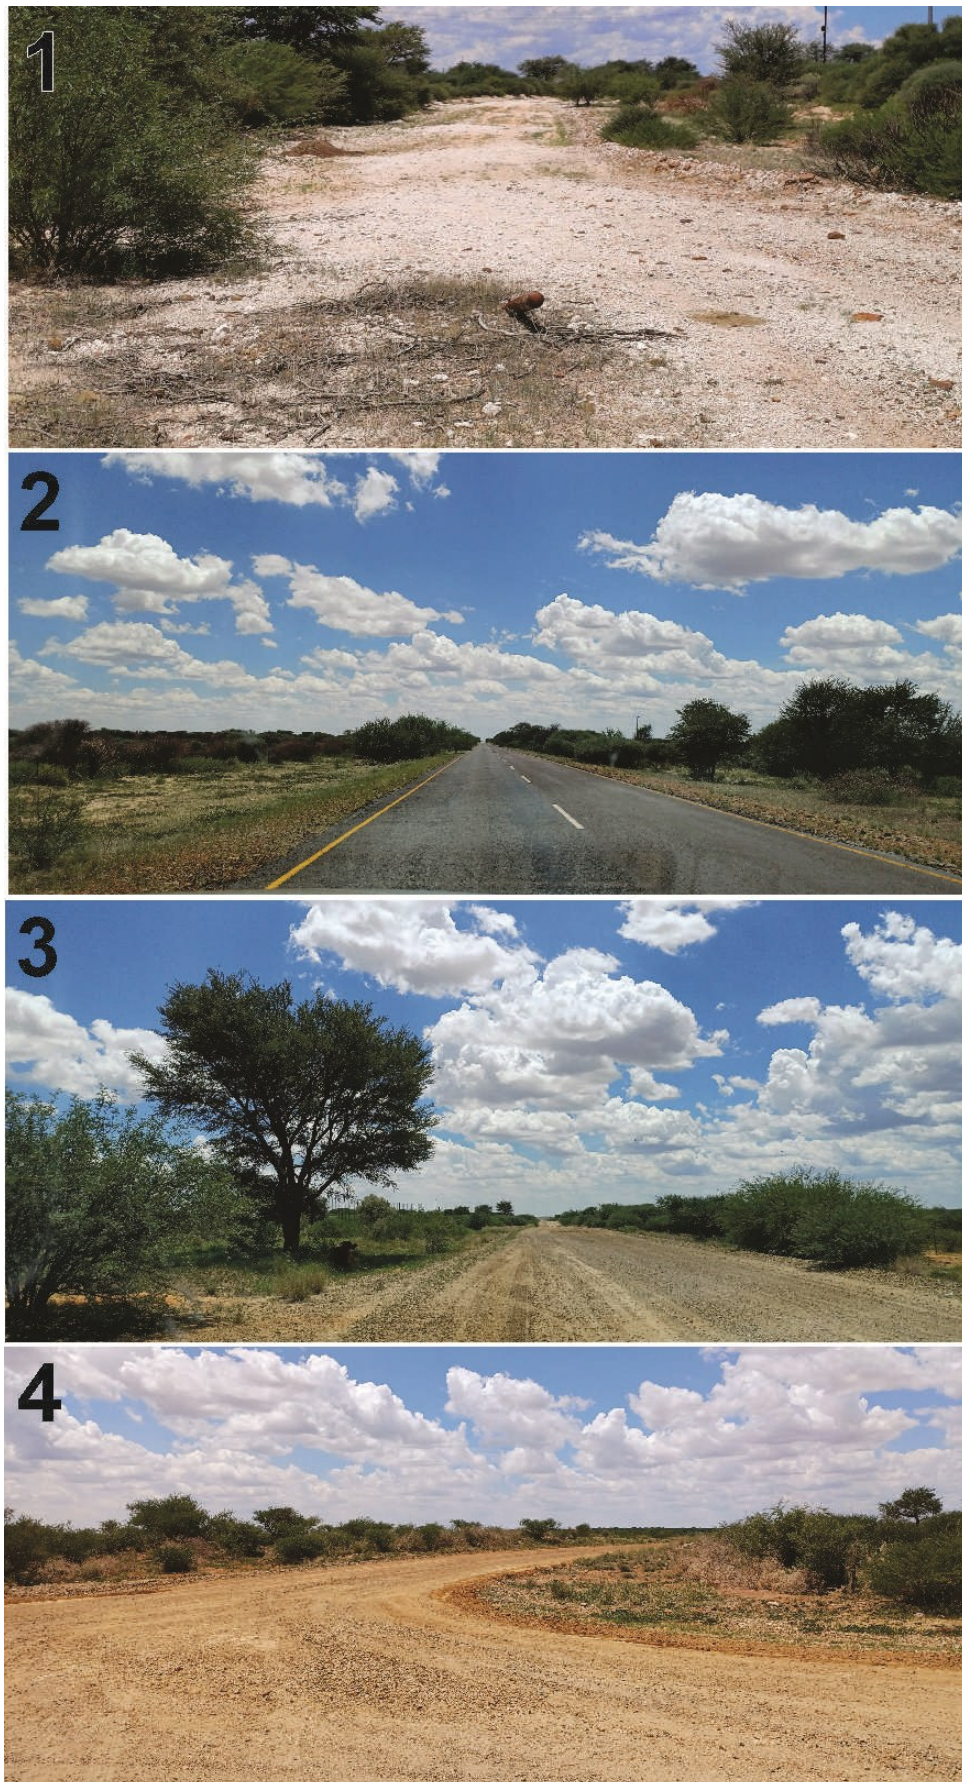
Figure 2. General view of the start of the section (top) to the Tsineng turn-off (bottom). Site numbers marked on map in Figure 1.
