# **Appendix D**

## **Specialist Reports:**

## **Wetland Assessment for the proposed upgrading of the road between Ga-Sese and Washington, situated to the north of Kuruman, Northern Cape Province.**

December 2024

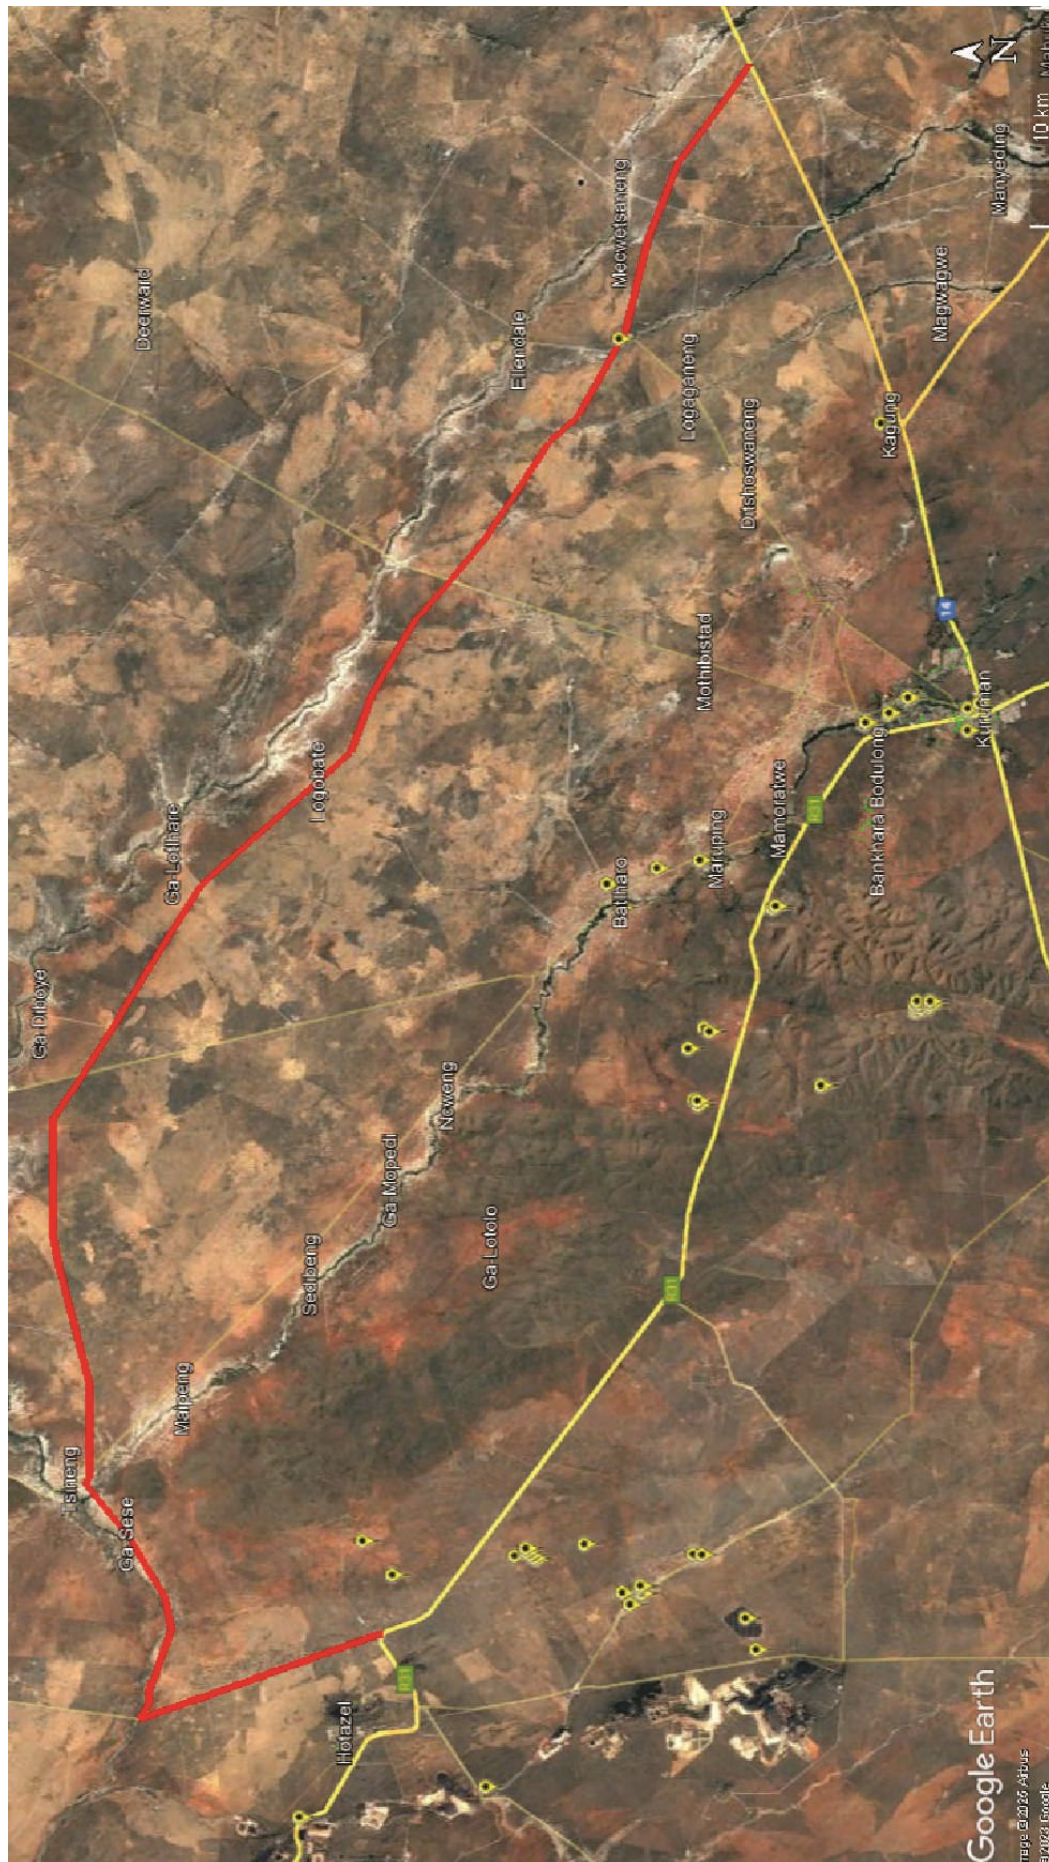
Figure 6. Distribution of previously recorded heritage features/sites located between Kuruman and the proposed development footprint (yellow icons).

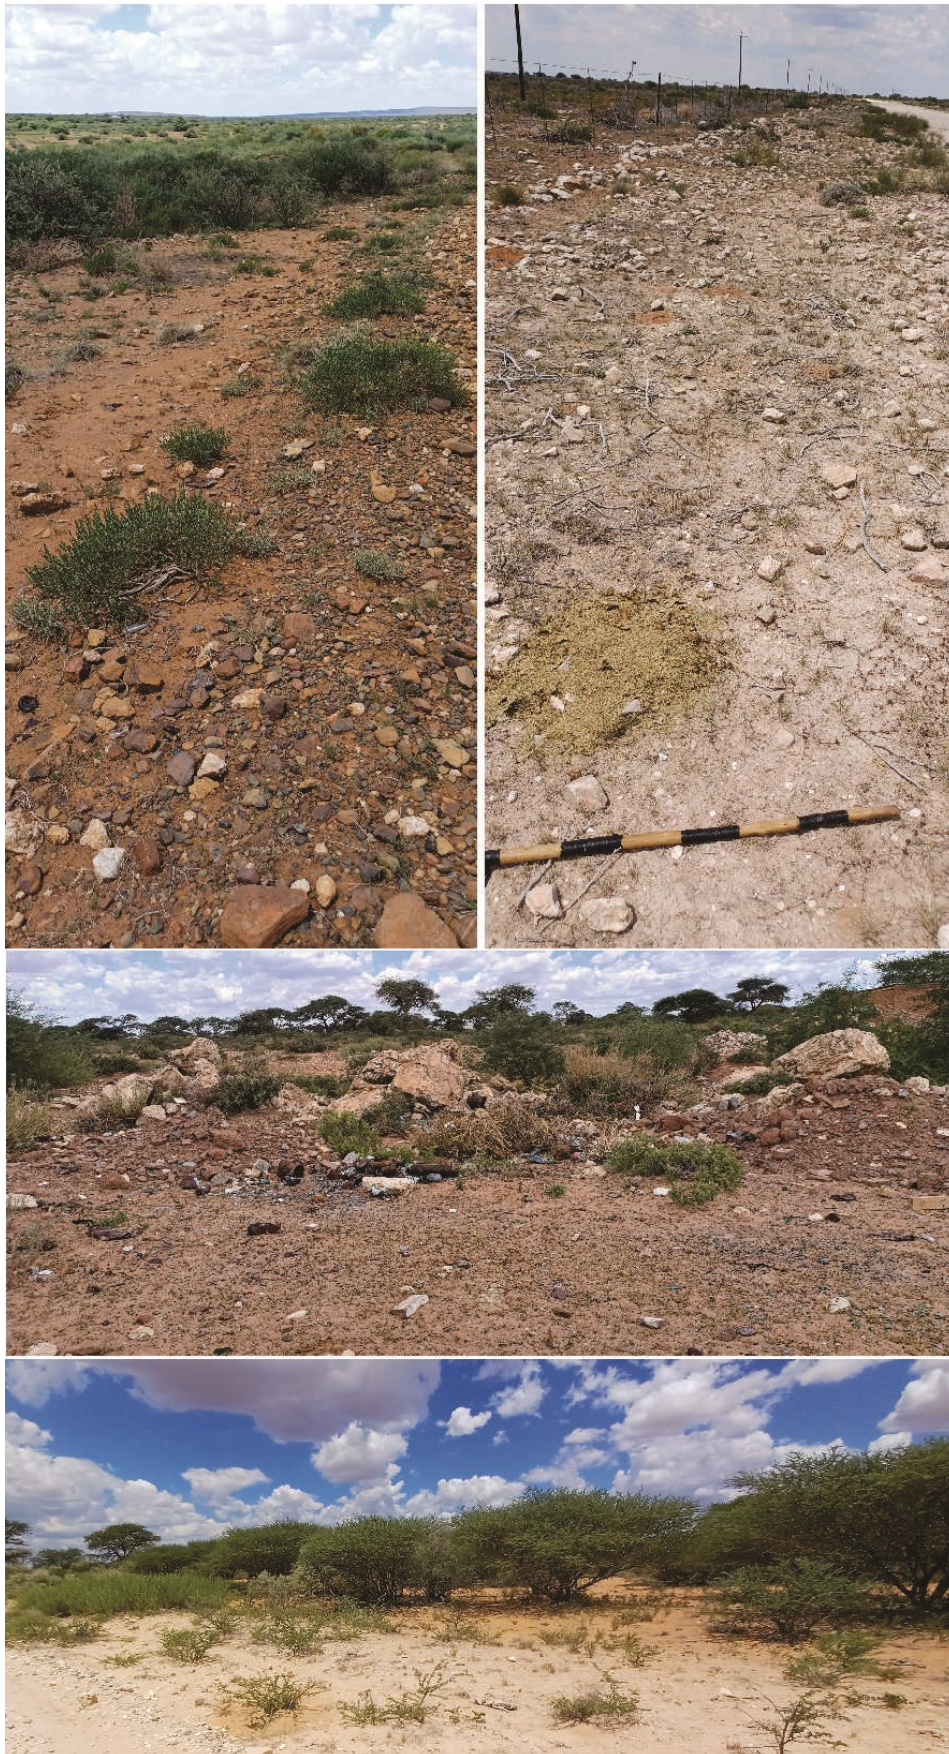
Figure 7. The road reserves are capped by severely degraded surface limestone rubble and residual soils (windblown sand) resulting from the construction of the existing road

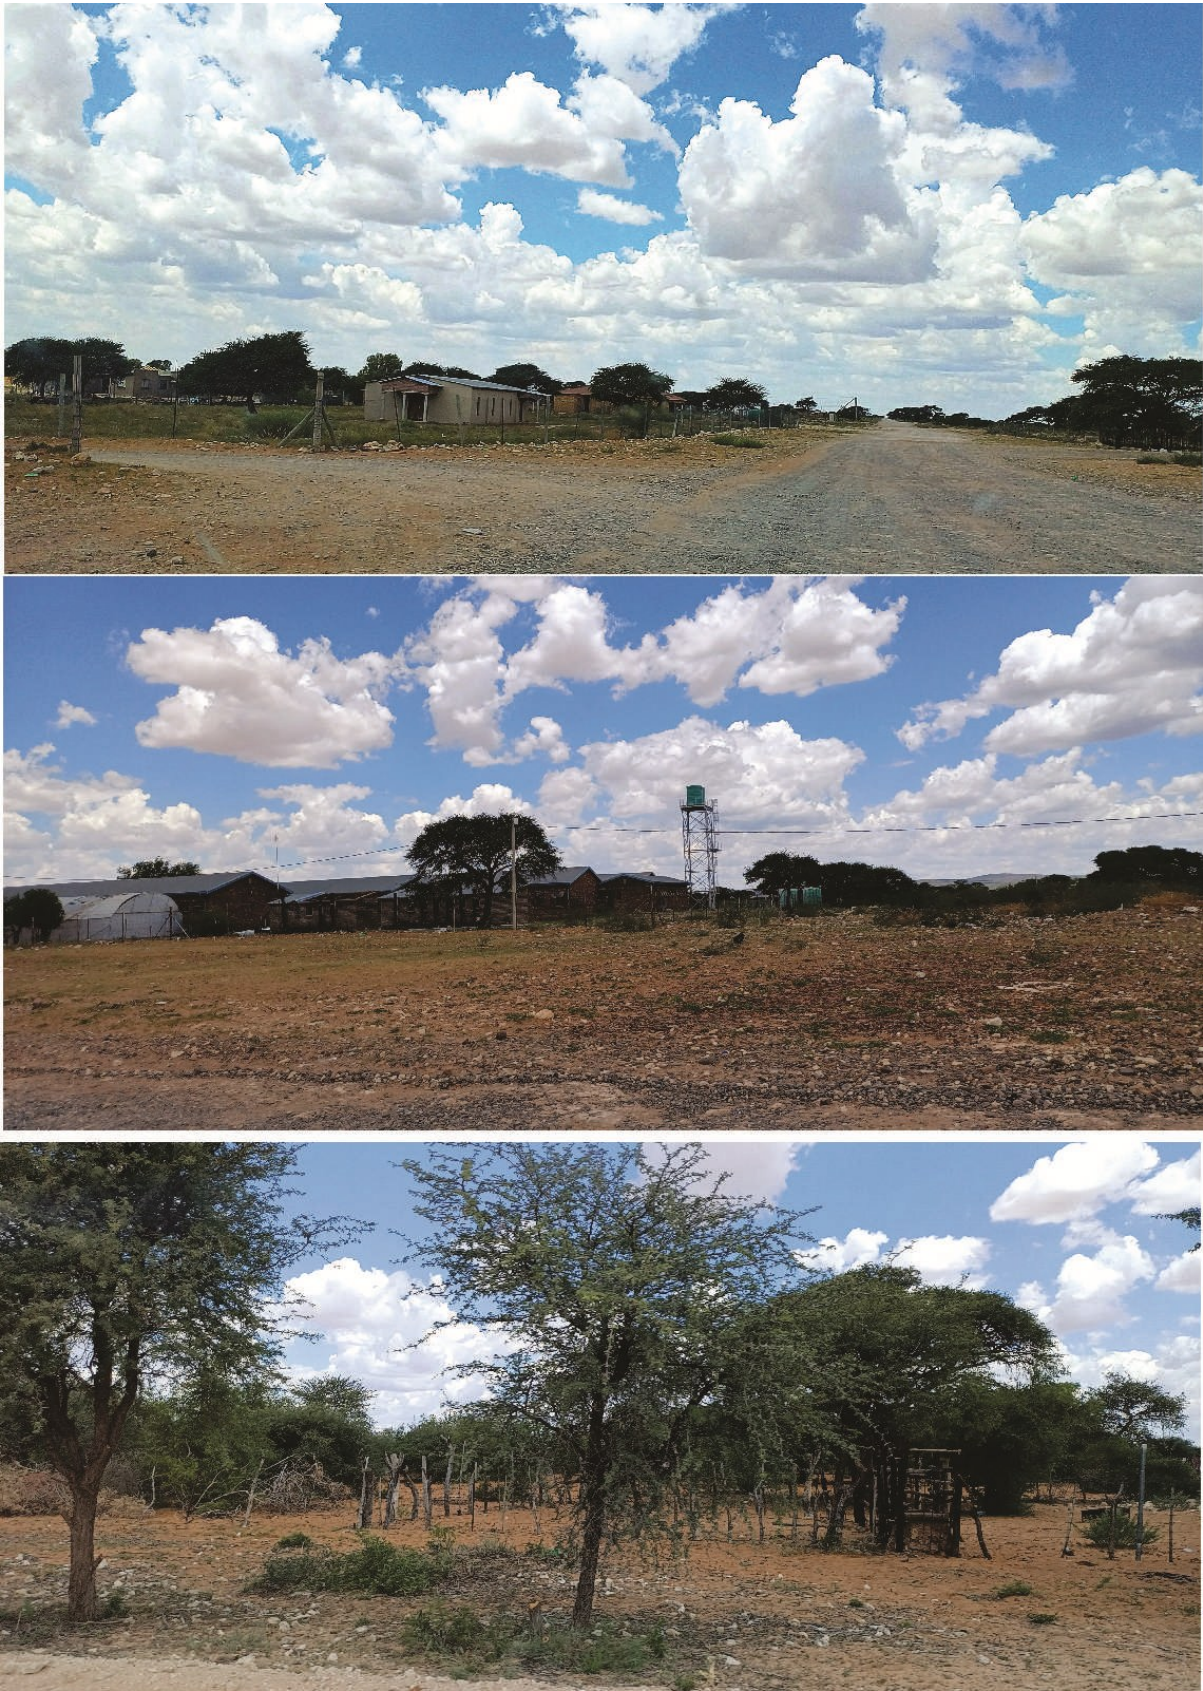
Figure 8. Modern man-made structures situated near or within the vicinity of the road reserves.

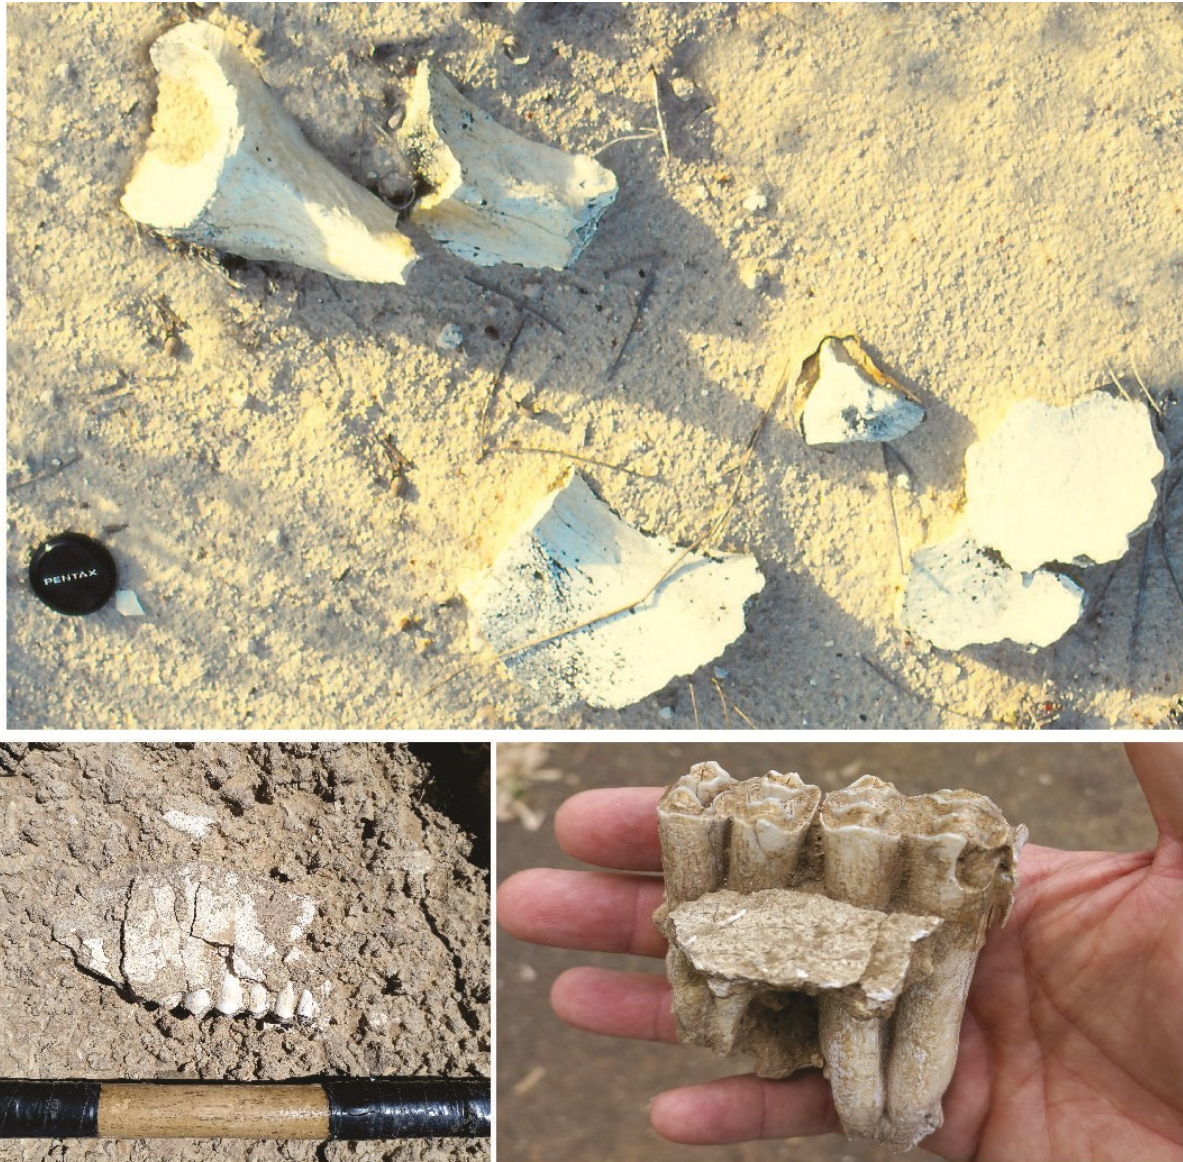
Figure 9. Quaternary vertebrate fossils to look out for in surface limestones / calcretes may resemble cylindrical and elongated, stone-like objects with odd-looking patterns, shapes and surfaces (below).

- Fossil remnants to look out for if excavations are to be conducted into subsurface Quaternary calcretes and surface limestones may resemble modern-looking long bones, horn cores, and teeth (**Fig. 9**).
- If material is significant, a palaeontologist must be able to confirm the finds as soon as possible.
- Newly excavated fossil remains must be stored in a safe place if it is portable. The material should not be washed or cleaned in any way.
- Intact remains must be kept in place and protected from further damage by covering it with a light but rigid object like a box, bucket, or metal sheet if possible and the

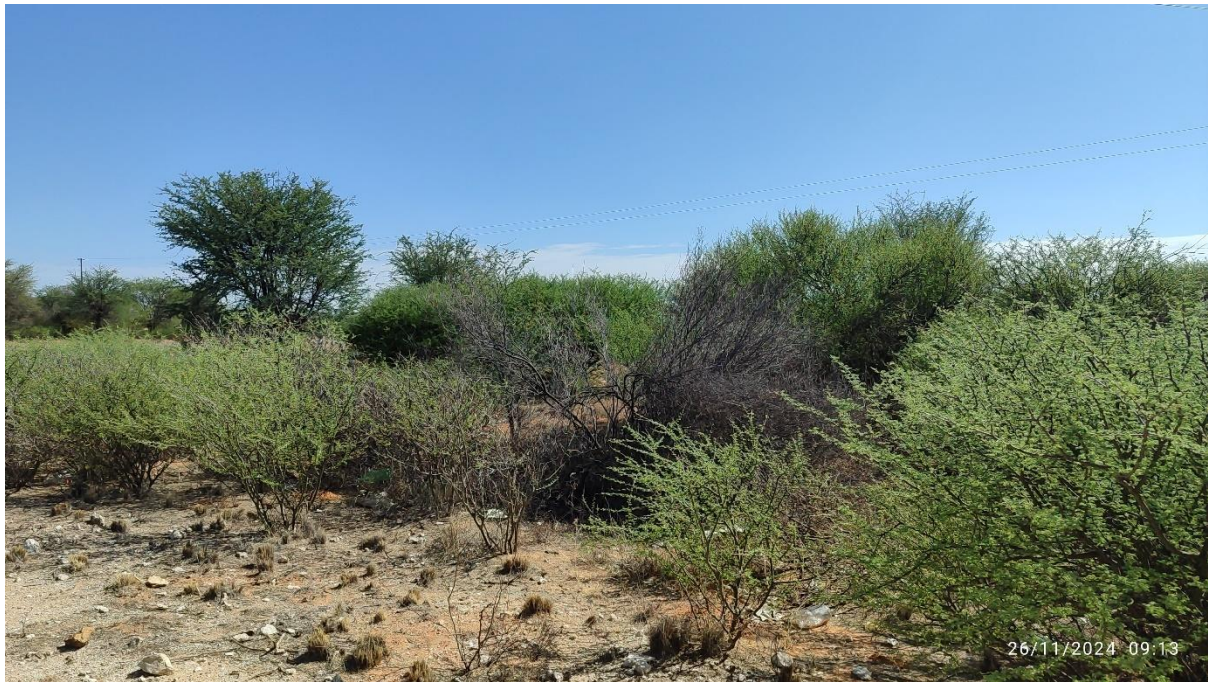
recorded. Some illegal dumping of hazardous material (Asbestos) and building rubble also occurring. Grazing goats were encountered. Many tall shrub individuals were dead in certain areas – indicating that the health of the tall shrub layer is negatively influenced by something in the environment. Thus, the ecological functioning of this vegetation unit is likely negatively influenced as well. However, the current ecological functioning of this vegetation unit is considered good. The majority of this vegetation unit is in a natural ecological condition.

Figure 5: A ground view of VU A. The tall shrub layer is well developed and dense. The tree layer is well developed but scattered while the herbaceous layer is fairly to poorly developed.

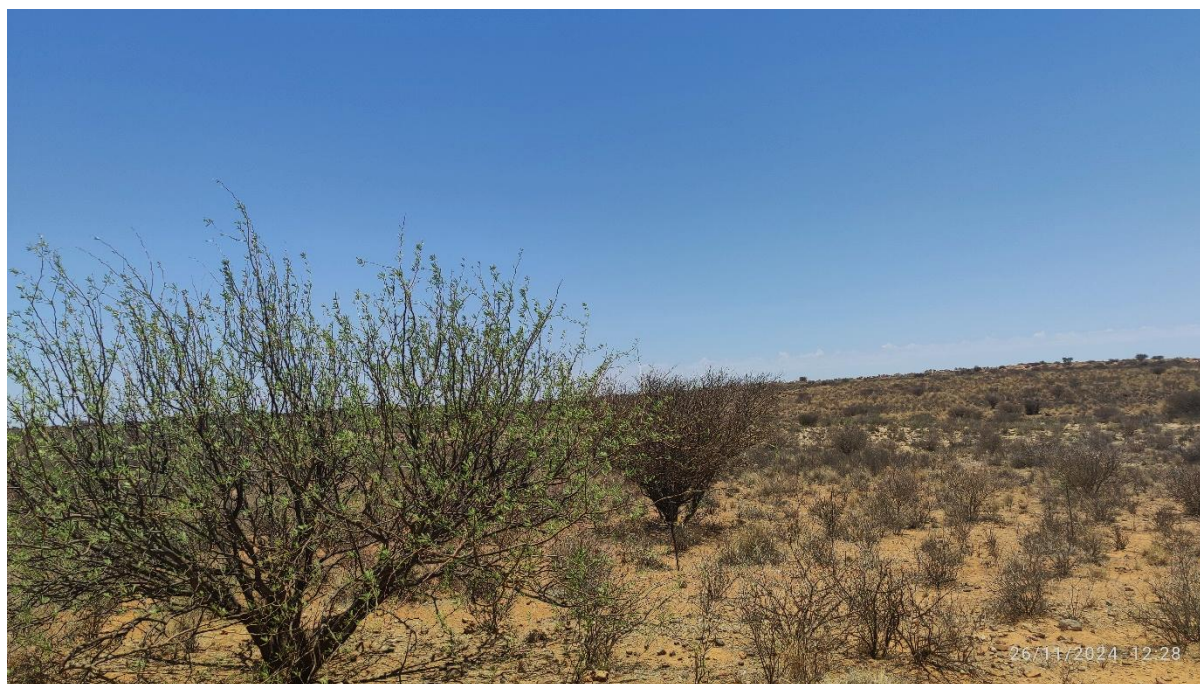
The ground is scattered with medium-large sized gravel/stones. Where stones lessen, bare ground becomes more prominent. Despite the existing gravel road (previous infrastructure development), few other ecological disturbances were visible. Minor amounts of litter was noticed, with one area having been exposed to illegal dumping of Asbestos products (presumably ceilings). Grazing by horses was observed. Several smaller gravel roads intersect with this vegetation unit. Despite these ecological disturbances, this vegetation unit has good ecological functioning, with a natural to near-natural ecological condition.

Figure 6: Ground View of VU B which has an open tall shrub layer and prominent sub-shrub layer.

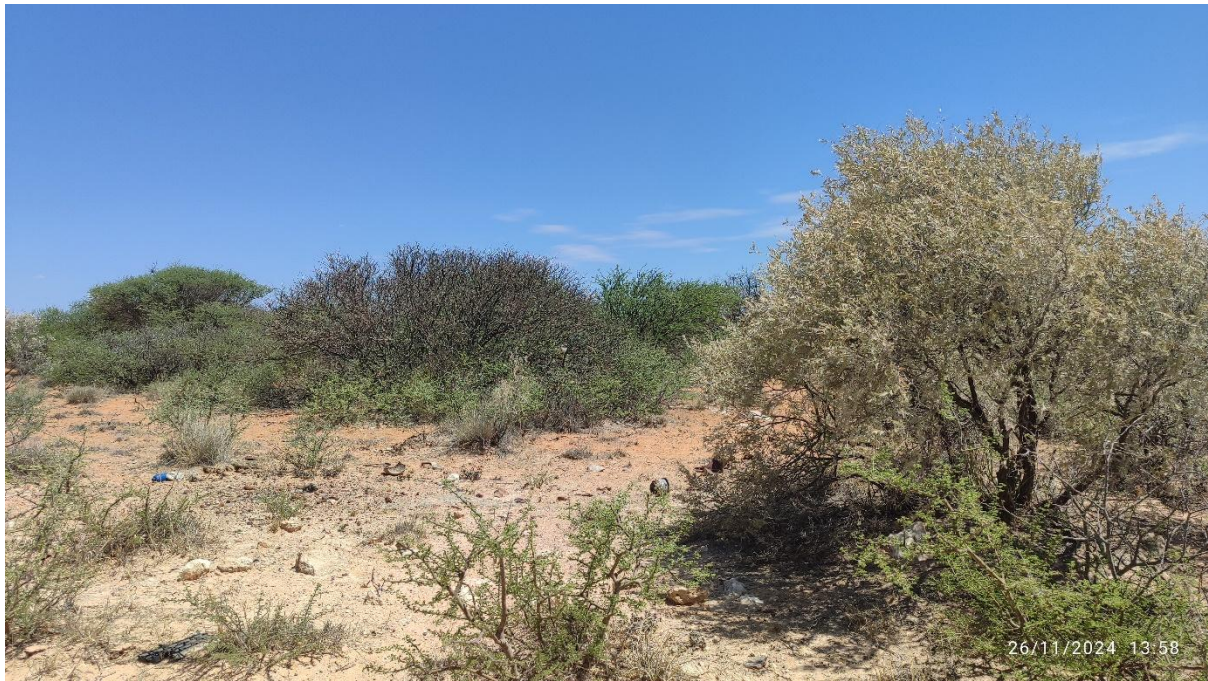
Vegetation removal was occurring within 10m on either side of the existing gravel road at the time of the survey. Woody and shrubby elements were being removed. The forbs and grasses were left remaining. However, this removal resulted in heaps of vegetative waste. Additionally, dumping was observed frequently in parts of this vegetation unit. Litter was frequently observed throughout this vegetation unit. Some areas of this vegetation unit were affected by agriculture, where grazing of domesticated animals was observed. Erosion was observed in more calcareous areas.

Due to these ecological disturbances observed, the ecological functioning is likely negatively influenced. The ecological functioning is considered fair, with an ecological condition of near-natural to semi-natural.

Figure 7: A ground view of VU C which resembles the Kuruman Thornveld vegetation type.

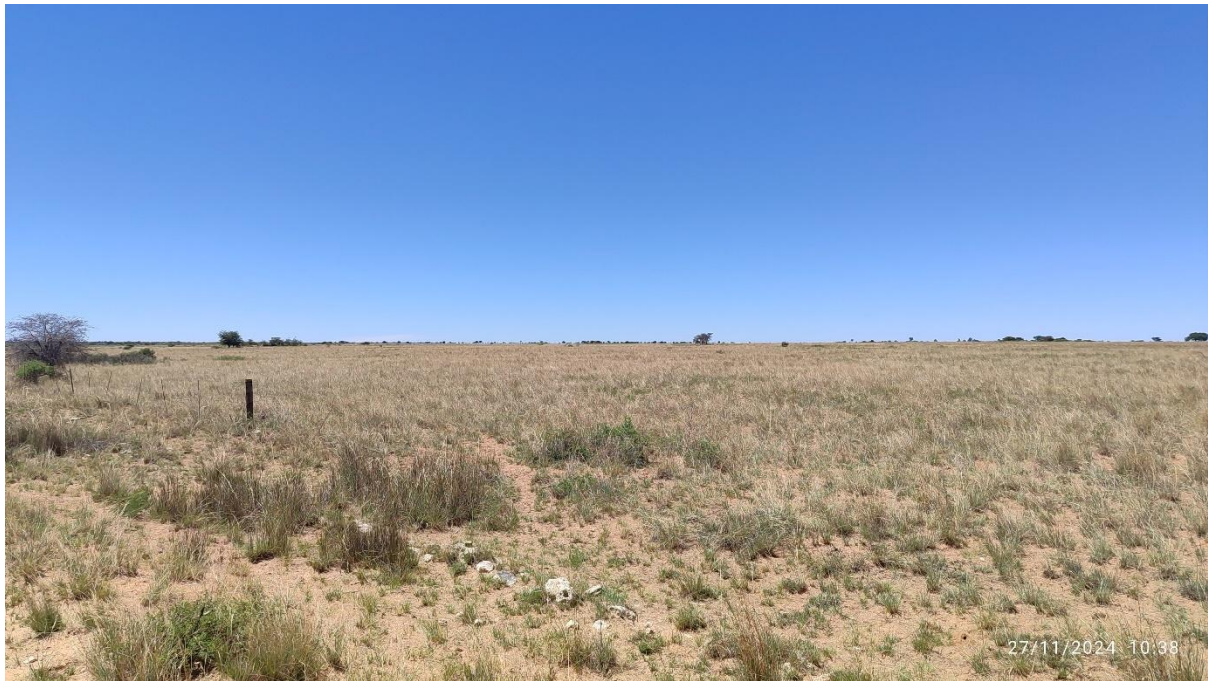
Despite the existing gravel road, a number of ecological disturbances were recorded in this vegetation unit. Litter and dumping were minimal. Grazing goats and horses were observed. Some infrastructure development (housing) was observed within and near this vegetation unit, influencing the surrounding area through day-to-day anthropogenic movements. Some areas surrounding trees and feeding/watering troughs showed signs of soil compaction and trampling. Some chickens and chicks were observed within close range to the housing. A graveyard was present, bordering slightly within the study area. Some erosion was observed in areas where calcrete was observed. With all these current and ongoing ecological disturbances, the ecosystem functioning is likely negatively influenced. However, the current ecological functioning of this vegetation unit allows for the occurrence of SCC species (*Drimia sanguinea* (NT)). The ecological functioning is considered poor to fair, with an ecological condition of semi-natural.

Figure 8: A ground view of VU D which is structurally an open savanna which is compositionally similar to the Kuruman Vaalbosveld and Kuruman thornveld vegetation types.
