## **Appendix 4:**

# **Specialist Reports and Declarations**

## **Wetland Assessment for the proposed new Waste Water Treatment Works (WWTW) and associated sewer network situated in the town of Warrenton, Northern Cape Province.**

November 2025

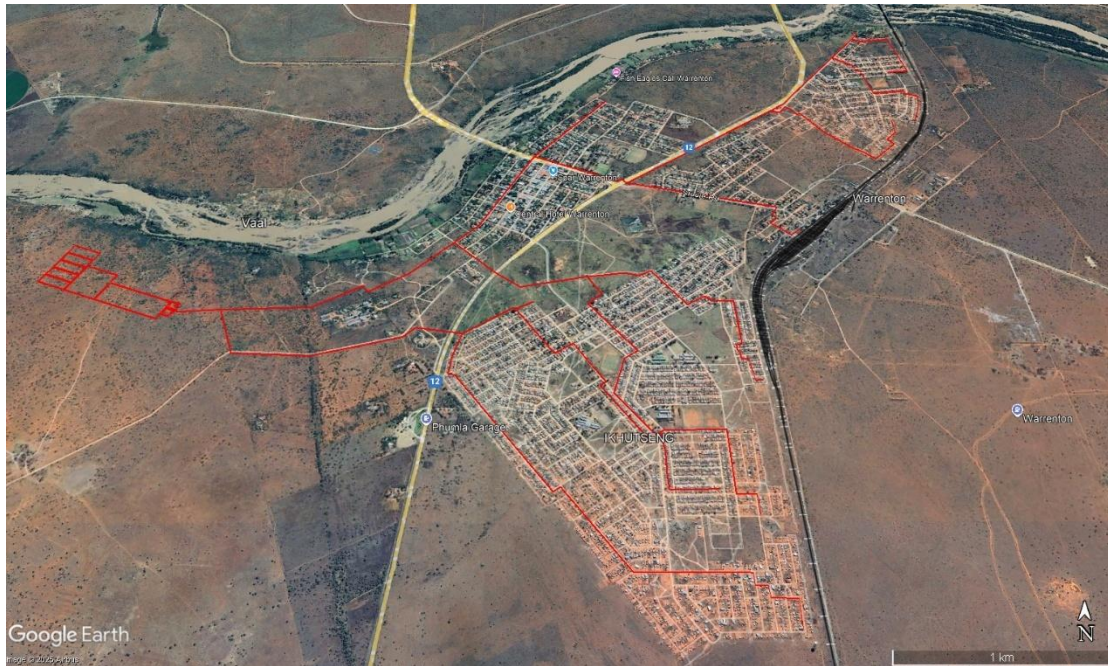
Figure 1: Aerial view of the recent condition of the study area (Google Earth 2023) which indicates extensive transformation as a result of urban surroundings. The Vaal River is clearly visible as the main watercourse in the area, with the proposed WWTW and sewer network also indicated (red).

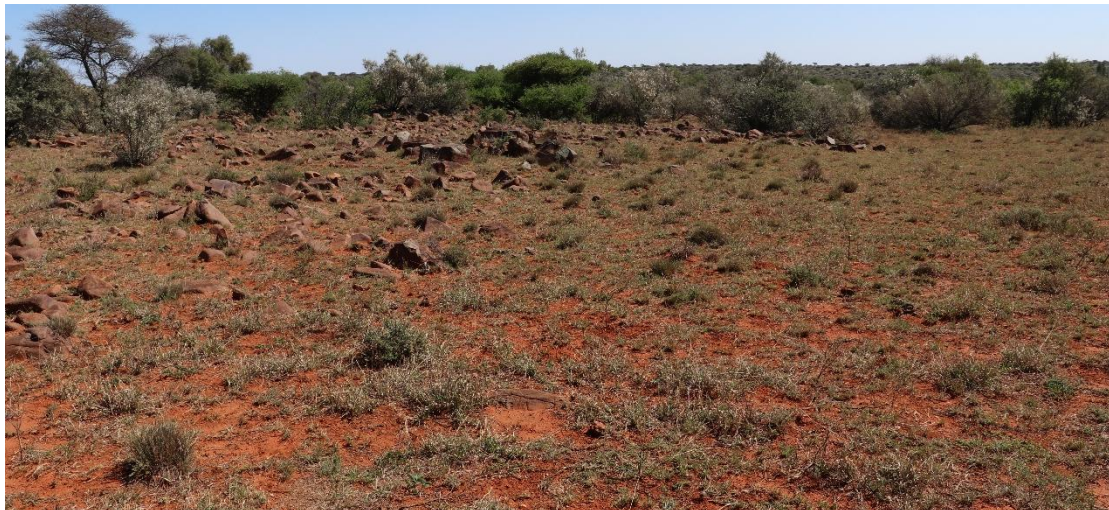
Figure 2: The surrounding terrestrial areas are dominated by a fairly flat topography, with vegetation affected by high levels of overgrazing by domestic livestock, resulting in a significant decrease of the grass layer and an increase in the tree layer.

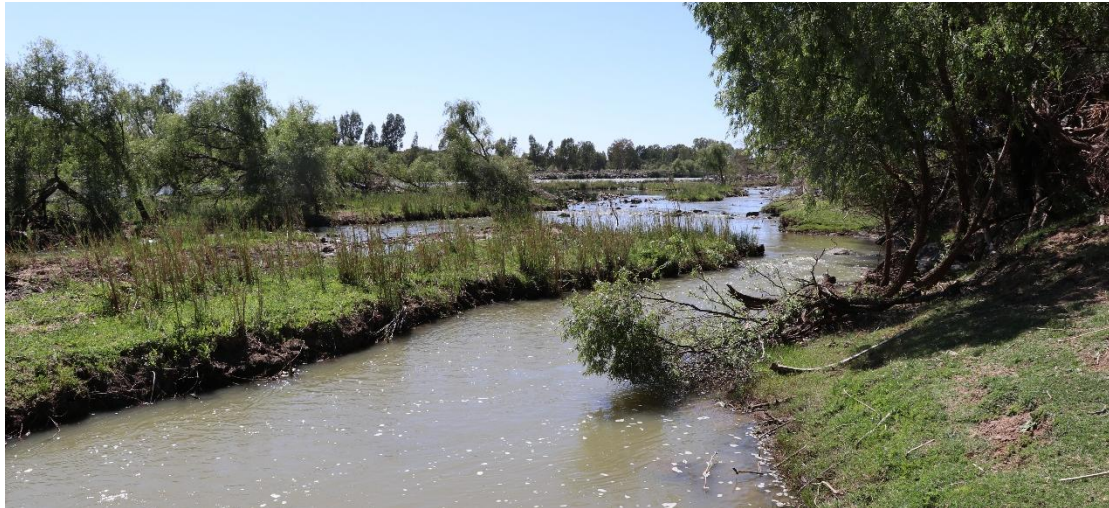
Figure 3: The Vaal River is the main surface water feature of the study area and contains extensive wetland areas.

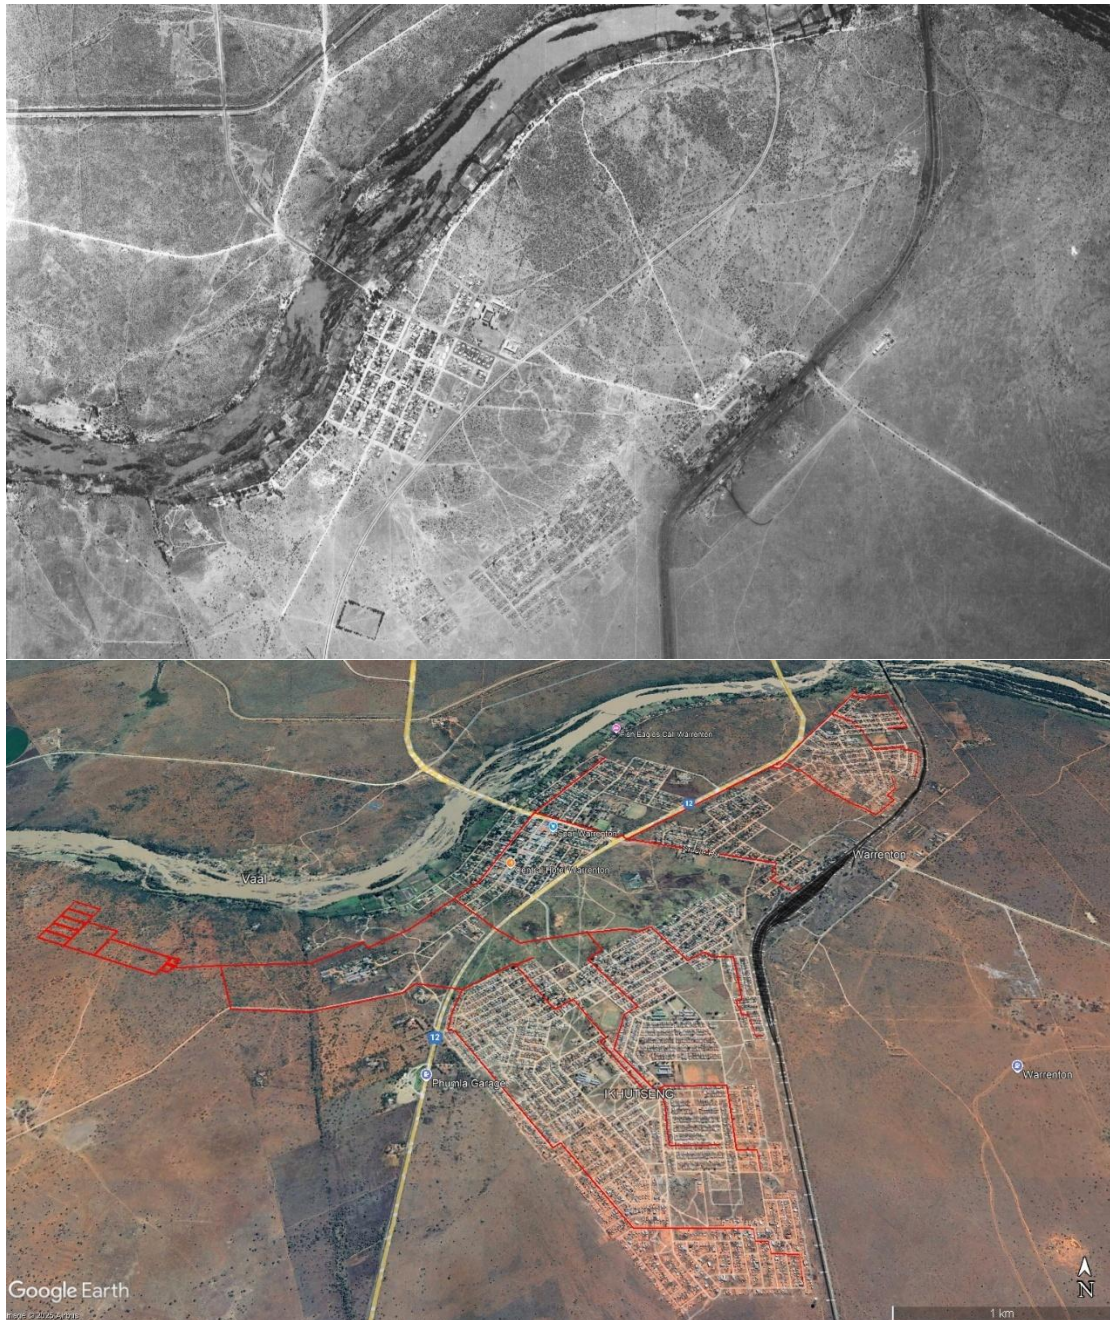
Figure 4: Aerial view of the WWTW and sewer network area. Historically (Top – National Geospatial Database 1956), the Vaal River remains prominent, though current artificial wetlands are completely absent (Bottom – Google Earth 2023), confirming that they are a consequence of the urban expansion over time.

As indicated, large areas of artificial wetlands have formed, associated with sewage effluent discharge from the existing, but defunct WWTW, as well as increased storm water runoff from the urban areas (Appendix A: Map 2). These areas contain extensive wetland conditions and will likely remain saturated throughout the year. They have however been confirmed to be completely artificial, not part of the remnants of any natural system and also not providing any significant ecosystem functions. They will therefore be noted in the report to confirm that they were surveyed but found to be artificial and therefore not part of the natural surface water resources of the area.

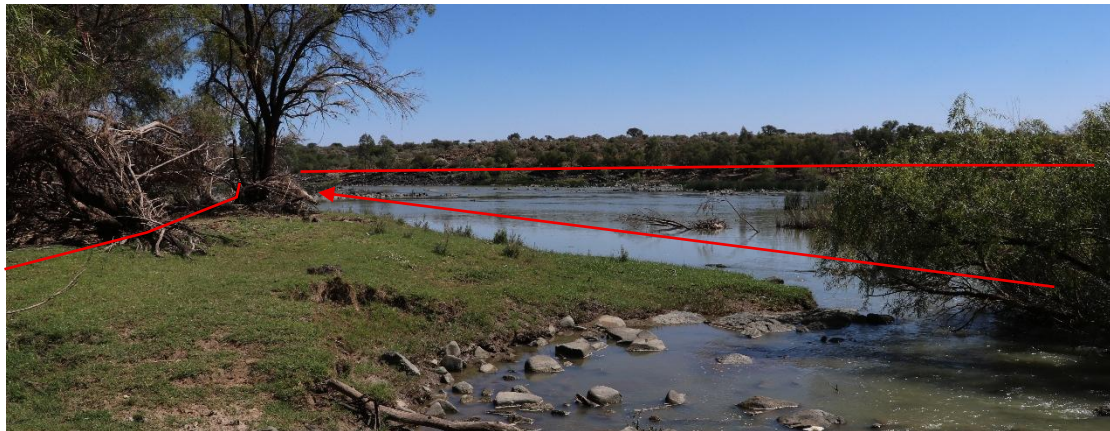
Figure 7: The Vaal River contains a clearly defined, active channel and well-defined channel banks (red). Flow also occurs as unidirectional flow within the channel (arrow).

This accurately describes the banks of the Vaal River, as well as the small lateral drainage line flowing into it. The wetland conditions are confined to the main channel of these systems which experience surface flow either seasonally or perennially. Here wetland conditions are most prominent along the main channel and decrease in distance from the channel.

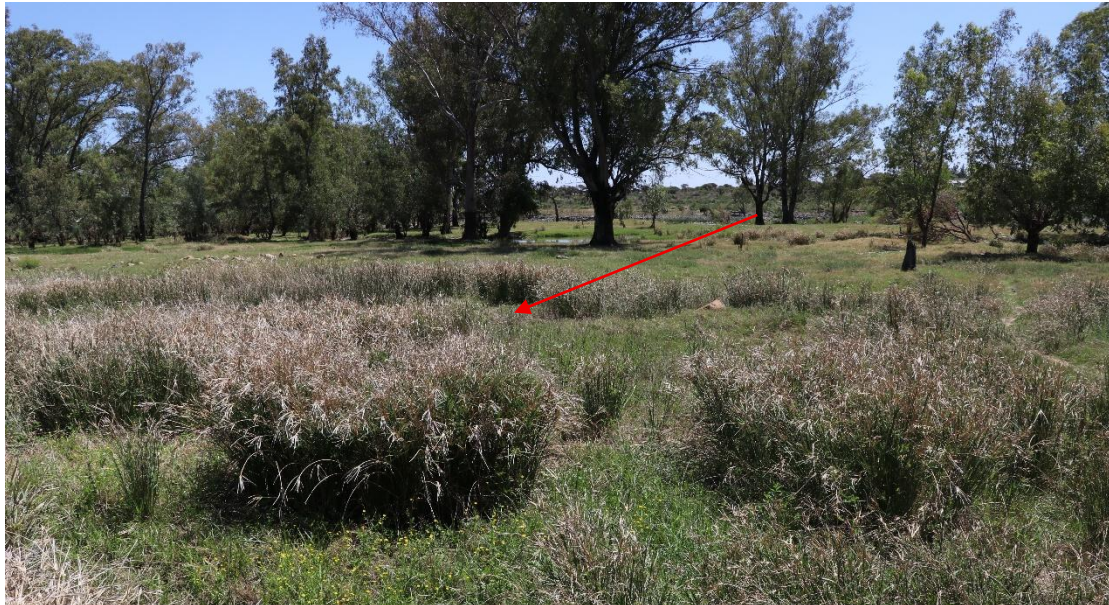
Figure 8: The Vaal River contains prominent floodplains where backwater flooding areas and extensive wetland areas are prominent. Water input is mainly from the overtopping of the main channel (arrow).

This accurately describes the wetland conditions which occur in the floodplain of the river. Floodplain and channelled valley-bottom wetlands are easily confused and do look similar but can be differentiated mainly by a floodplain wetland being associated with a lowland watercourse, while channelled valley-bottom systems are associated with the upper reaches where hills and valley-bottoms are present.

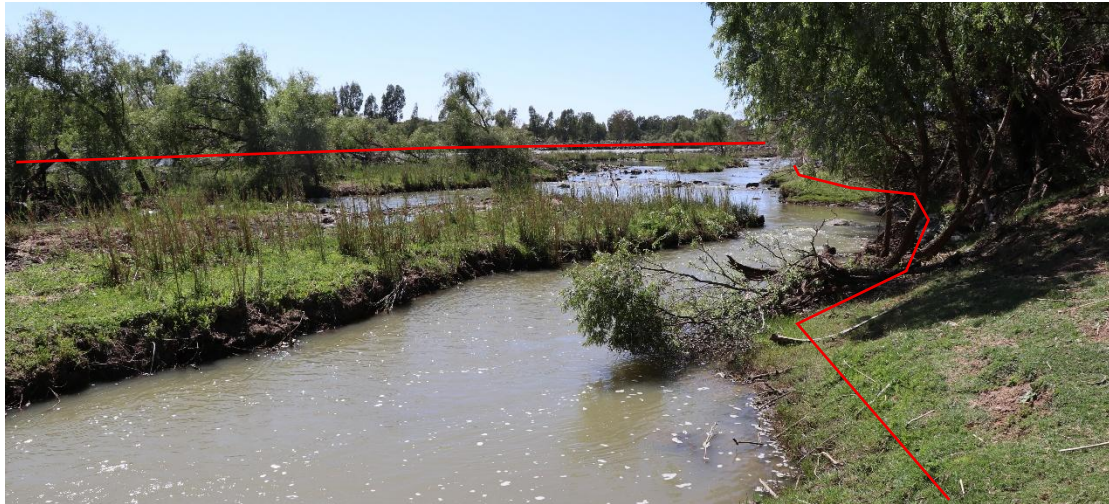
Figure 9: View of the banks of the Vaal River in the study area, indicating an extensive marginal zone (red) with an abundance of wetland areas.

The marginal zone is the lowest zone and is always present in river systems, while the other two zones may not always be present. The marginal zone is situated from the water level at low flow, if present, up to the features that are hydrologically activated for most of the year (Figure 12). The marginal zone within the Vaal River as it occurs within the study area is well defined and easily identifiable by the presence of a dense riparian and sedge layer which is inundated annually. The width of the marginal zone at the site is relatively extensive as a result of the braided nature of the main channel. The marginal zone constitutes perennial wetland areas. It will be modified to some degree as a result of upstream impacts, as well as the existing urban areas in the study area.

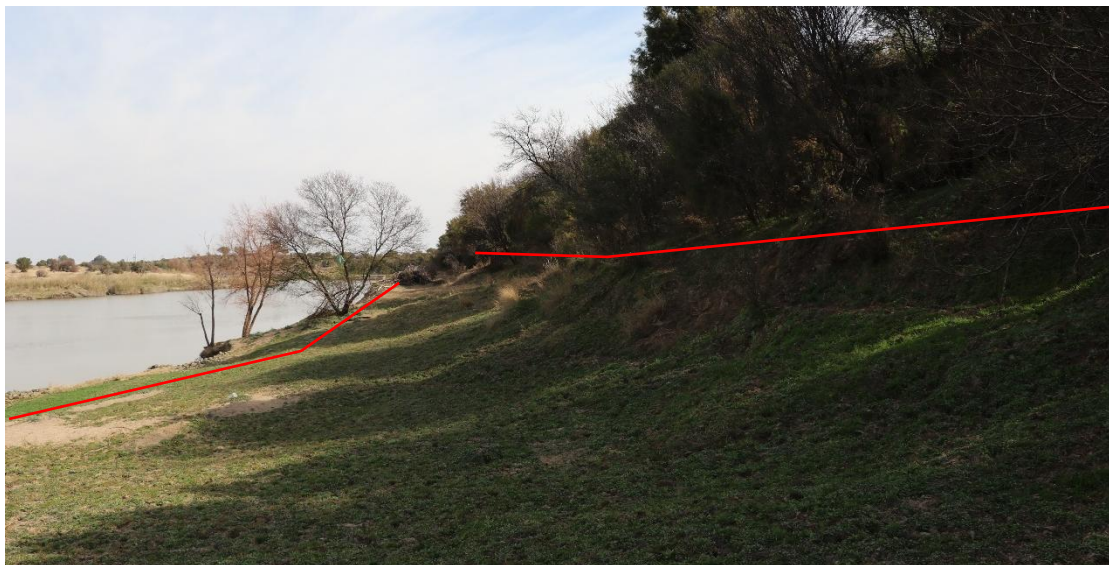
Figure 10: The lower zone is characterised by a steep bank between the marginal zone along the water's edge and the upper zone dominated by riparian thicket.

The lower zone is characterised by seasonal features and extends from the marginal zone up to an area of marked elevation. This area may be accompanied by a change in species distribution patterns. The lower zone consists of geomorphic features that are activated on a seasonal basis (Figure 12). The lower zone along the Vaal River is clearly defined and is easily visible. The lower zone is exceedingly steep with a sudden increase in slope over a short distance whereafter it levels off into the upper zone. In portions of the river and especially where the marginal zone is extensive, the lower zone extends over a larger distance and the increase in slope and elevation is more gradual. The boundaries between the zones in these areas are more difficult to discern. The lower zone is inundated infrequently and only during larger flooding events.

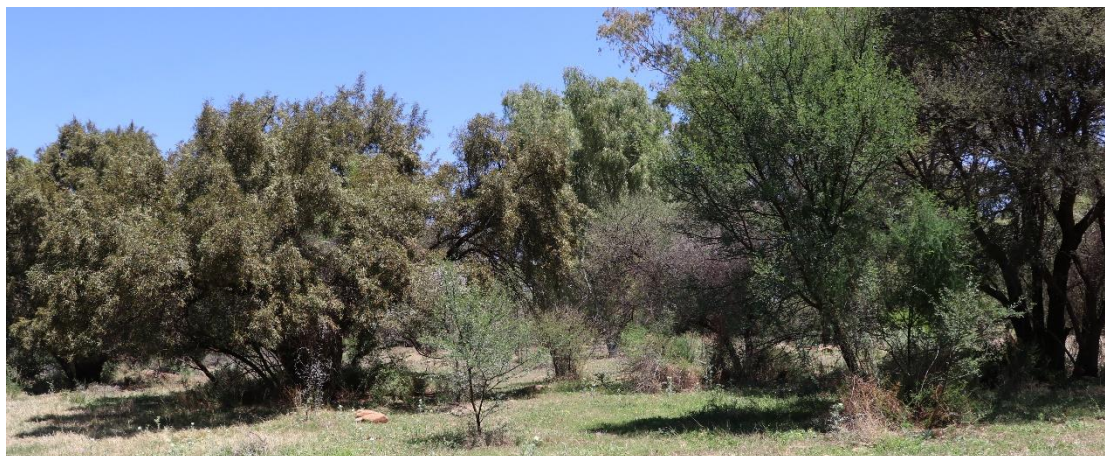
Figure 11: The upper zone is most obviously discernible as a decrease in the slope gradient and a significant increase in the riparian thicket component.

The upper zone is characterised by ephemeral features, as well as the presence of both riparian and terrestrial species. The zone extends from the lower zone to the riparian corridor. The upper zone contains geomorphic features that are hydrologically activated on an ephemeral basis (Figure 12). The upper zone along the Vaal River is clearly visible as a decrease in slope and an increase in the woodland component. The border between the upper- and lower zones is clearly

visible as a drastic decrease in slope gradient with the upper zone having a much more gradual slope. The tree species are able to attain height and age due to their deep root systems still being able to access the higher moisture levels and as flood disturbance in the upper zone is much less, the trees are allowed to grow old without being removed by flood damage. The riparian tree species within the upper zone are dominated by *Vachellia karroo* (Sweetthorn), *Searsia lancea* (Karee), *Ziziphus mucronata* (Buffalo Thorn) and *Diospyros lycioides* (Bluebush), which then also indicate the border of the upper zone.

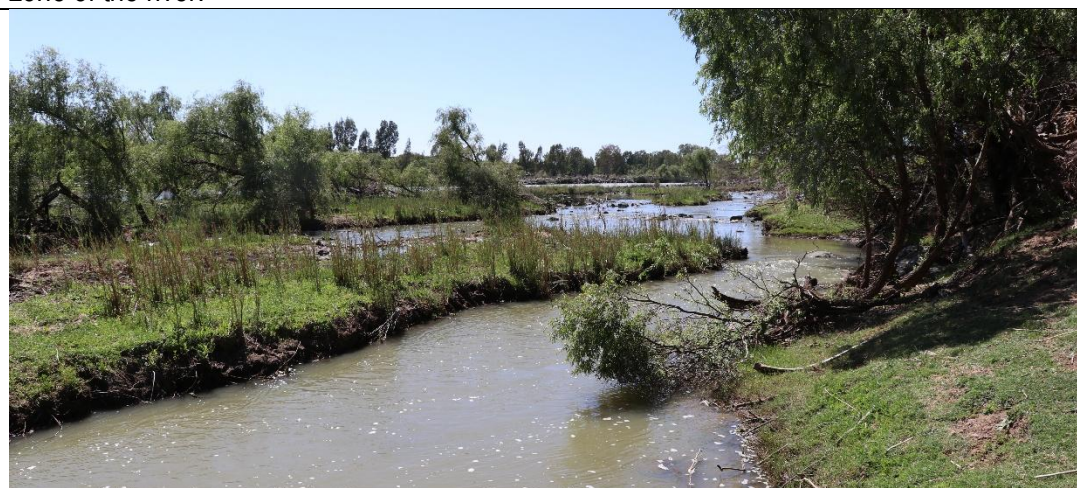
View of the main channel of the Vaal River, which can contain extensive wetland areas in this section.

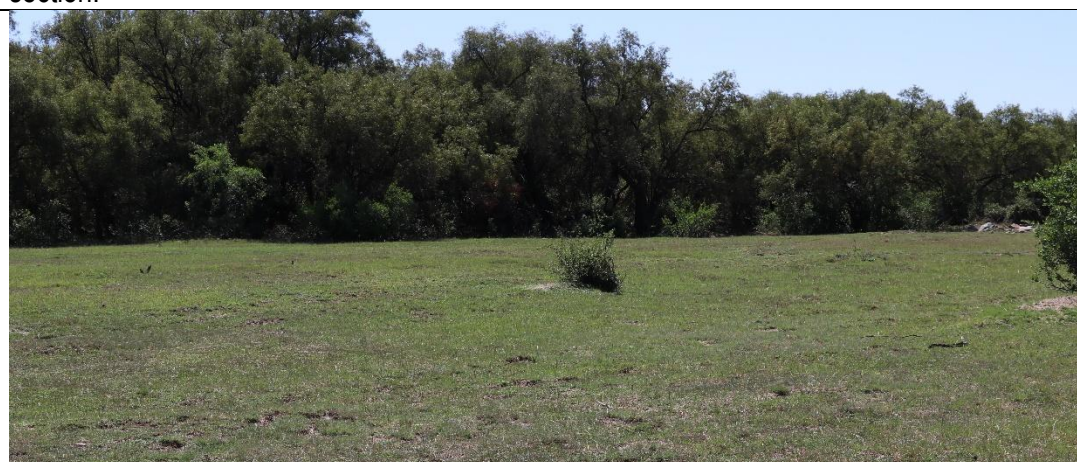
The river also contains a prominent backwater wetland system within the floodplain, visible as a shallow depression, devoid of trees. Note also riparian thicket in the background, associated with the upper zone of the river.

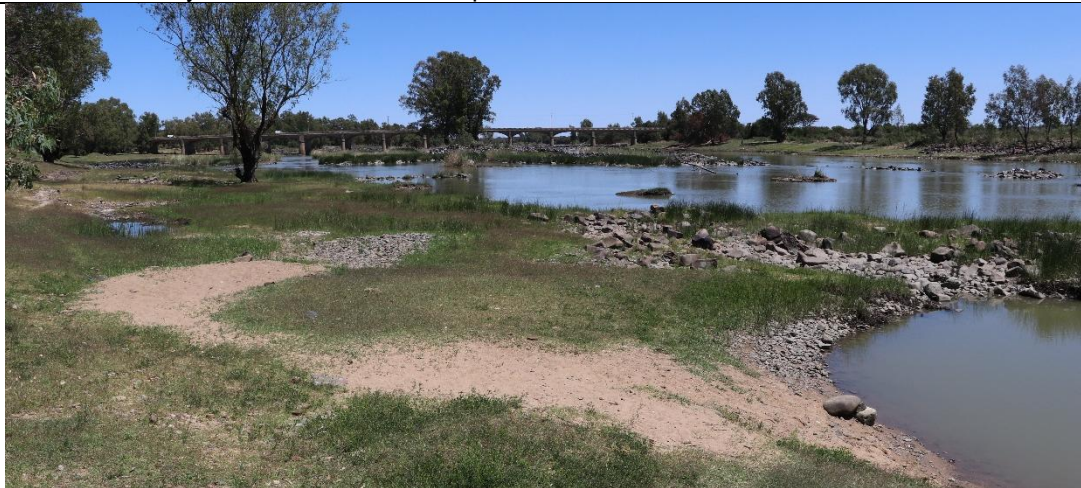
View of the main channel of the Vaal River, which can contain extensive wetland areas in this section.

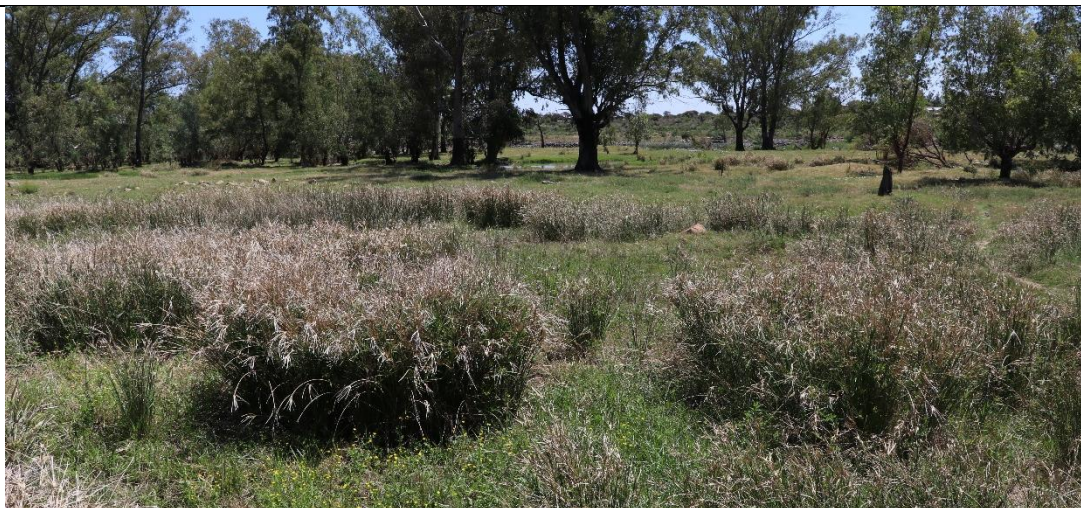
The river also contains extensive wetland conditions within the floodplain, with obligate wetland vegetation being prominent.

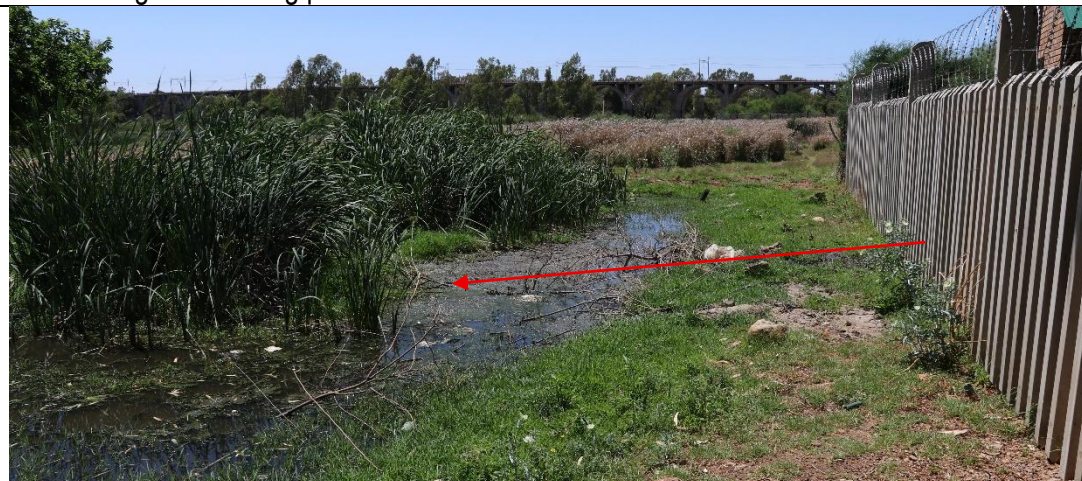
Sewage overflow (red) from the existing pump station is currently ongoing and will have a significant impact on the river. This also indicates the risk involved with construction of a pump station within the floodplain of the river.

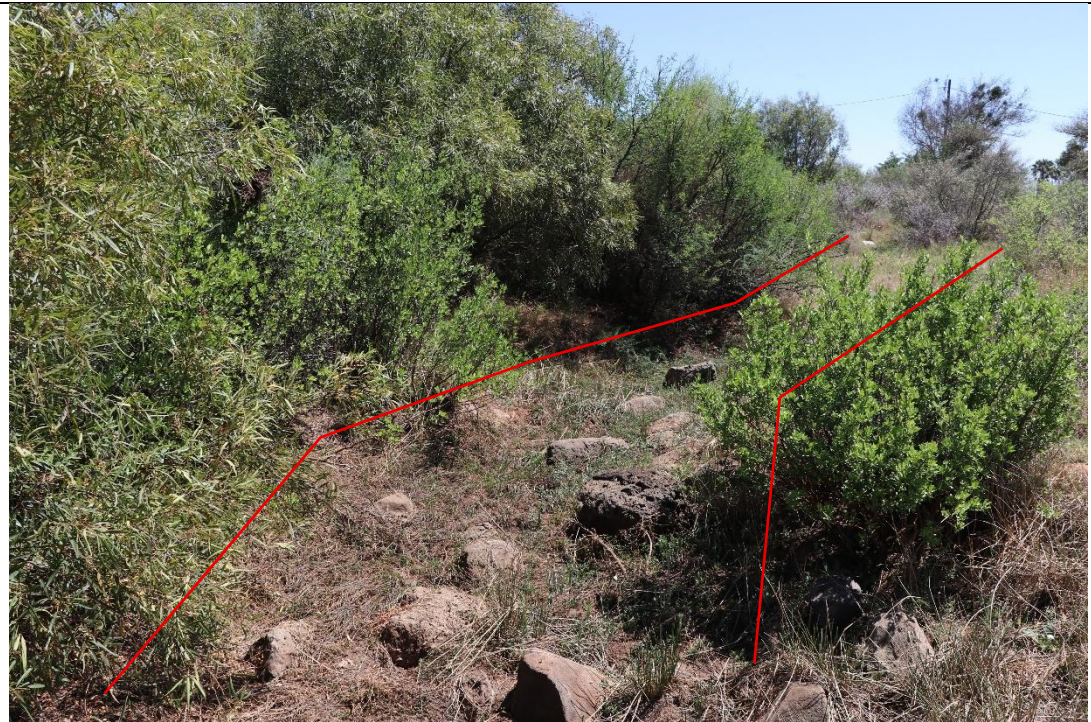
The drainage line is quite small, but contains a defined channel (red), which has developed prominent wetland vegetation, while riparian species are also abundant along the channel.

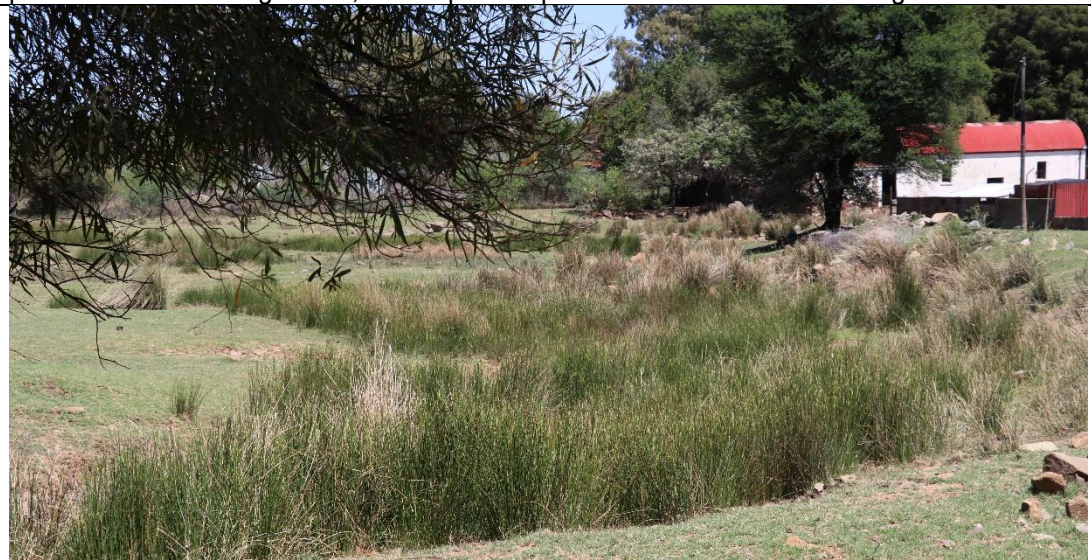
Though the drainage is quite small, it has developed prominent wetland conditions, especially downstream of the site, indicating at least seasonal saturation, which is however most probably also a consequence of the upstream discharge of storm water and effluent from the urban areas.

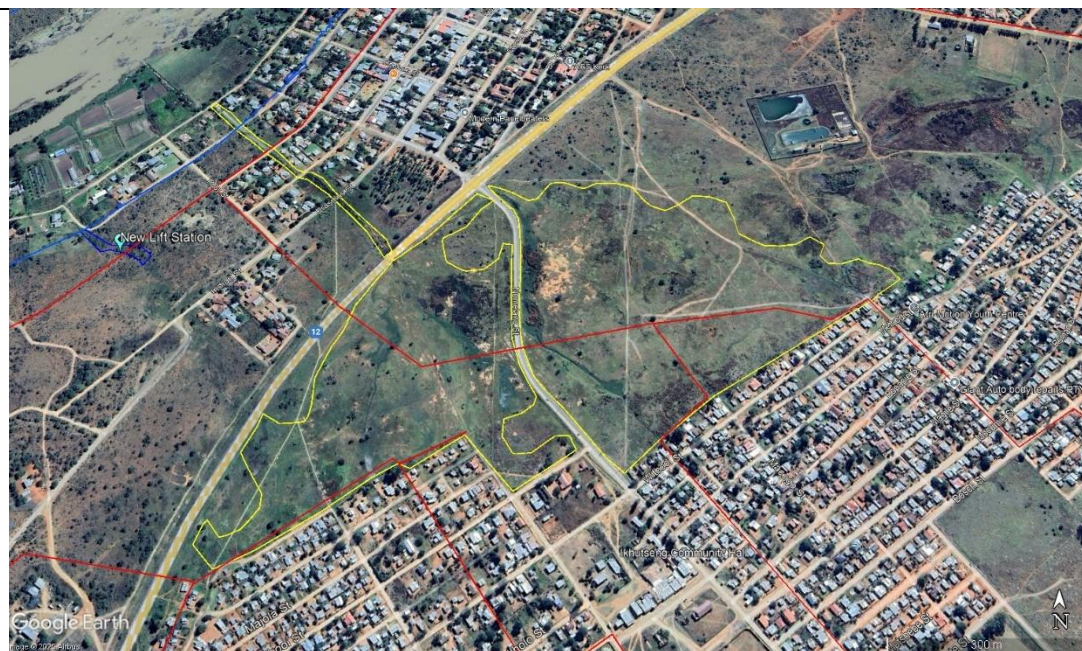
Aerial view of the artificial wetland areas (yellow) in the study area, the result of sewage overflow, storm water and effluent discharge from the urban areas. These feed into an artificial canal (yellow), which eventually flows into the Vaal River to the north. Note also the existing and defunct WWTW to the north east.

- The existing WWTW situated to the west of the N12 National Road is currently in disrepair and not functioning well, therefore overflowing into the adjacent terrestrial areas, which has subsequently led to the formation of fairly extensive artificial wetland areas.
- In addition to the above, storm water and effluent discharge from the adjacent urban areas are significant, also flowing into the adjacent terrestrial areas, further increasing the formation of artificial wetland areas.
- These sources of artificial surface water flow slowly northwards, toward the N12 National Road, where they flow into a fairly large artificial canal. This canal can also, with high level of confidence, be regarded as completely artificial and not a remnant of a natural drainage system. This canal then allows for the discharge of effluent into the Vaal River to the north.

Artificial wetland areas as listed above, will be crossed at several locations by the proposed sewer network, which may then entail spillages of untreated sewage, that may eventually flow into the Vaal River. The impact should therefore be low, given the artificial nature of these areas, but should still be taken into account, in terms of the residual impact on the Vaal River.

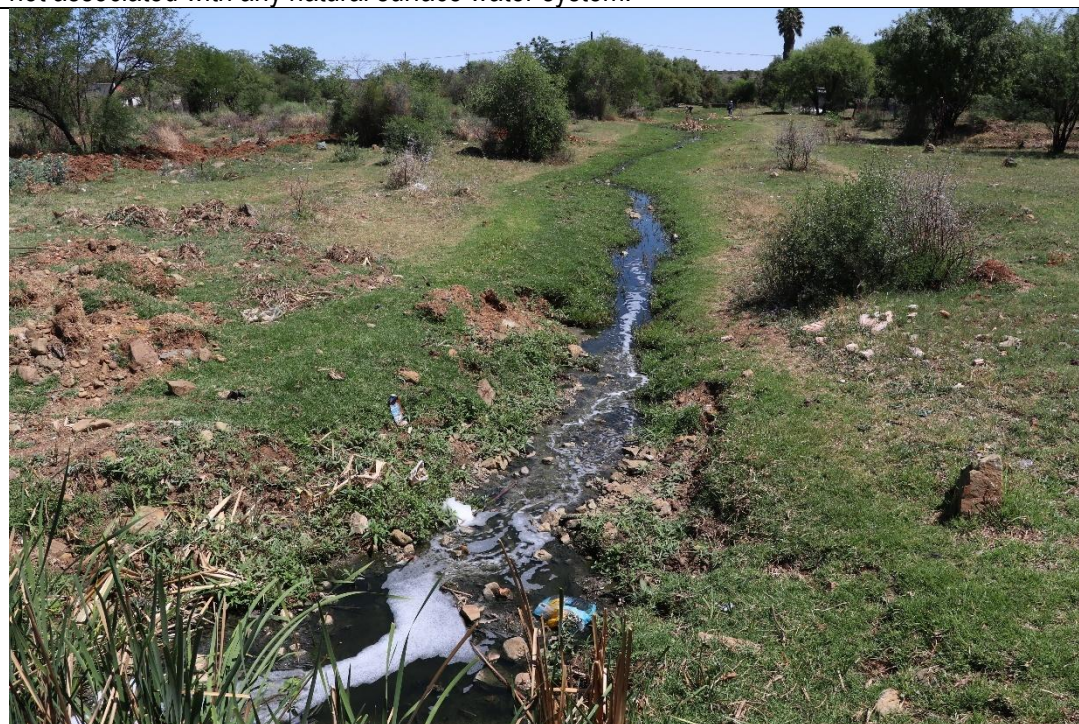
Discharge from the existing WWTW and effluent from the urban area then enter an artificial canal, flowing toward, and eventually into, the Vaal River.

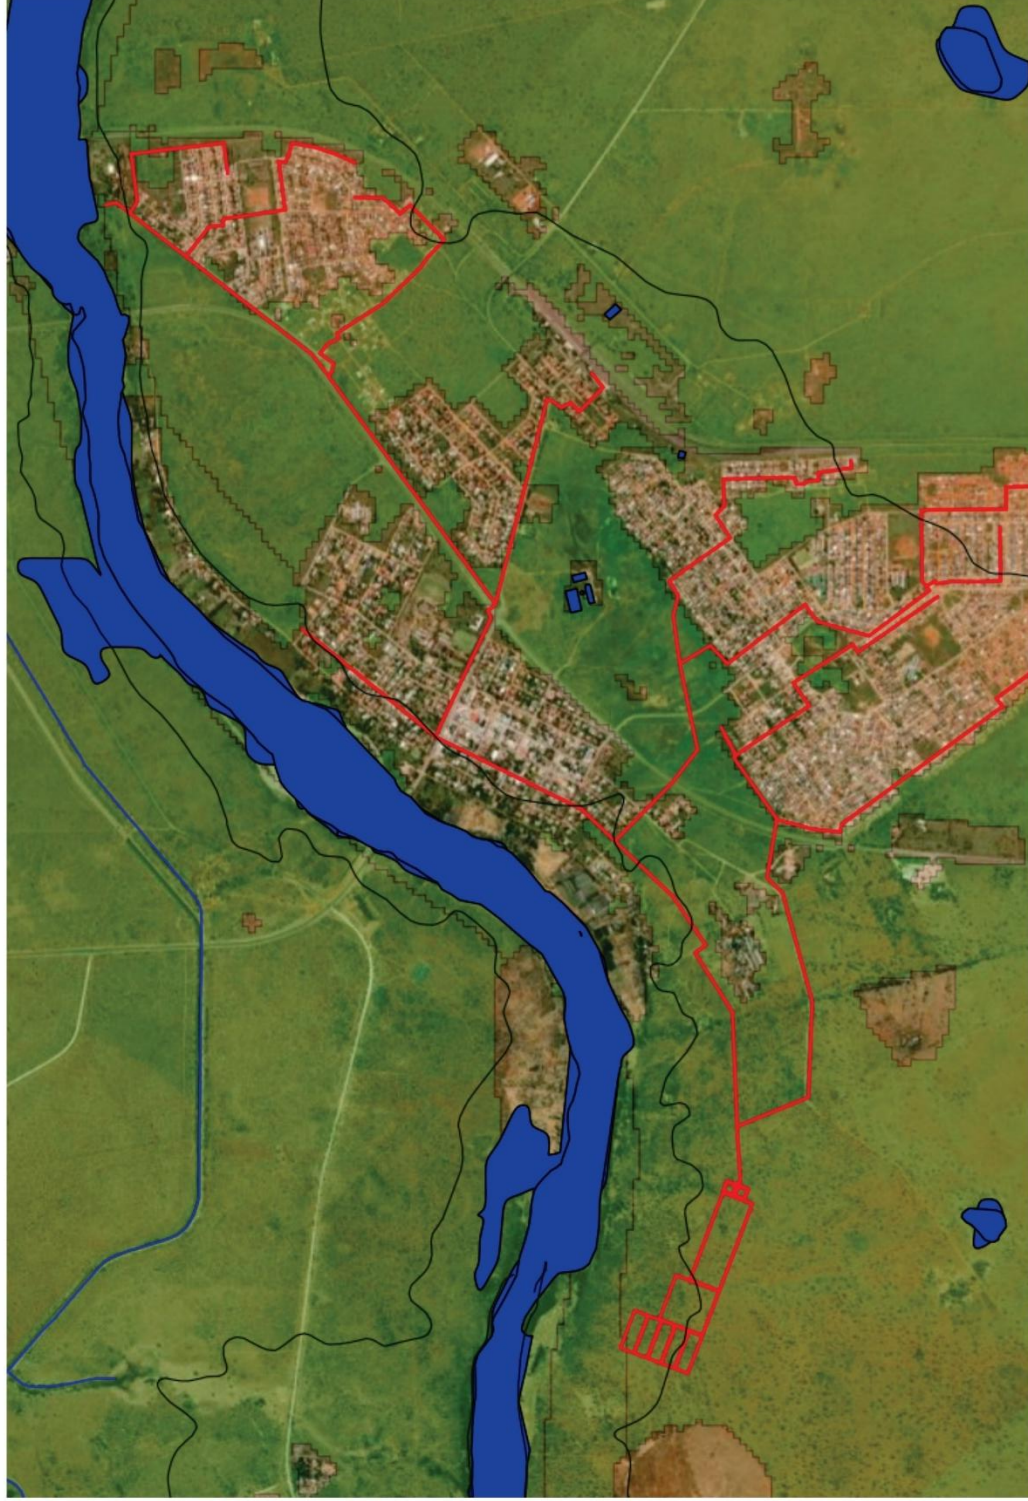
**Map 1:** General ecology map of proposed new WWTW and sewer network in Warrenton. The approximate extent of remaining natural vegetation is indicated (National Biodiversity Assessment 2018) and indicates the urban areas to be transformed, while extensive natural areas remain in the surroundings. The National Biodiversity Assessment 2018: Wetland Map 5 and National Freshwater Ecosystems Priority Areas also indicates the extensive wetland conditions associated with the Vaal River and its floodplain, while the surroundings only contain a few pan systems, being largely devoid of wetland systems. Where the Vaal River or associated wetland areas could be affected by the development, their delineation was also refined by on-site delineation (refer to Map 2).

gradient increases and runoff toward the river results in the forming of concentrated flowpaths) (Appendix A: Map 1). The flat topography does however contribute to the formation of pans or depression wetlands in the landscape, though none were found within the study area. Within the urban area, the natural surface topography has been modified to a large degree, with surface runoff patterns and storm water flow especially being heavily modified.
