PALAEONTOLOGICAL AND HERITAGE IMPACT  
ASSESSMENT FOR THE PROPOSED MANGAUNG  
METROPOLITAN MUNICIPALITY NORTHERN BULK  
DISTRIBUTION PIPELINE, BLOEMFONTEIN, FREE STATE  
PROVINCE.

A Phase 1 Archaeological and Palaeontological Impact Assessment (AIA/PIA) was undertaken for the proposed Mangaung Metropolitan Municipality Bulk Distribution Pipeline project, comprising the installation of a ~13 km Bulk pipeline, a ~2.5 km Sewer pipeline, and a ~1.25 km Water pipeline within a predominantly urban and peri-urban setting north of Bloemfontein, Free State Province. **Palaeontology** — The three pipeline routes are underlain by sedimentary strata of the late Permian Adelaide Subgroup (Beaufort Group, Karoo Supergroup), which are regionally assigned a high palaeontological sensitivity. However, field verification confirmed that across all three alignments, fossil-bearing bedrock is variably mantled by eluvium, late Quaternary aeolian-derived topsoils, and residual dolerite weathering material, resulting in a low effective palaeontological sensitivity at surface level. No fossil material was observed during the field assessment. The probability of encountering in situ fossiliferous material

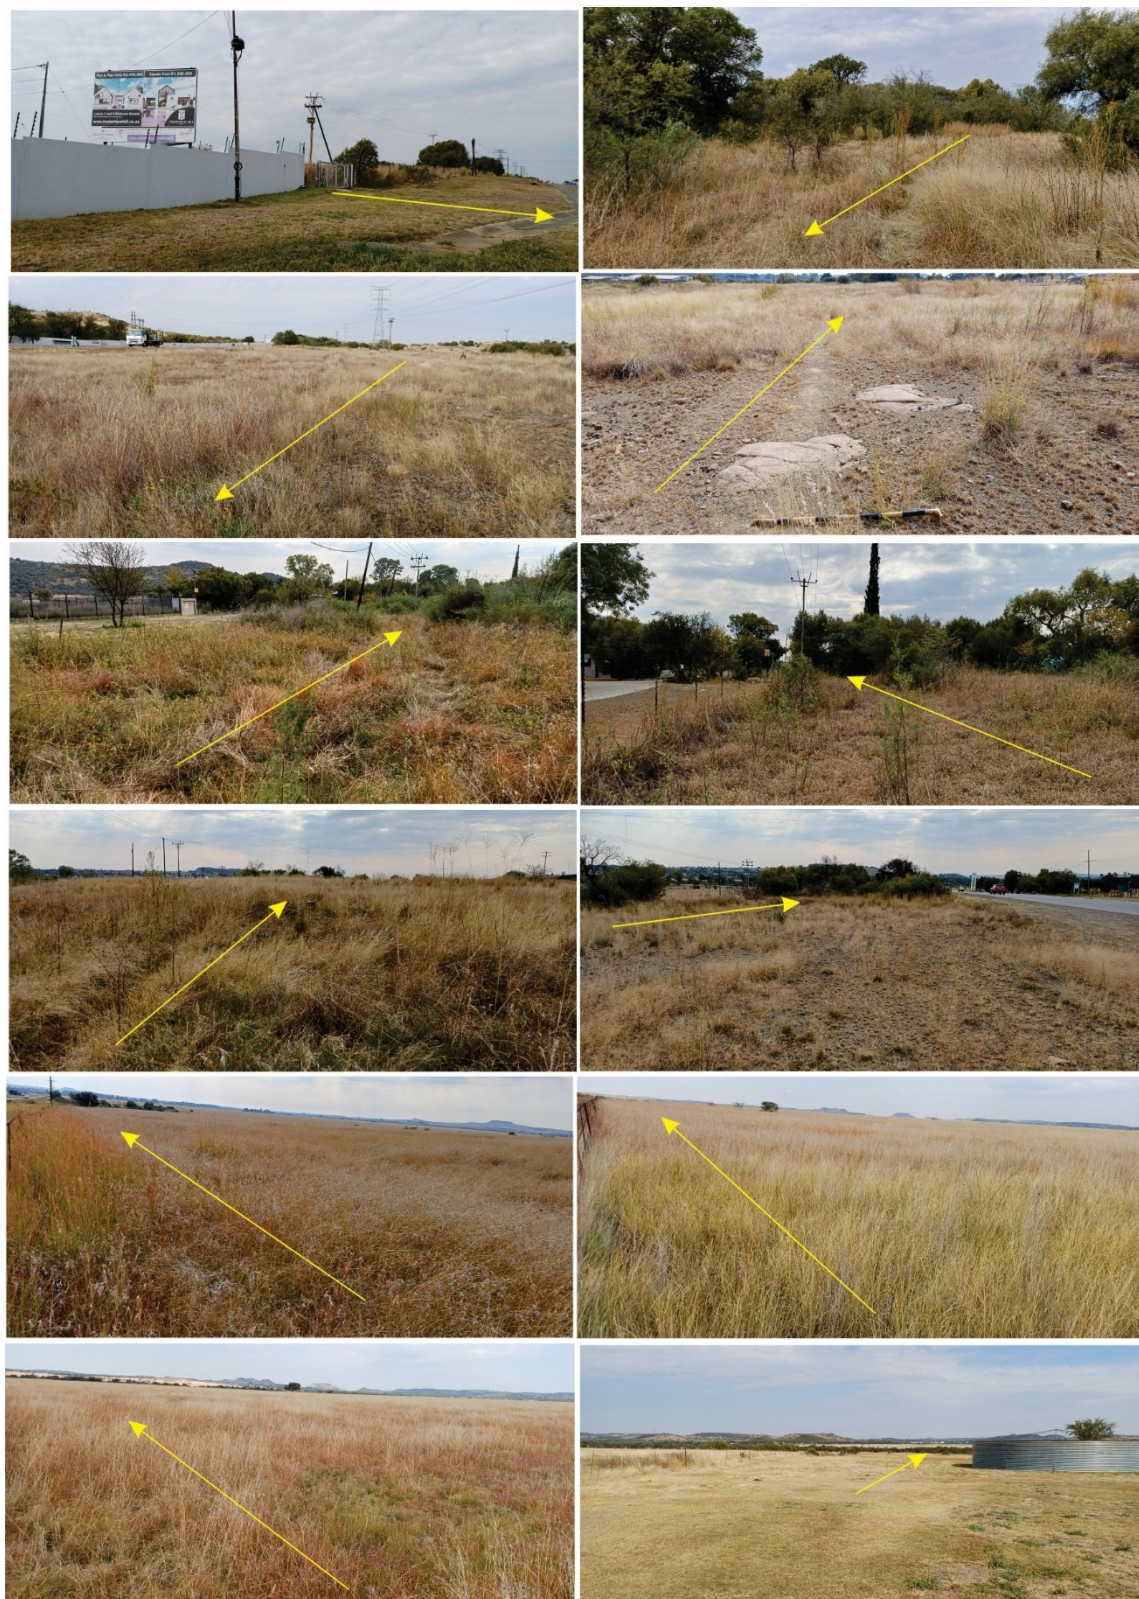
Figure 3. General view of the Bulk pipeline route with arrow indicating direction of the alignment.

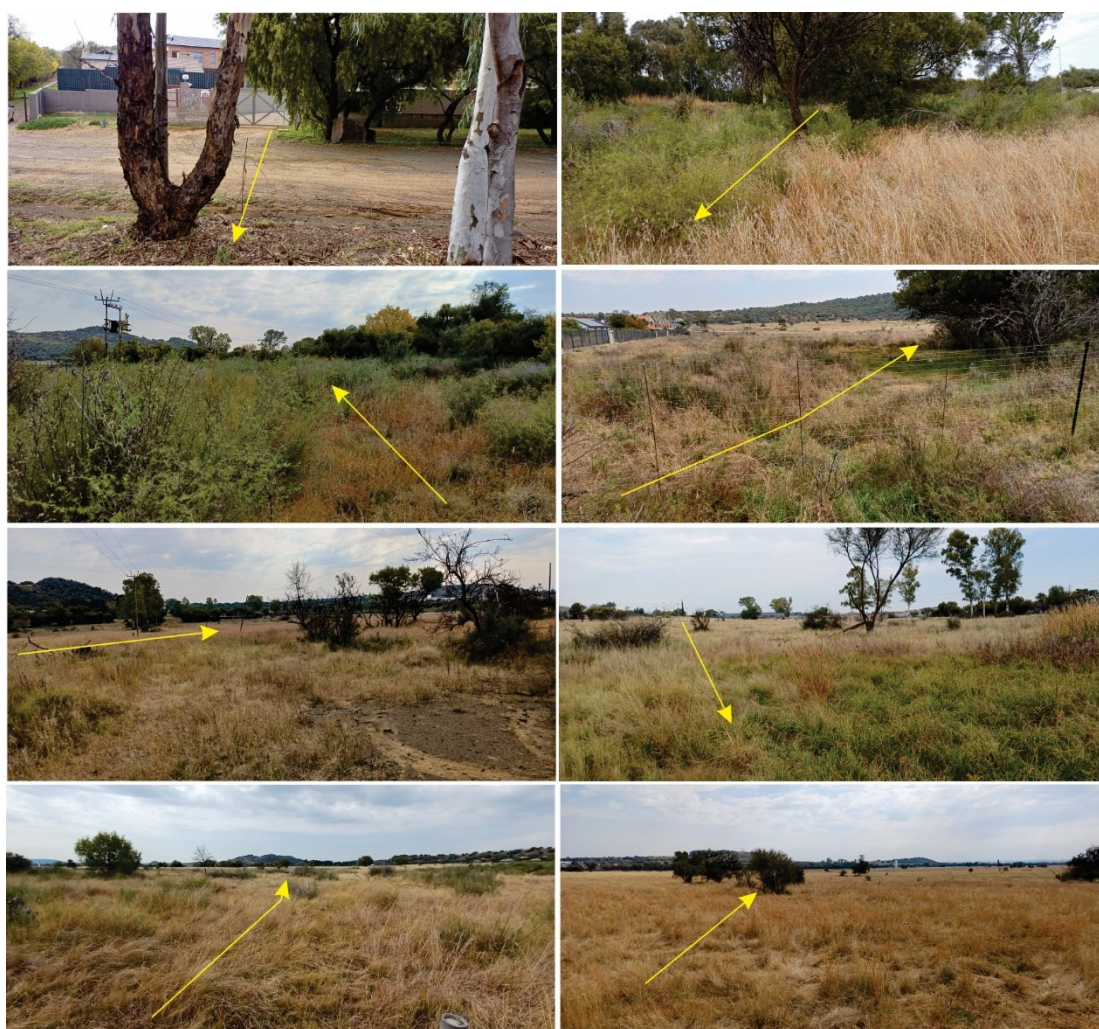
Figure 4. General view of the Sewer pipeline route with arrow indicating direction of the alignment.

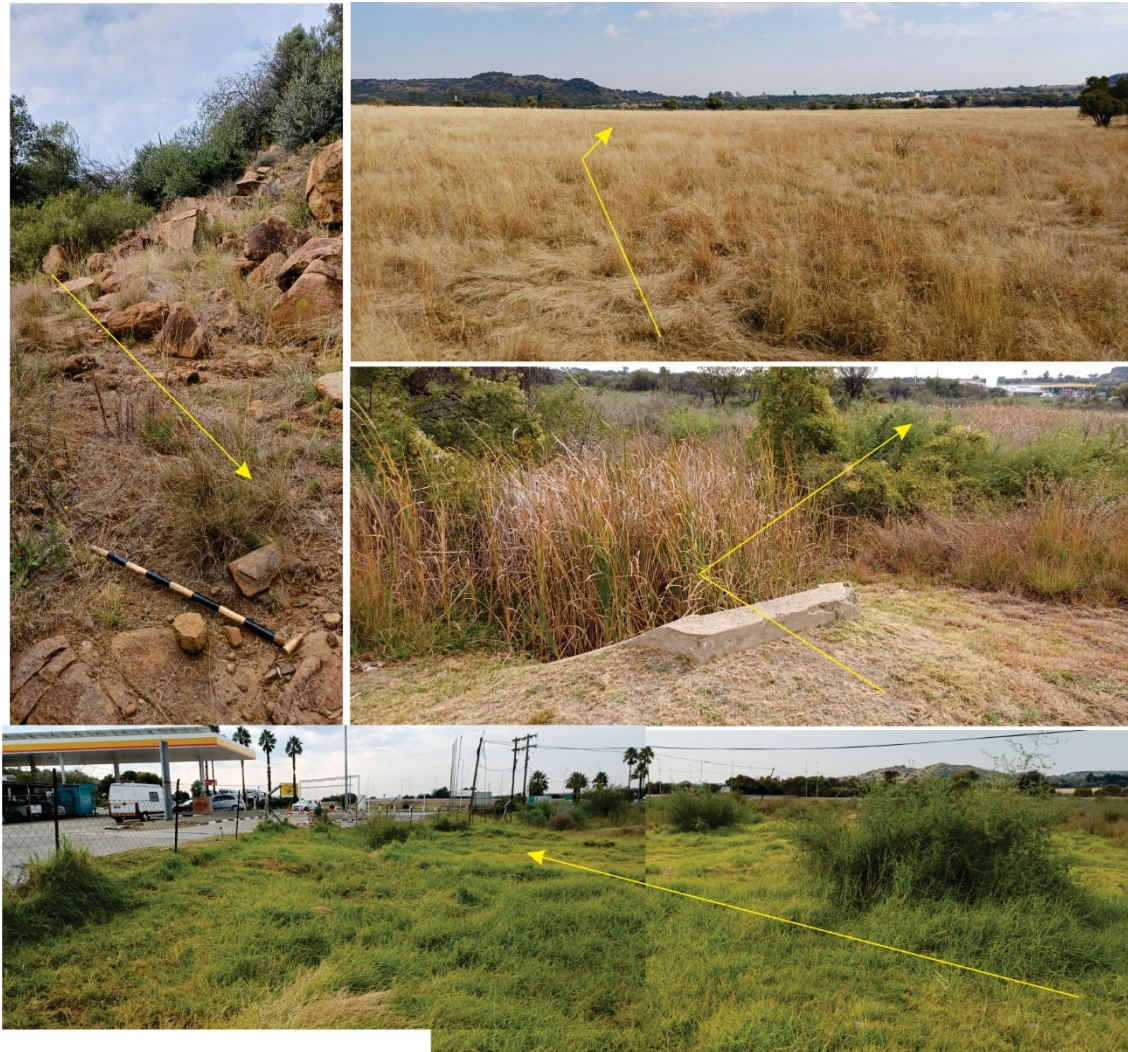
Figure 5. General view of the Water pipeline route with arrow indicating direction of the alignment.

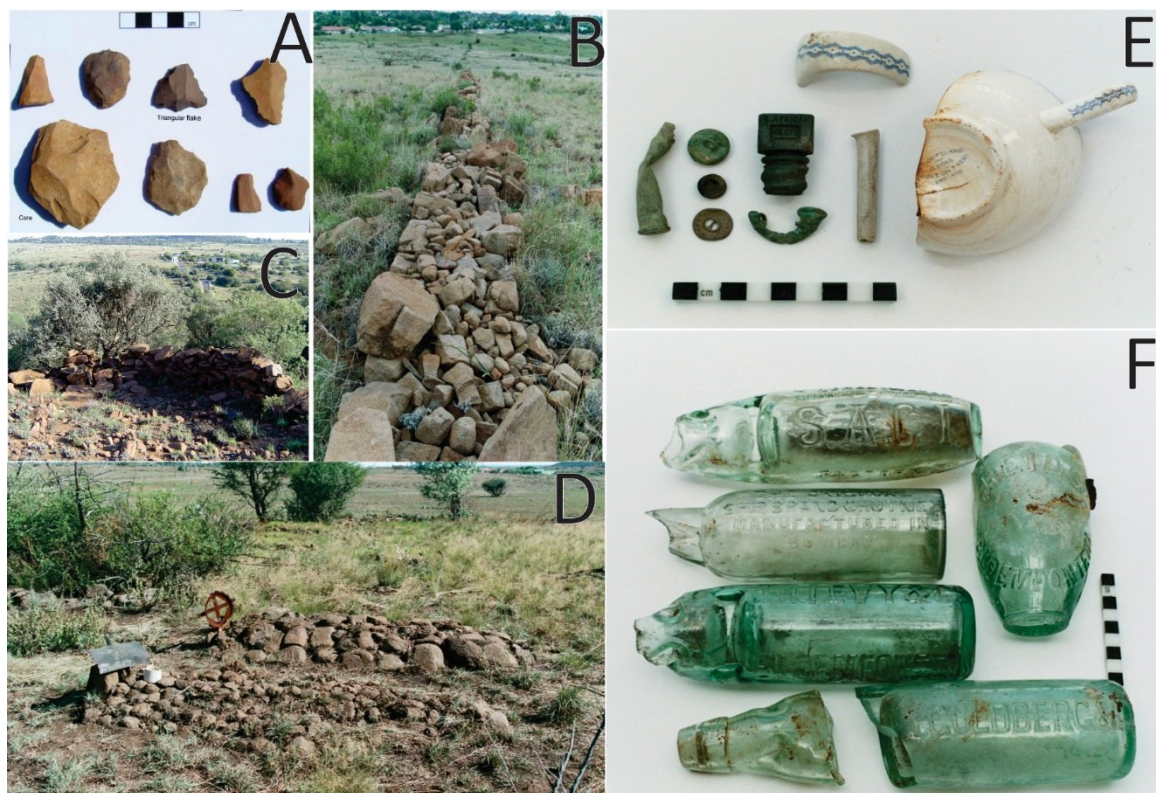
The prehistoric archaeological record of the northern Bloemfontein landscape is tied especially to the Modder River catchment. This record extends back to the early Middle Stone Age, with localized occurrences of in situ Middle and Later Stone Age material preserved in overbank sediments of the Modder River and its tributaries between Maselspoort and Glen north of Bloemfontein. In addition, widespread traces of prehistoric human occupation, in the form of stone tool scatters and isolated surface finds, have previously been recorded at Bayswater 2865, Lilyvale 2313 and Hillandale 249 (**Fig. 12A**).

Figure 12. Archaeological remains previously recorded in the area include MSA stone tools and remnants related to the Anglo Boer War and early 20th century pastoral farmstead infrastructure: stone wall structures (B), sangars (C), graves (D) and surface-strewn military debris such as bullet casings, tin cans, glass and ceramics (E,F).

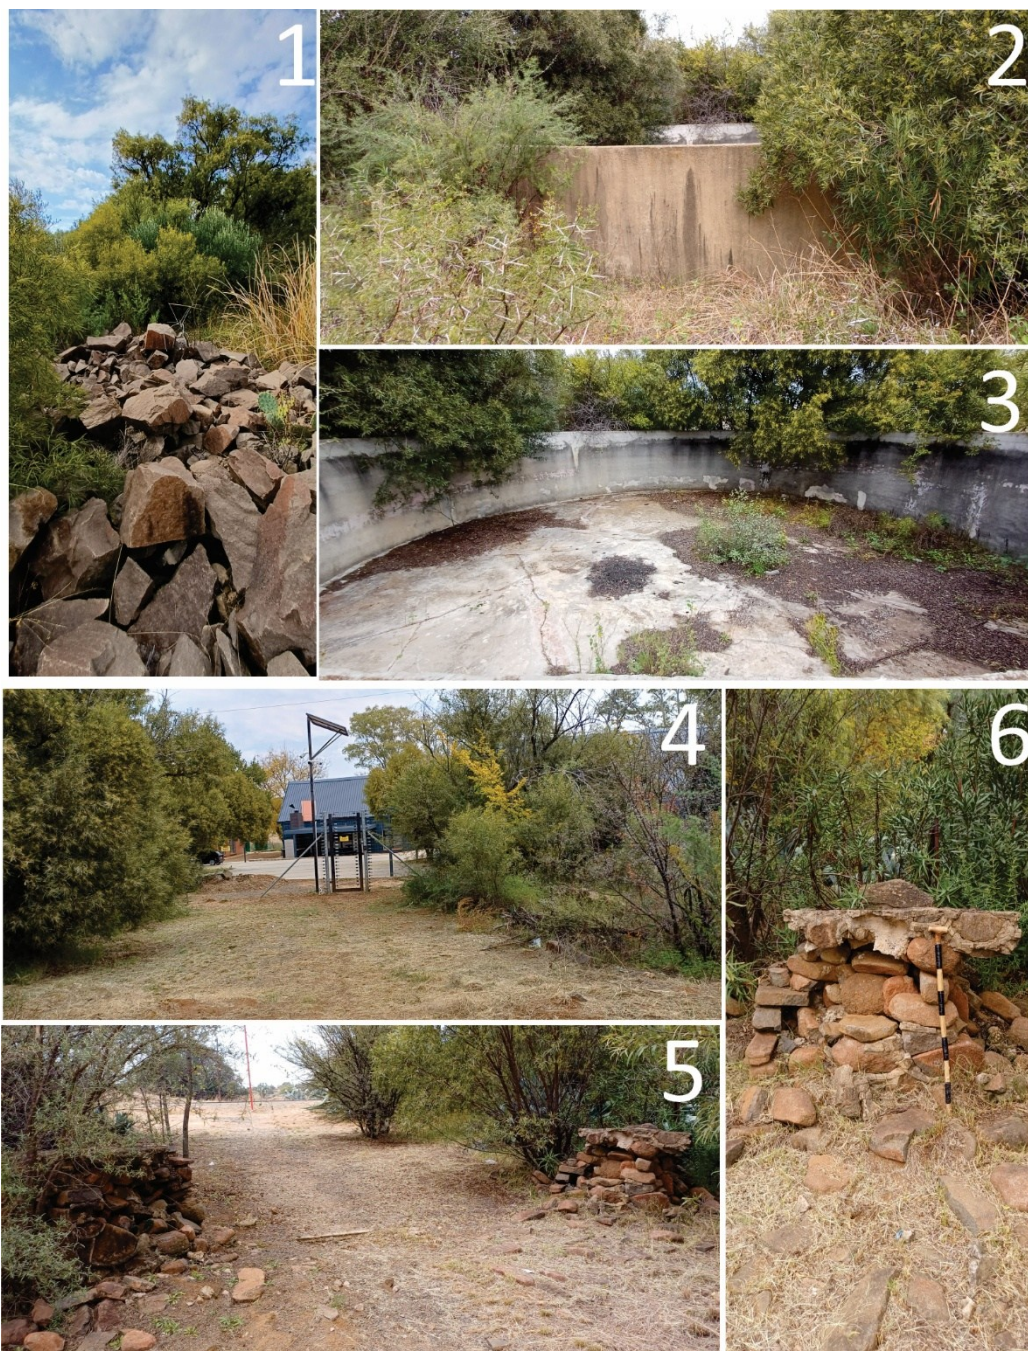
Figure 13. Built environment features and structural remnants associated with ongoing peri-urban encroachment recorded within a 10 m corridor of the proposed bulk water pipeline route. These include: a stockpile of displaced dolerite rubble indicative of recent land clearance (1); a derelict cast-concrete agricultural dam (2, 3); an occupied homestead compound with corrugated-iron roofing and perimeter fencing (4); and an unpaved access track linking the homestead to the R700 public road (5), flanked by dry-packed dolerite stone gateway pillars (6).

significance to warrant formal protection under Section 34 of the NHRA (No. 25 of 1999). The unpaved access track linking the homestead to the R700 public road is flanked by a dolerite

stone gateway pillar located 16 m east of the footprint (Waypoint 6). which may reflect an earlier phase of rural settlement predating the current peri-urban expansion and should be avoided by a 10 no-go buffer zone during construction phase of the project.

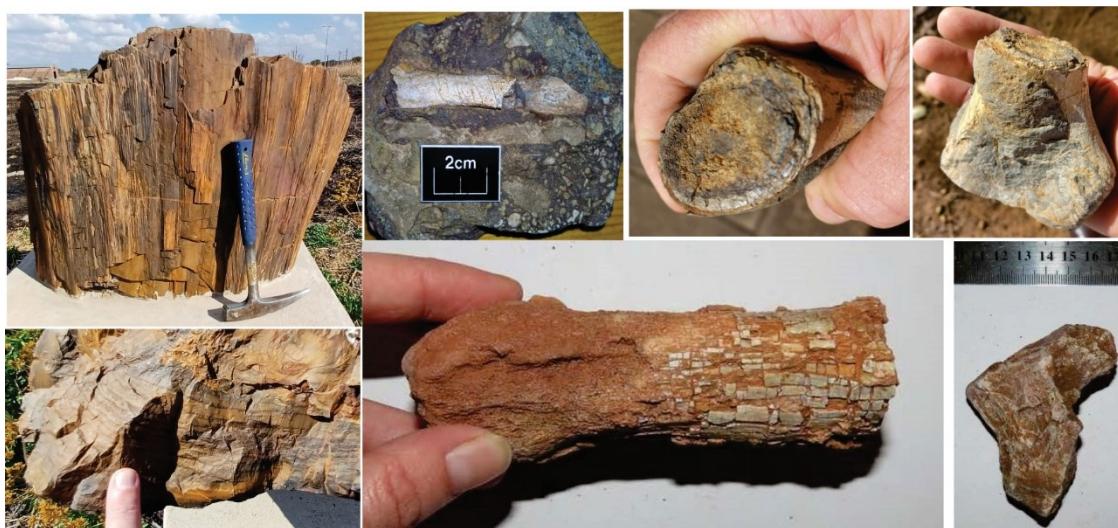
**Palaeontology** - Easily noticeable fossil remains from freshly exposed sedimentary rocks in the region may resemble petrified wood fragments of variable size that usually exhibit concentric ring-like structures or bones resembling odd shaped, nodular or cylindrical, stone-like objects (**Fig. 17**).

Figure 17. Easily recognizable features likely indicative of fossil remains within Adelaide Subgroup sedimentary rocks may include fragmentary silicified wood resembling stone-like objects of variable size exhibiting concentric ring-like structures in distal or proximal view (far left) and fossil bones resembling odd shaped, nodular or cylindrical, stone-like objects.

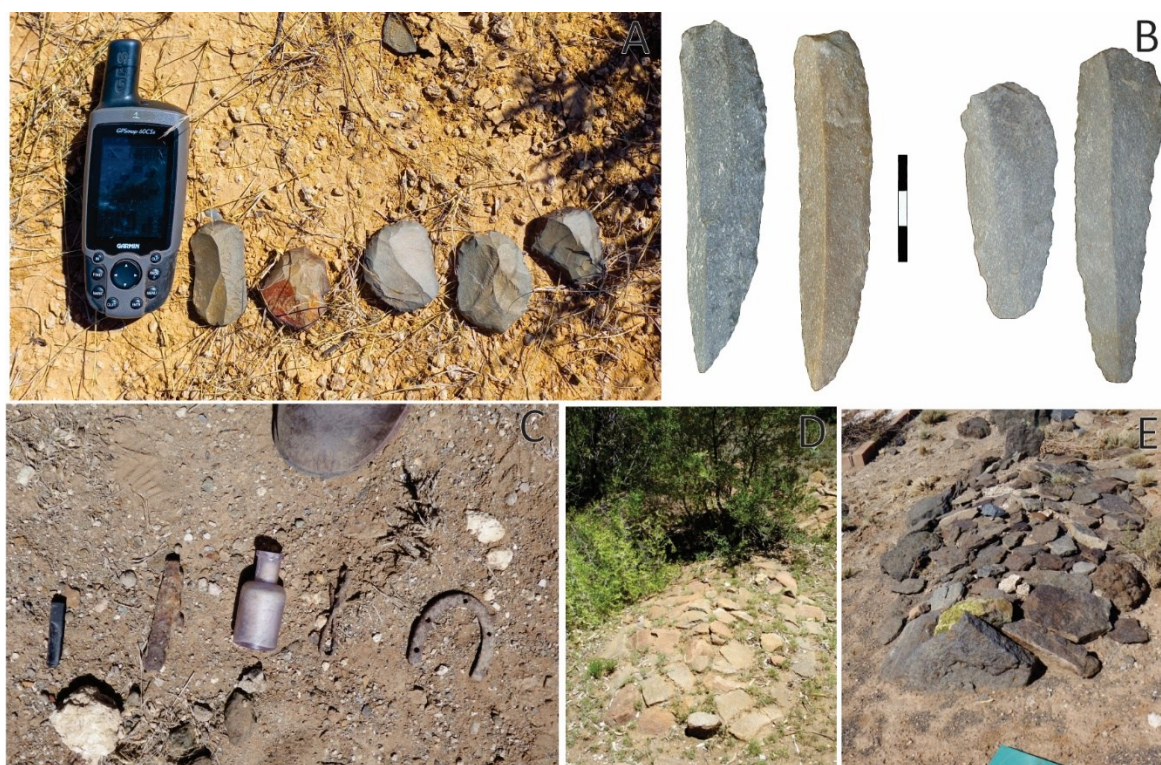
**Archaeology** - Archaeological remains that may be encountered in the project area include, but are not limited to, the following (**Fig. 18**): Stone Age lithic artefacts — typically presenting as concentrations of knapped debitage, retouched flakes and convergent points consistent with reduction or knapping sites — may occur on older, stable land surfaces beneath the aeolian sand cover and eluvial mantles, particularly in proximity to contact metamorphic zones where hornfels and indurated shale provided suitable raw material for stone tool manufacture. Surface scatters of glass, fragmented bone and corroded ferrous metal are diagnostic of late 19th- to early 20th-century refuse middens associated with historical-period farmstead occupation. Unmarked burial sites, which may lack formal headstones, are typically identified by low, tightly packed stone cairns or domed cobble coverings consistent with vernacular grave-marking traditions in the region.

Figure 18. Surface concentrations of knapped lithic debitage and retouched flake-tools (A) — including convergent flake-blades consistent with MSA typologies (B) — may signal deflated or shallowly capped in situ Stone Age occurrences. Localised surface scatters of glass, fragmented bone and corroded metal artefacts are diagnostic of late 19th- to early 20th-century refuse middens associated with historical-period occupation (C). In the absence of formal headstones, unmarked burial sites are typically identified by low, tightly packed stone cairns or domed cobble coverings — surface features consistent with historically vernacular grave-marking traditions (D, E).
